Futures Fire Risk Assessment

Futures Homeway, 1 - 11 Howard Close: NN11 4TD, - UPRN: 2020000 / 171928 / QA Approved / Colin Reilly

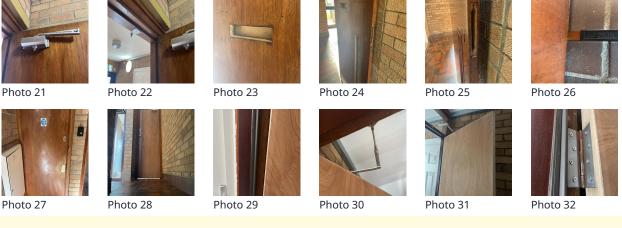
M1

Common area fire doors were all noted to be notional timber fire doors. None were seen to be installed with combined strips and seals. The following defects were noted:

- The ground floor lobby door had its self closing device disconnected

- The ground floor lobby door had holes in the leaf from old locking mechanisms and a letterbox that have both been removed

- Although no access was possible, there was visible damage to the leaf and frame of the electrical intake cupboard

- An excessive threshold gap was noted to the electrical intake cupboard door

- The 1st floor lobby door did not have fire rated hinges installed

1st floor lobby door had an excessive threshold gap

- Communal doors were not found to be installed with intumescent strips and cold smoke seals.

Due to the volume of defects found, and the electrical intake cupboard not being available for inspection, it is recommended that a fire door survey is completed in the block to identify all defects that exist. The results of the survey should be used to compose a risk based remedial program of works to rectify doors. Remedial works should be completed by a competent third party accredited contractor.
