Futures Fire Risk Assessment

Futures Homeway, Flats 27-32 Rodney
Close: NN11 4JZ, - UPRN: 2430000 /
171948 / QA Approved / Piotr Iwan

UPRN:	2430000
JOB NUMBER:	171948
FRA COMPLETED BY:	Pennington Choices Limited
FIRE RISK ASSESSOR NAME:	Lee Grint
INSPECTION DATE:	27 Oct 2023
REPORT STATUS:	QA Approved
REASSESSMENT PRIORITY	Medium - 2 Years
VALID TO: (QA Use Only)	13 Nov 2025
VALIDATION DATE: (QA Use Only)	13 Nov 2023
VALIDATED BY: (QA Use Only)	Piotr Iwan
VALIDATOR'S SIGNATURE: (QA Use Only)

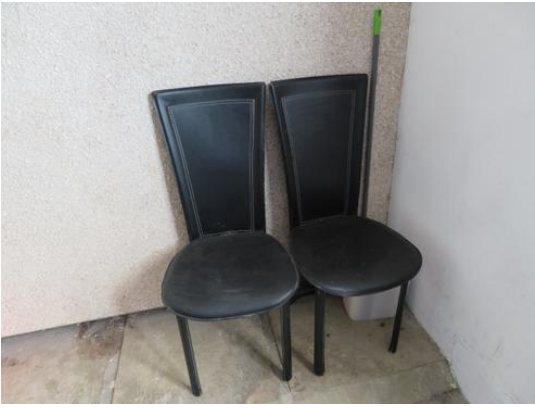
Photo 7

The common escape routes were clear of combustible materials, trip hazards and waste at the time of inspection with the exception of two chairs on the ground floor adjacent to the final exit door at the rear of the block.

Items noted should be removed from the communal areas as soon as is reasonably practicable. Residents should be informed that items must not be stored in the communal areas at any time. Regular checks should be conducted to ensure compliance.

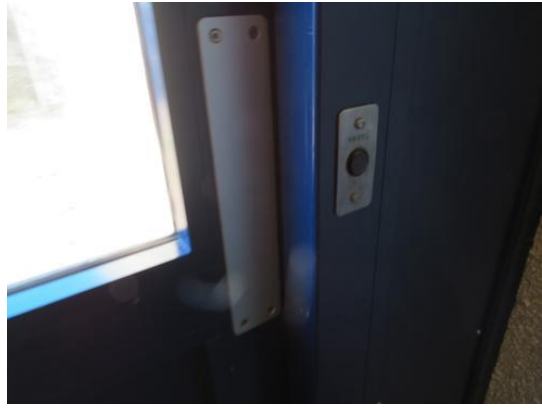
Photo 8

Push to exit release buttons are installed to the front and rear entrance doors for the block.

The client should confirm that the exit system defaults to an open position in the event of a power failure, or that it is installed with a battery backup power supply. The omission of a manual override in accordance with BS7273-4 is noted and acceptable if the above is confirmed and if malicious activation risk is high. If the risk of malicious activation is deemed to be low, the client should consider the installation of manual override systems to the entrance doors of the block.

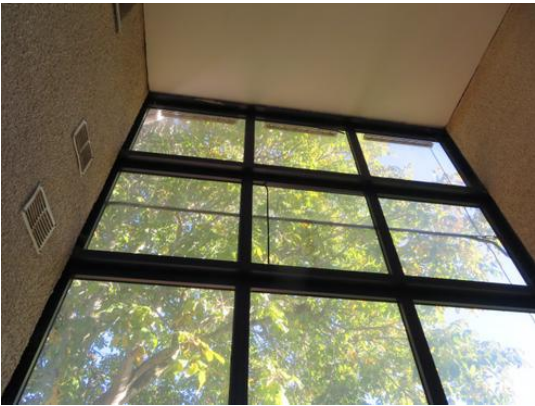
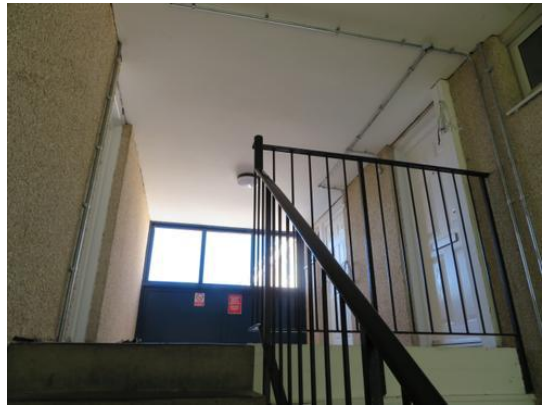
The block appears to have originally been designed as an open deck approach but subsequently has been enclosed. There are no means of ventilated the block on the first floor with fixed window units now in place.

The ventilation arrangements within the first floor should be assessed against the fire strategy document and the building regulations at the time of construction. Remedial works should be completed to ensure that the block is adequately ventilated if it does not meet the standard detailed above.

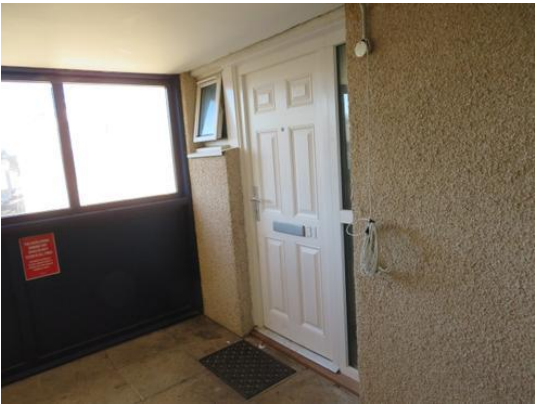
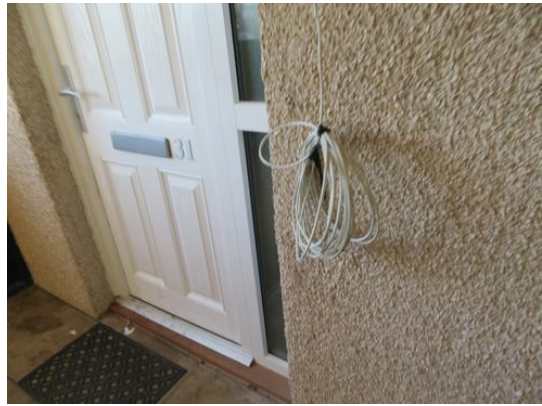
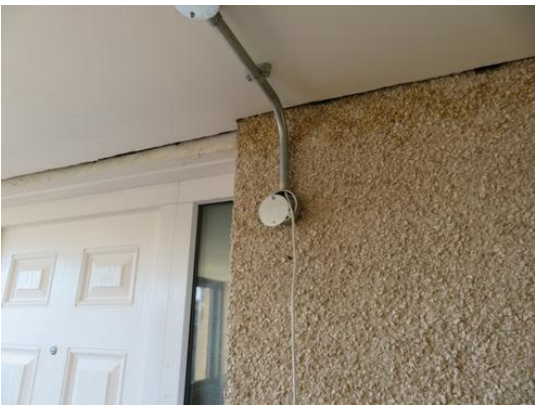
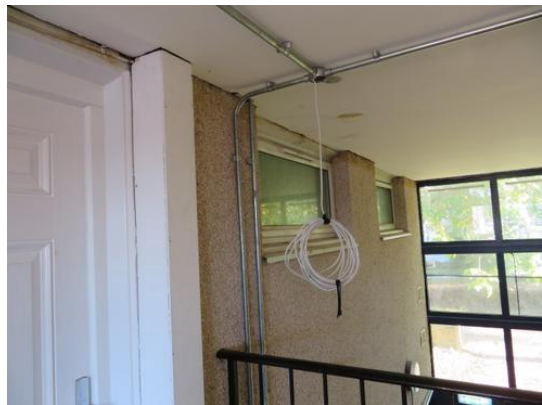
It was noted that two coiled sets of wires were hanging down outside of flat entrance doors on the first floor.

The hanging wiring noted should be made good as soon as is reasonably practicable to prevent cable entanglement scenarios for persons escaping the building in the event of a fire situation.

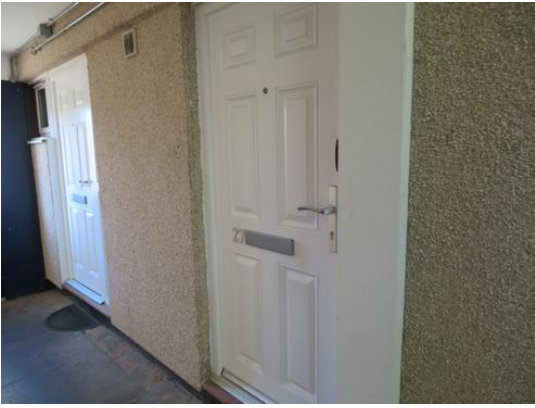
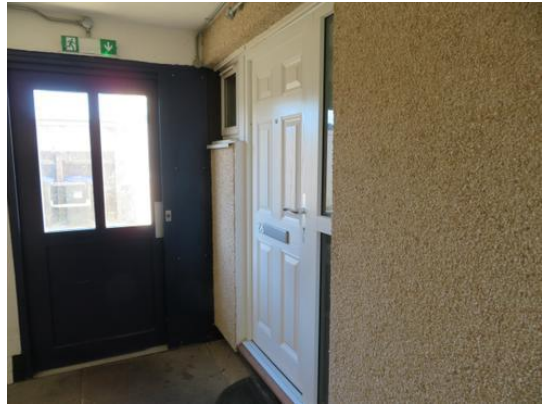
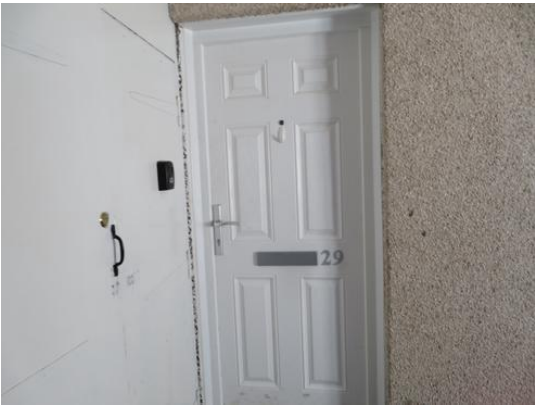
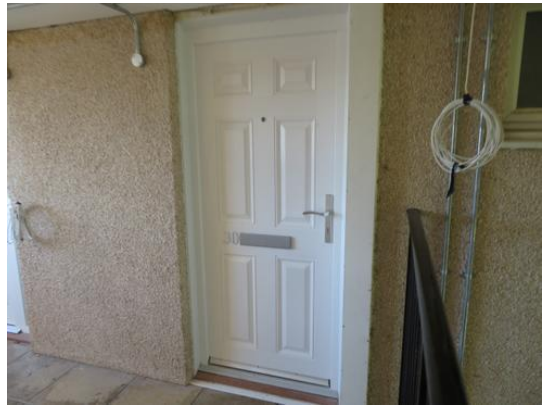
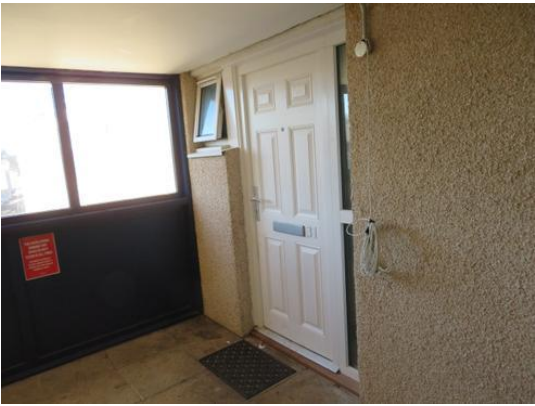
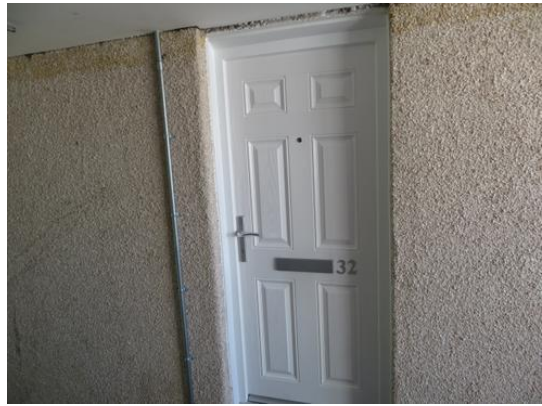
Flat entrance doors appeared to be replacement certified FD30 fire doors. (NB. - from limited visual inspection, certification not seen; adequacy of installation not confirmed).

No flats available for sample inspection at the time of the assessment.

Management should establish an ongoing programme of rolling checks to flat entrance doors to ensure they are installed with combined intumescent strips/cold smoke seals and positive action self-closing devices.

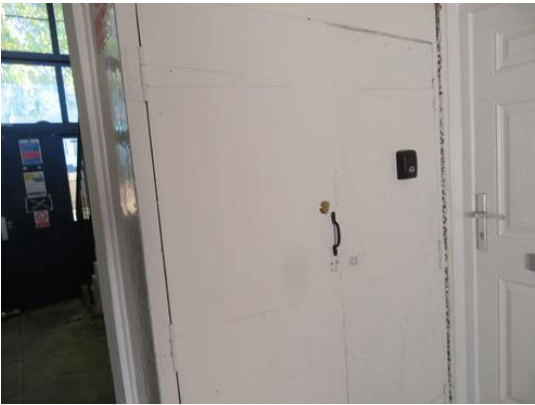
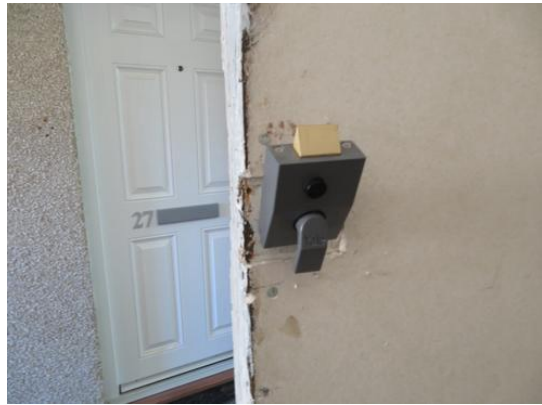
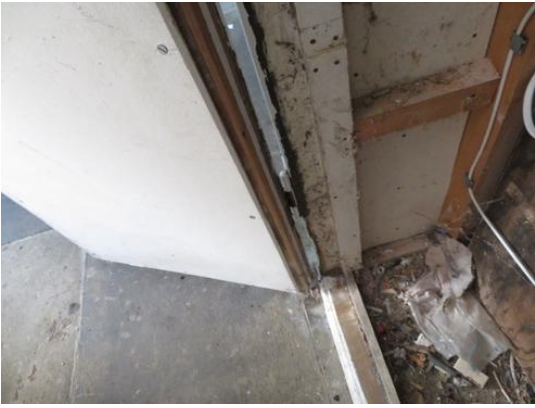
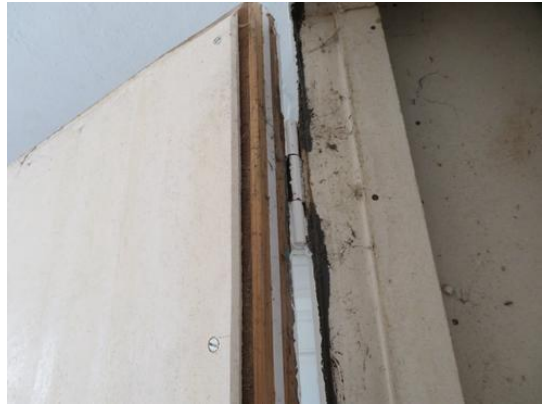
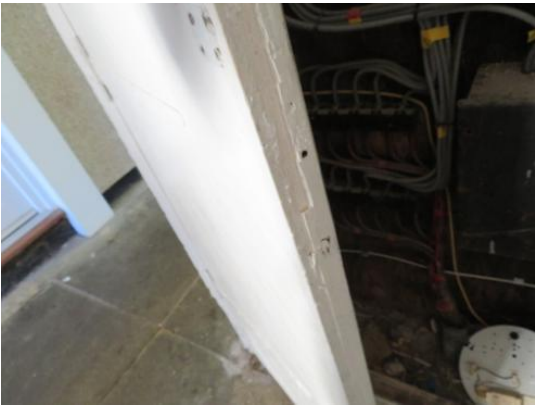
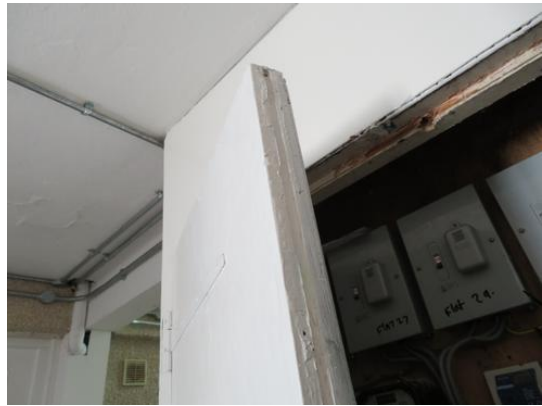
The doors noted to the electrical intake cupboard appeared to be 44mm thick solid core timber doors installed with intumescent strips only. The doors were noted to be in a poor state of repair with damage noted to the door edges and faces, and a damaged locking mechanism preventing the door from being locked shut when not in use.

The doors and locking mechanism for the electrical intake cupboard should be repaired or replaced to ensure that they remain locked shut when not in use and to ensure that they are adequately fire resisting for a minimum of 30 minutes. This should also include upgrading the current intumescent strips for combined intumescent strips and cold smoke seals across the entirety of both doors. Remedial works should be completed by a competent third party accredited contractor.

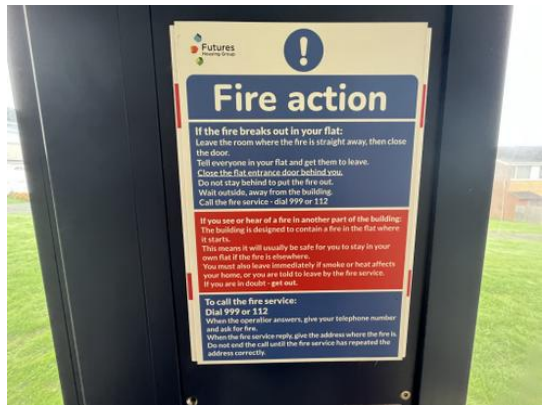
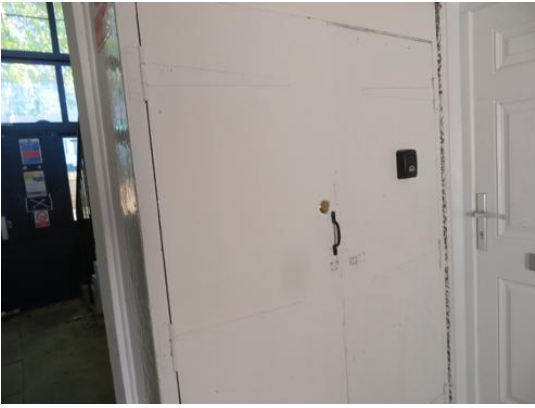
Fire door signage was not installed to the electrical intake door.
