Futures Fire Risk Assessment

Futures Homeway, Flats 22-27 Hawkins
Close: NN11 4GQ, - UPRN: 1930000 /
171944 / QA Approved / Colin Reilly

INSPECTION DATE: **26 Oct 2023**

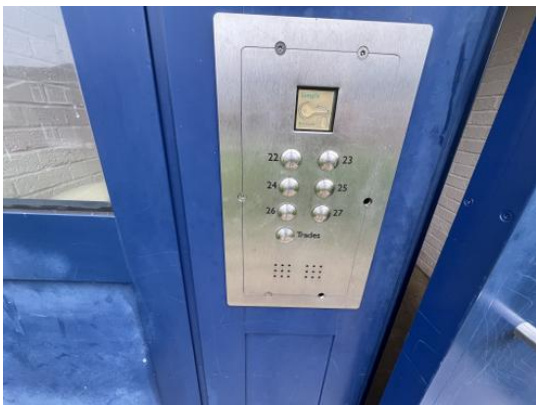
Photo 5

The front and rear doors did not appear to be locking closed with the mag lock system at the time of the assessment leaving the block open to unauthorised access.

The access control system should be repaired by a competent contractor to ensure the block remains secure against unauthorised access.

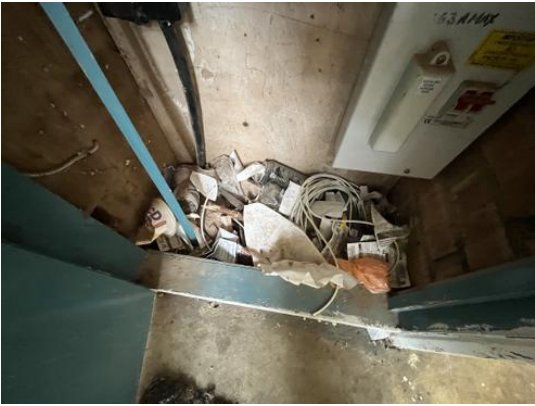
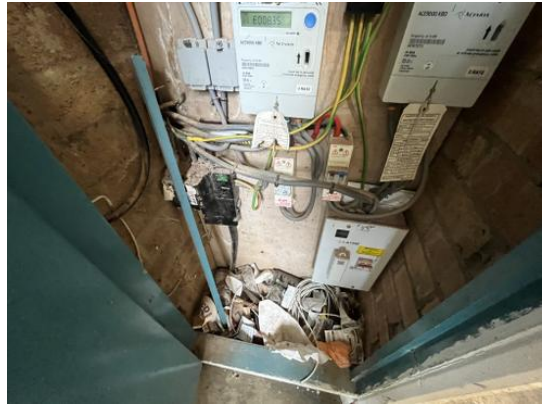
A build up of combustible waste was noted at the bottom of the electrical intake cupboard at the time of the assessment.

The waste materials noted should be removed and disposed of as soon as is reasonably practicable. Management should ensure that the door remains locked to the cupboard at all times when not in use. Regular checks to be conducted to ensure compliance.

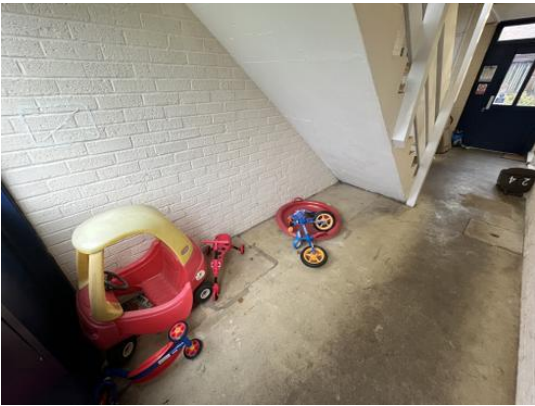
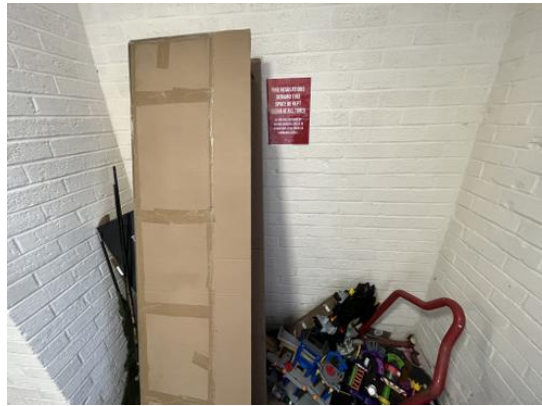
The common escape routes were clear of combustible materials, trip hazards and waste at the time of inspection with the exception children's toys under the stairs on the ground floor and children's toys stored in the alcove opposite flat 26 entrance door.

Items noted should be removed from the communal areas as soon as is reasonably practicable. Residents should be informed that items must not be stored in the communal areas at any time. Regular checks should be conducted to ensure compliance.

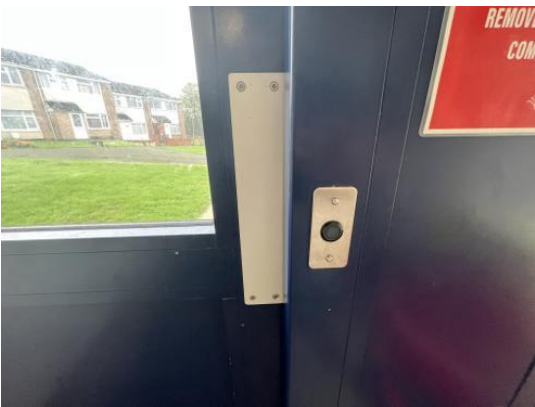
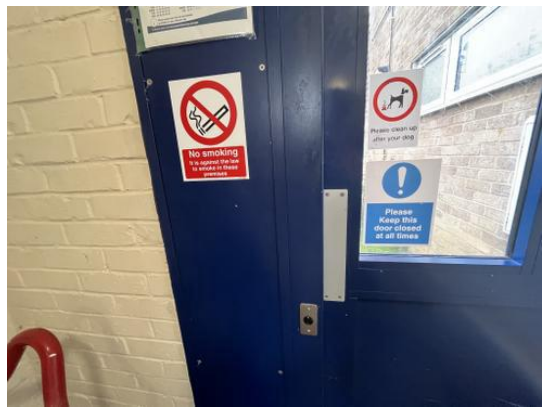
Push to exit release buttons are installed to the front and rear entrance doors for the block.

The client should conform that the exit system defaults to an open position in the event of a power failure, or that it is installed with a battery backup power supply. The omission of a manual override in accordance with BS7273-4 is noted and acceptable if the above is confirmed and if malicious activation risk is high. If the risk of malicious activation is deemed to be low, the client should consider the installation of manual override systems to the entrance doors of the block.
