# **Futures Fire Risk Assessment**

Futures Homeway, Flats 4-7 Dee Walk: NN11 4QN, - UPRN: 1650000 / 171925 / QA Approved / Paul Doodson

UPRN:	1650000	
JOB NUMBER:	171925	
FRA COMPLETED BY:	Pennington Choices Limited	
FIRE RISK ASSESSOR NAME:	Lee Grint	
INSPECTION DATE:	8 Sep 2023	
REPORT STATUS:	QA Approved	
REASSESSMENT PRIORITY	Low - 3 Years	
VALID TO: (QA Use Only)	1 Oct 2026	
VALIDATION DATE: (QA Use Only)	1 Oct 2023	
VALIDATED BY: (QA Use Only)	Paul Doodson

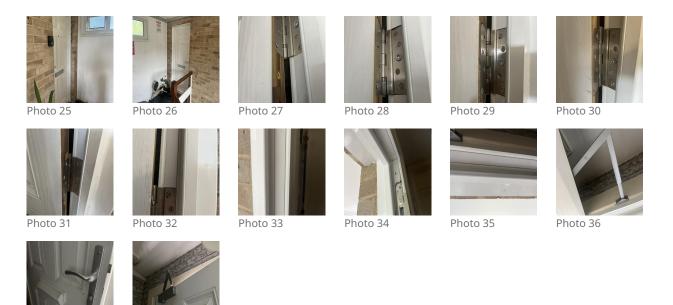
Photo 37

Flat entrance doors were seen to be FD30 fire rated doors. (NB. - from limited visual inspection, certification not seen; adequacy of installation not confirmed).

Flat 5 entrance door was seen to be a certified FD30 fire door leaf. The frame appeared to be a composite frame which was installed with intumescent strips and cold smoke seals. The door was installed with an overhead positive action self closing device.

No other flats accessed at the time of the assessment. Remaining flat entrance doors appeared uniform in design and appearance with Flat 5 entrance door.

Management should establish an ongoing programme of rolling checks to flat entrance doors to ensure they are installed with combined intumescent strips/cold smoke seals and positive action self-closing devices.

As flat entrances have been fitted with composite frames/doorsets, these should have test evidence demonstrating they meet the performance requirement in Building Regulations guidance for fire resistance and smoke control from the flat side only. Management should confirm that suitable fire door test certificates are held and that these relate to the doors fitted. If adequacy cannot be confirmed it may be necessary for frames/doorsets to be replaced under a risk-based programme.

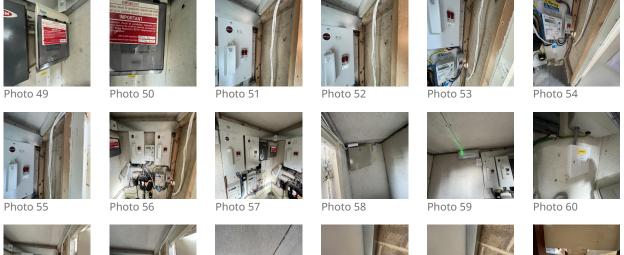
Photo 66

The electrical intake cupboard did not appear to be adequately fire resisting. Compartment boundaries were not adequately sealed and construction to the front wall and ceiling did not appear to be constructed from fire resisting materials. As the cupboard is located directly beneath the escape stairs which appear to be constructed from timber, this is deemed a high risk. Penetrating services were also not seen to be adequately fire stopped.

The electrical intake cupboard should be upgraded to ensure that the compartment offers a minimum of 60 minutes resistance from fire. This should include the fire stopping of all

penetrating services. Remedial works should be completed by a competent third party accredited contractor.

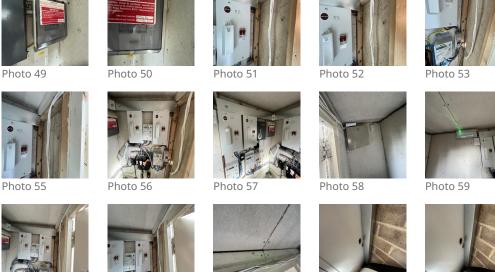
The electrical intake cupboard did not appear to be adequately fire resisting. Compartment boundaries were not adequately sealed and construction to the front wall and ceiling did not appear to be constructed from fire resisting materials. As the cupboard is located directly beneath the escape stairs which appear to be constructed from timber, this is deemed a high risk. Penetrating services were also not seen to be adequately fire stopped.

Action/Recommendation Required?	Yes
Action Priority:	High - 1 Month
