Futures Fire Risk Assessment

Futures Homescape, Valerie Hanson
House: NN2 7JQ, - UPRN: JUN002-BLK /
173568 / QA Approved / Colin Reilly

INSPECTION DATE: 20 Oct 2023

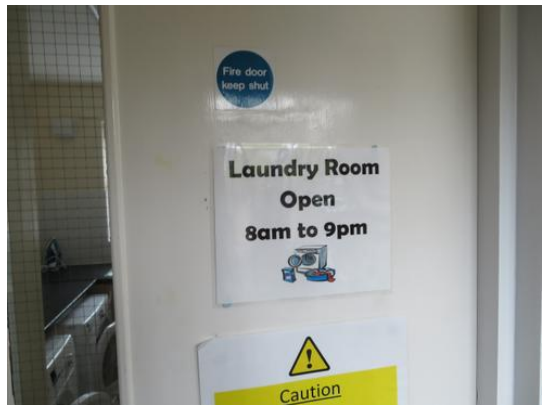
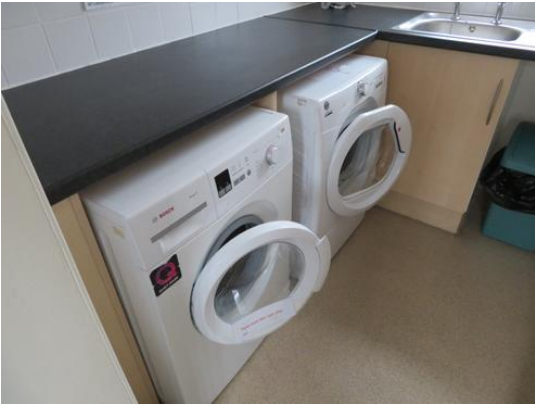
The laundry room is installed with drying machines. There was no evidence to suggest regular checking of the lint traps, nor any signage erected to instruct residents to empty traps at the end of each use.

Management should ensure that lint traps for dryers are emptied regularly. Signage should be erected instructing residents to empty the traps following each use. Regular checks should be conducted and recorded to ensure compliance.

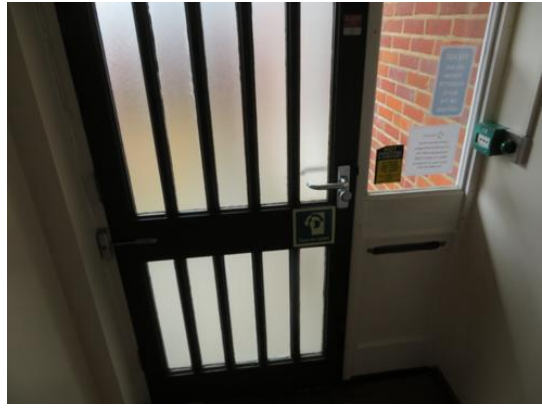
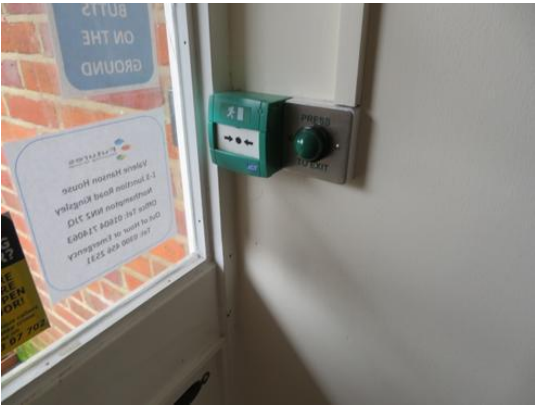
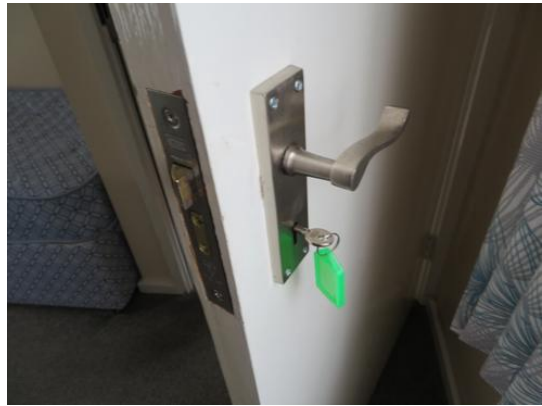
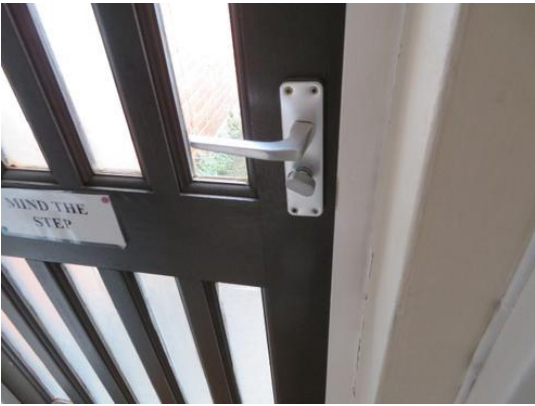
All doors on escape routes are fitted with ironmongery which is easily opened without the use of a key, and there are no sliding or revolving doors with the exception of the door leading from the staff bedroom to the escape route which is lockable with a key.

The front entrance door to the block was installed with a push button override with an emergency call point installed to override the mechanism in the event of an emergency.

The lockable door noted should have the locking mechanism replaced with a thumb turn style mechanism.

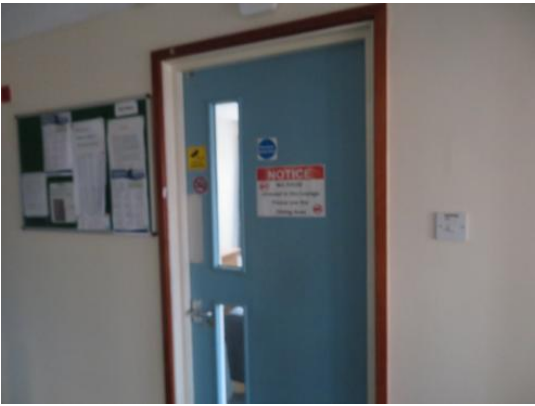
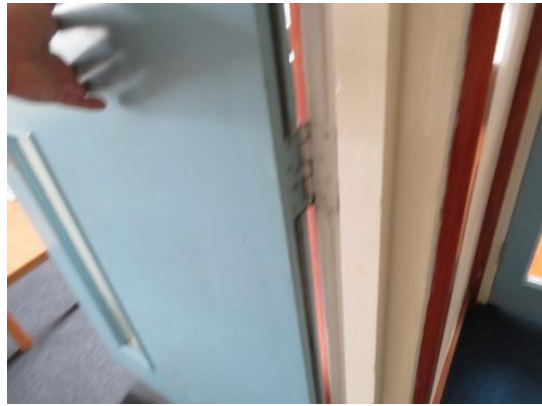
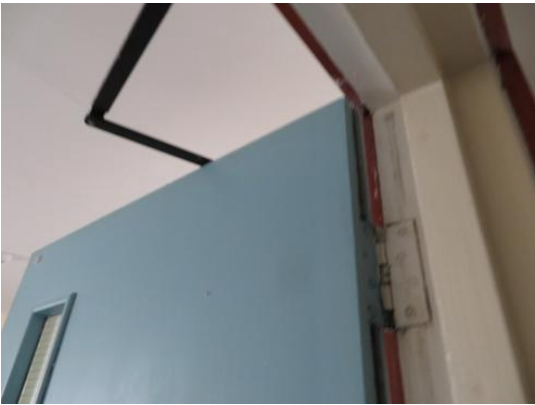
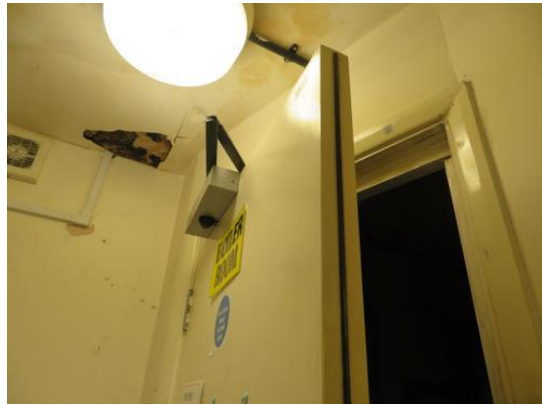
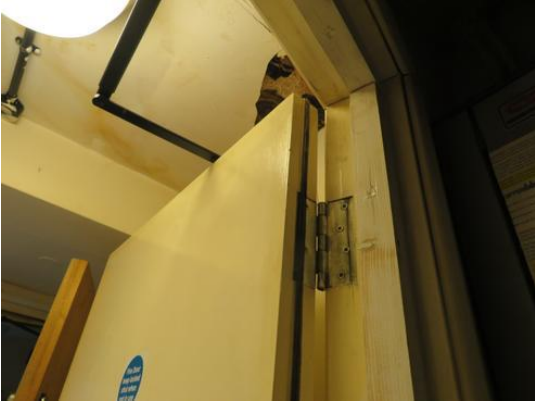
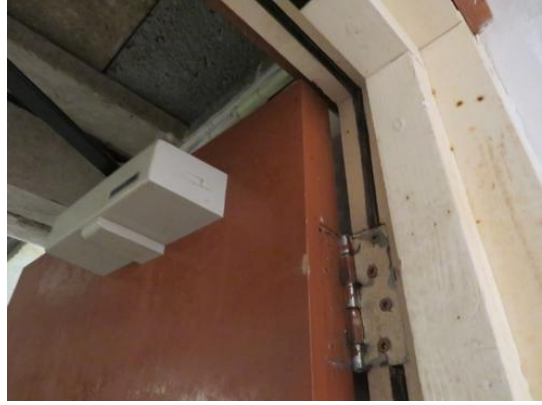
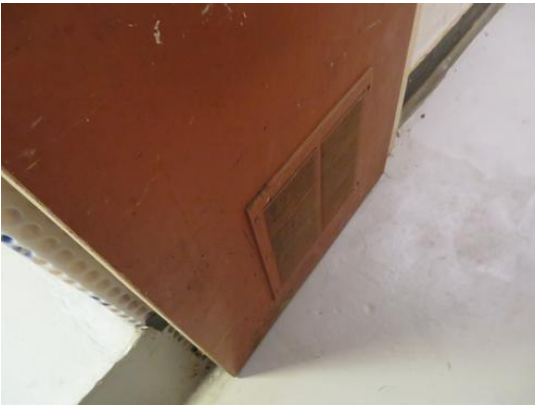
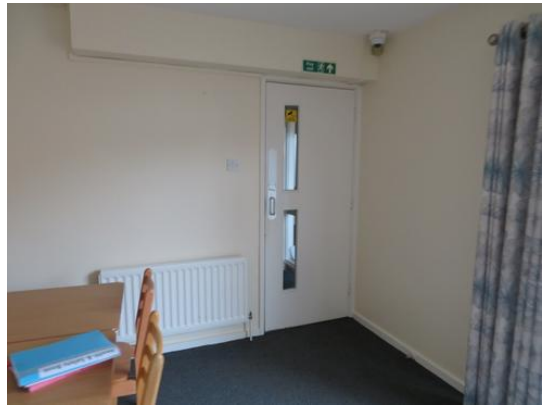
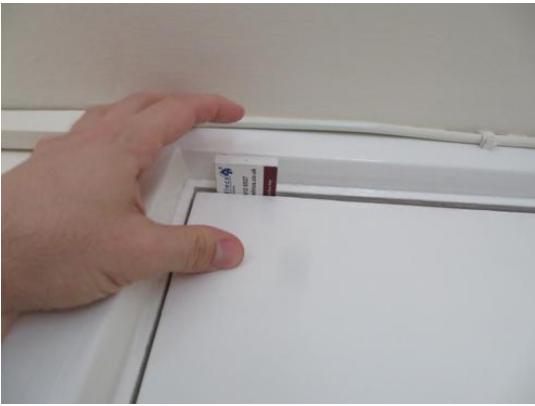
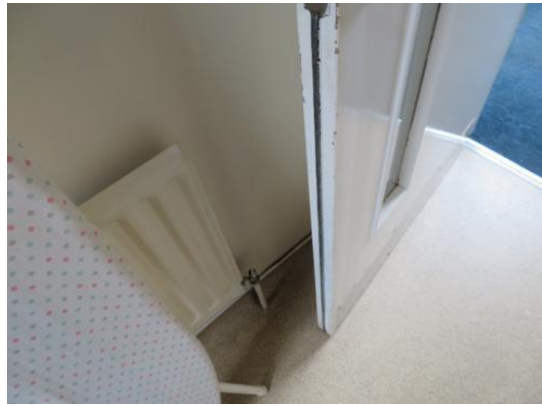
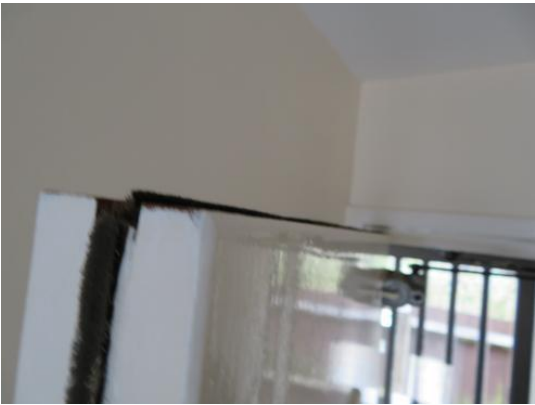
- An air transfer grille was installed to the cellar fire door. This did not appear to be an intumescent grille
- Excessive perimeter gaps were noted to the fire door leading from the dining room back into the main house.
- Excessive threshold gaps were noted to the door leading from the kitchen to the staff areas.

Doors noted with excessive perimeter and/or threshold gaps should be repaired by a competent contractor to reduce the gaps to within acceptable tolerances. If doors cannot be repaired then they should be replaced with FD30/S certified replacements. Remedial works should be completed by a competent contractor.

It is recommended that the grille noted to the cellar fire door is replaced with an intumescent style grille. Alternatively the door should be replaced with an FD30/S timber fire door with intumescent grille installed if required.

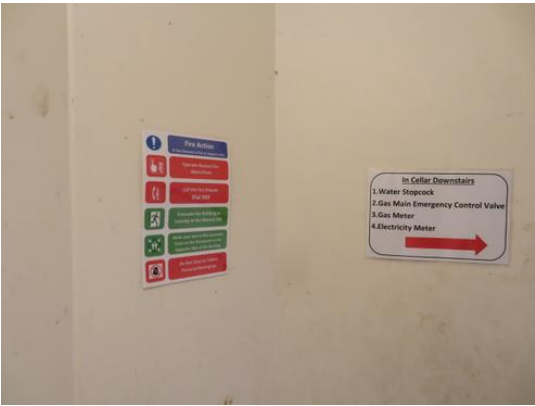
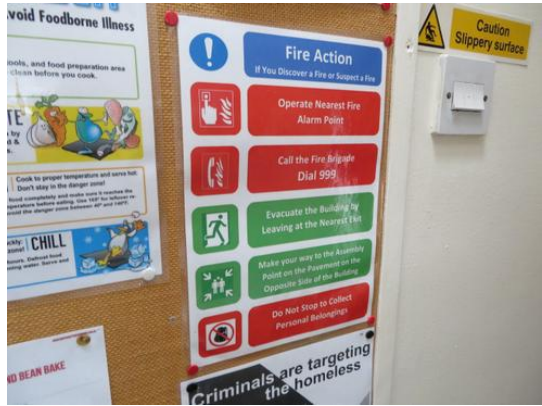
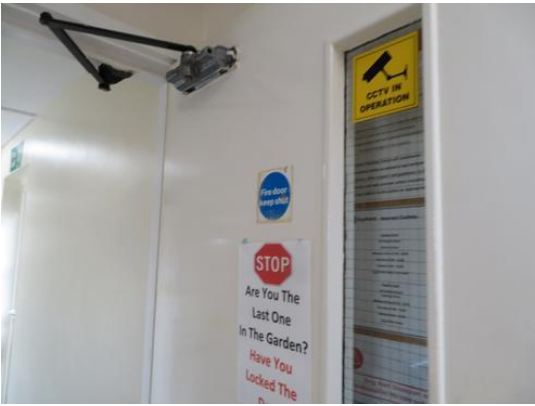
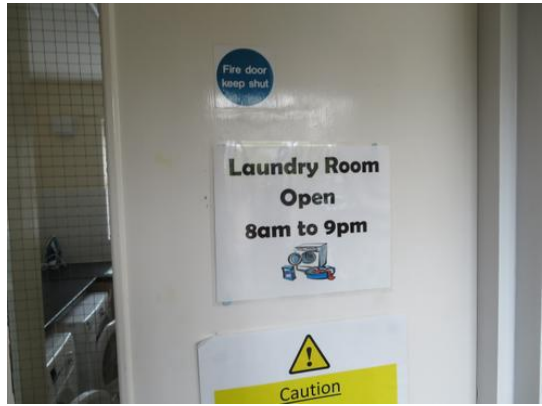
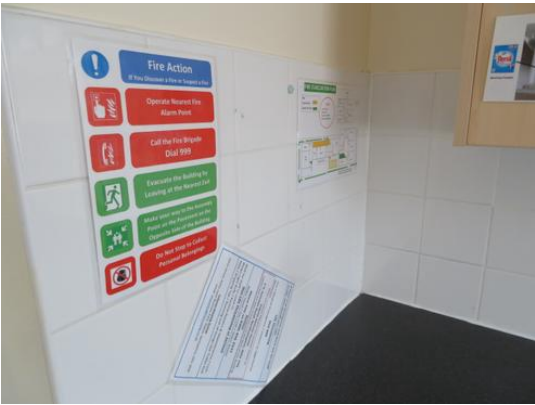
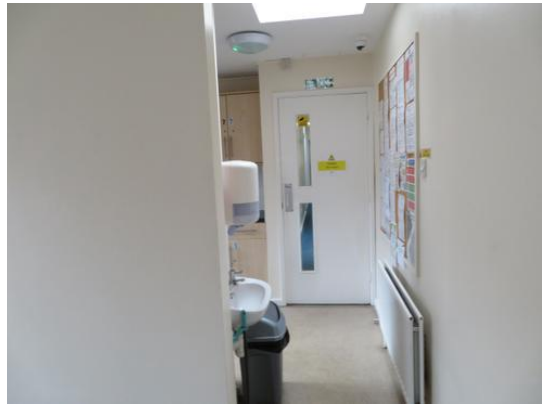
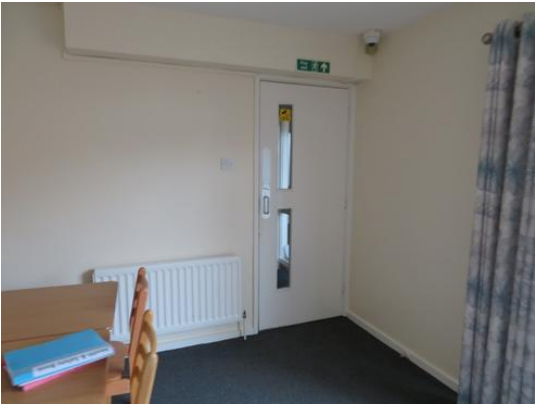
Fire door signage was installed where required with the exception of the fire door leading into the main building from the dining room and from the kitchen to the staff areas.

'Fire Door - Keep Shut' signage should be installed to both faces of the door noted.

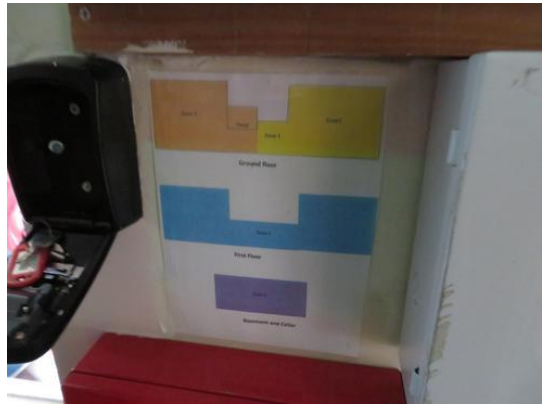
Photo 54

Although a zone map is installed, it is not compliant with BS5839:1.

BS 5839-1: states that zone plans are required on every system of any size. A zone map indicating the following should be provided.

- The zone plan must be a geographical representation of the building clearly showing the division into fire alarm zones;
- The drawing of the building layout should clearly show final exits, common escape routes, circulation areas and stairs;
- Fire alarm zones must be clearly identifiable;
- You must indicate a 'You Are Here' point on your zone plan.
