Futures Fire Risk Assessment

Futures Homeway, 5-8 Dane Court, Church Road:
NN11 7HG, - UPRN: 340001 / 171936 / QA
Approved / Andy Cloke

Futures Homeway, 5-8 Dane
Court, Church Road: NN11 7HG,
- UPRN: 340001, Fire Risk
Assessments, Futures
Homeway

INSPECTION DATE: 14 Sep 2023

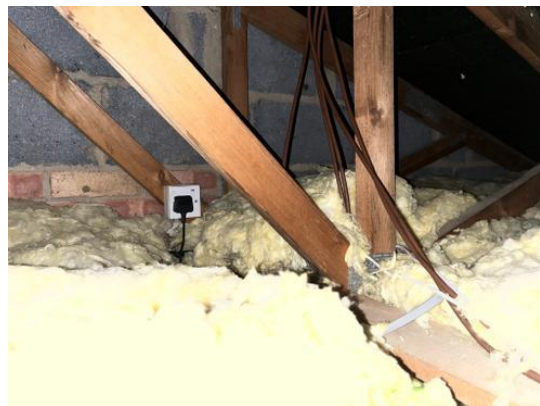
Photo 4

A portable appliance was noted in the loft space. This had no visible testing stickers attached.

The client should ensure that the portable electrical item located the loft forms part of the PAT testing schedule mentioned in the Policy Principle.

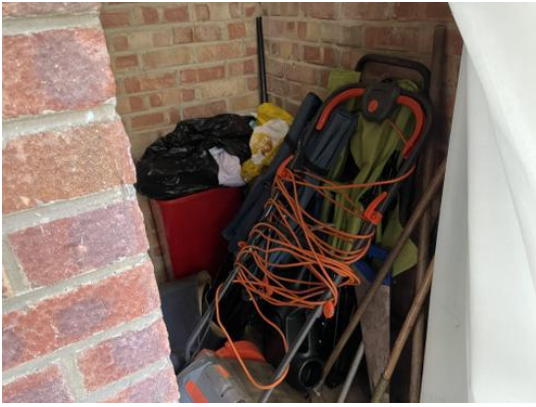
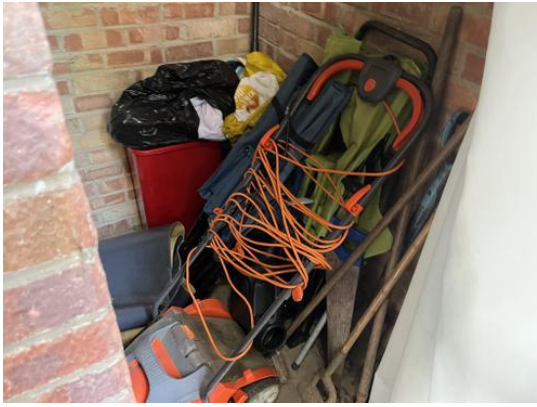
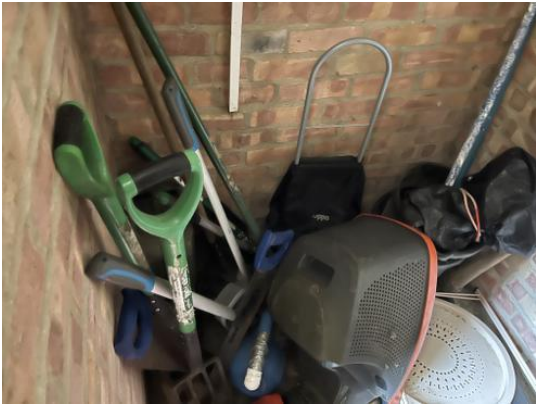
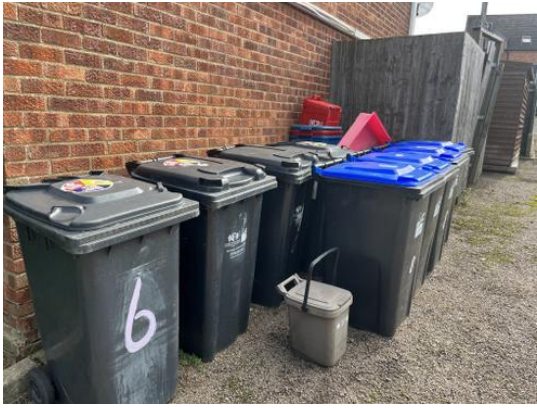
Wheelie bins were noted to be stored to the rear of the block close to the boundary wall.

It was noted that an open storage area adjacent to the rear entrance door for the block was being used by residents for storage.

The open store adjacent to the block entrance door should only be used for storage of non-combustible items. There should also be no storage of sources of ignition. It is recommended that signage be erected to detail this policy with regular checks conducted to ensure compliance.

The wheelie bins noted should be relocated away from the building a minimum of 2 meters. Ideally bins should be placed in a secure bin store. Regular checks should be conducted by the client to ensure that bins remain away from the building in their designated storage area.

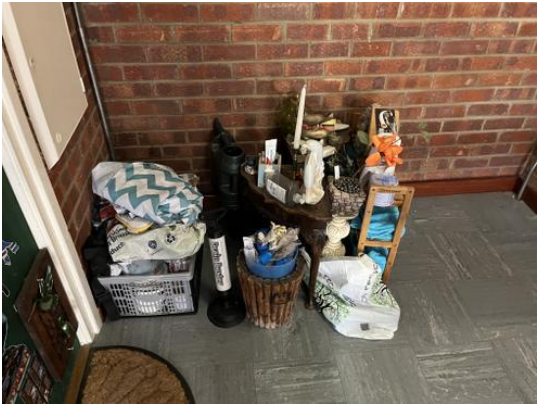
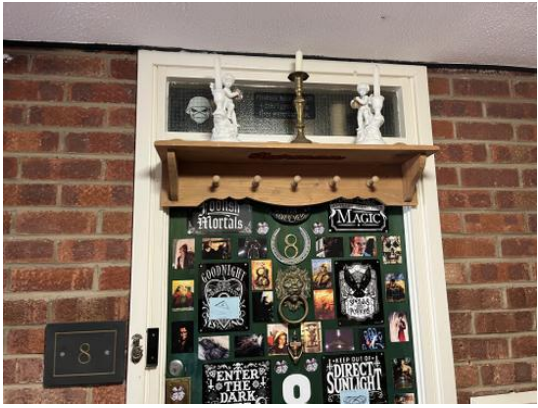
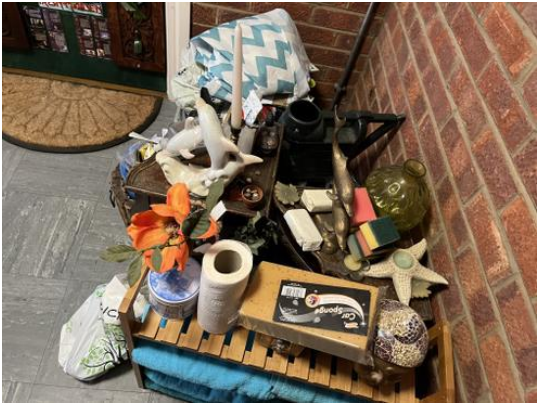
The following items were noted on the escape routes:

- Large amount of personal items stored outside of flat 8 entrance door
- A shelf was affixed to the frame of flat 8 entrance door. This was used to hold candles.

Items noted should be removed from the communal areas as soon as is reasonably practicable. Residents should be informed that items must not be stored in the communal areas at any time. Regular checks should be conducted to ensure compliance.

The shelf affixed to flat 8 entrance door should be removed as soon as is reasonably practicable.

Residents should be informed that items must not be affixed to flat entrance doors or frames and that candles must never be used in the common areas under any circumstances. Regular checks should be conducted to ensure compliance.

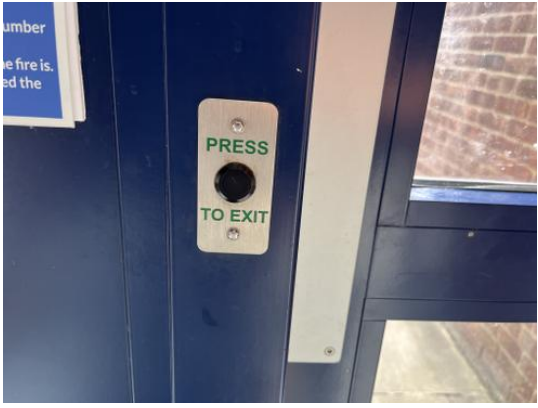
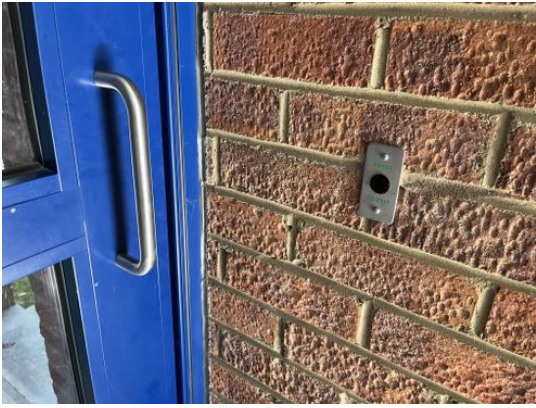
Push to exit release buttons are installed to the front and rear entrance doors for the block. It is not known if the doors failsafe to open in the event of a power failure or if a battery backup device is installed. No emergency override was seen to be installed.

The client should conform that the exit system defaults to an open position in the event of a power failure, or that it is installed with a battery backup power supply. The omission of a manual override in accordance with BS7273-4 is noted and acceptable if the above is confirmed and if malicious activation risk is high. If the risk of malicious activation is deemed to be low, the client should consider the installation of manual override systems to the entrance doors of the block.

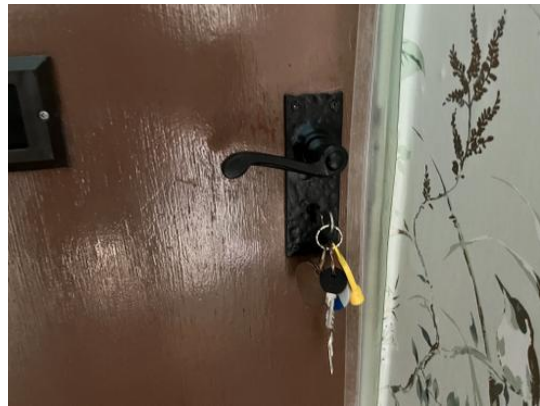
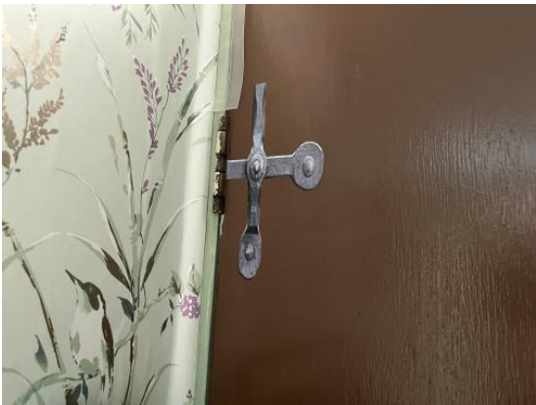
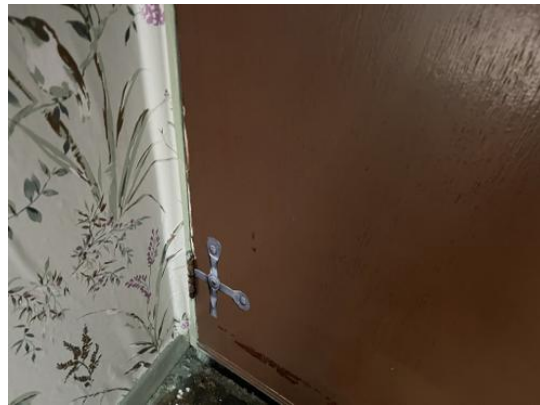
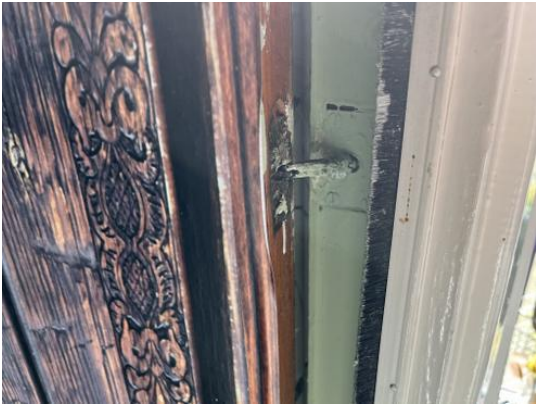
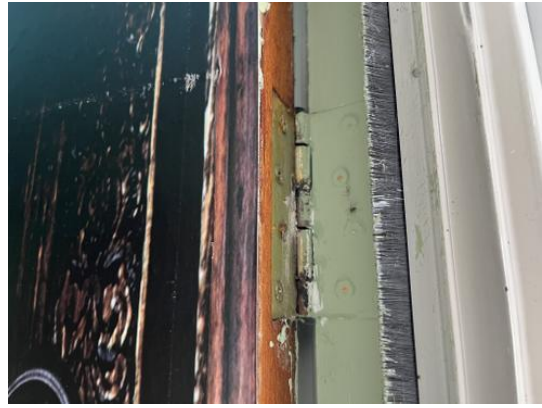
Flat 6 and Flat 8 entrance doors were covered in vinyl/stickers.

Sample inspection of flat 6 entrance door found it to be a notional timber fire door. The door was installed with a perko style closer and 25mm door stops. The door had excessive perimeter gaps. A mortice style lock was installed requiring the use of a key to open the door.

Flat 6 entrance door should be repaired or replaced to reduce the perimeter gaps to 3mm +/- 1mm. Remedial works should be completed by a competent third party accredited contractor.

It is recommended that flat 6 entrance door locking mechanism is replaced with a thumb turn style arrangement. Remedial works should be completed by a competent contractor.

Stickers should be removed from the flat entrance doors noted. Stickers could promote the spread of fire across the surface of the door. Residents should be informed that stickers/vinyl should not be affixed to flat entrance doors as it could compromise the fire rating of the door. Regular checks should be conducted to ensure compliance.
