## Futures Fire Risk Assessment

Futures Homescape, Apartments 1-9 The Maltings Old Brewery Yard: NG16 2YT, - UPRN: 15322 / 173596 / QA Approved / Jack McLinden

**INSPECTION DATE:** 19 Dec 2023

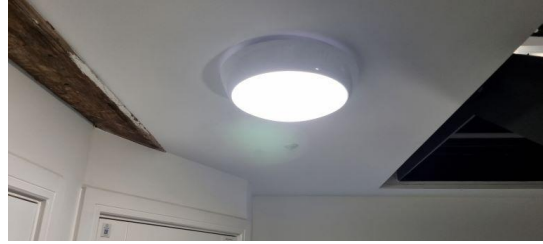
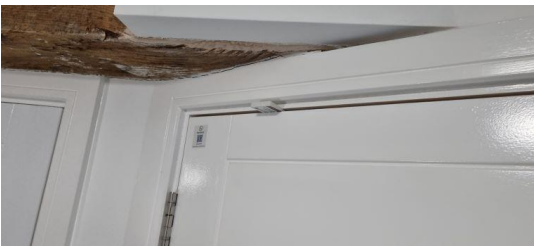
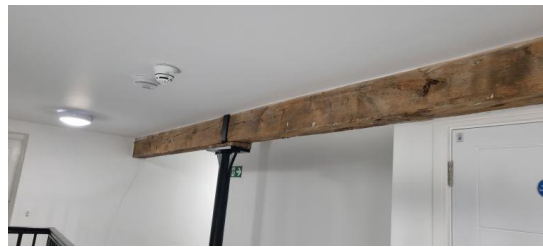
Walls and ceilings are plaster / plasterboard with emulsion painted finish. Stairs are metal construction with plasterboard underside. Floors to the first and second floor are wooden with solid floor to the ground floor. There are wooden beams to each floor on the escape route; it was not possible to establish if beams have been treated with fire retardant materials. Also refer to section Q regarding compartmentation issues.

Management should confirm if wooden beams have been treated with flame retardant materials. Where timber has not been treated it should be treated or covered with fire retardant materials.

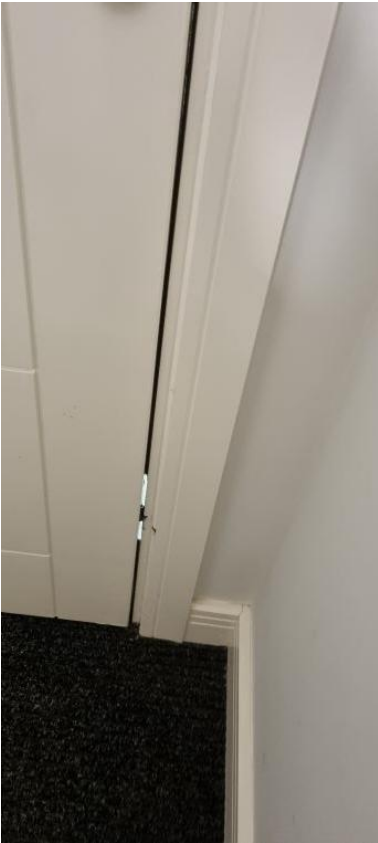
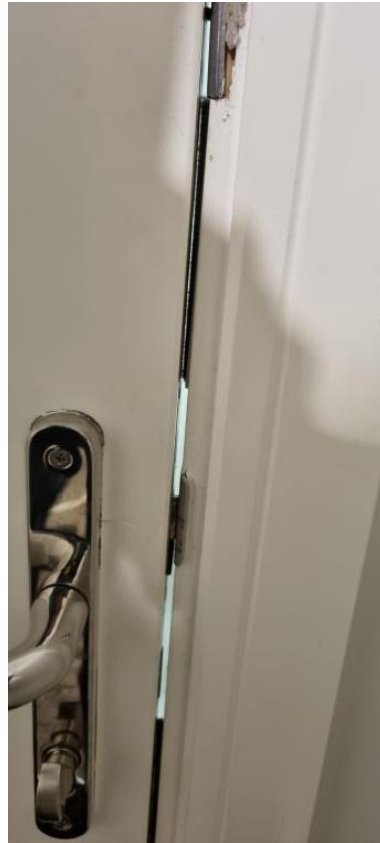
Flat 9 was sampled. The door is labelled to confirm that it is a PWL fire door to FD30 specification. Intumescent strips are fitted however gaps around the door are excessive. In addition, it was not possible to establish fire rating / condition of other dwelling doors as no other flats were accessible.

Intumescent strips are fitted however gaps around the door are excessive. In addition, it was not possible to establish fire rating / condition of other dwelling doors as no other flats were accessible.

Management should repair the door to flat 9 to ensure that gaps around the door meet the required 4mm tolerance. Any repair should only be conducted by a certified fire door contractor.

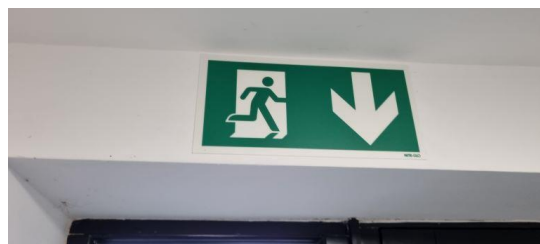
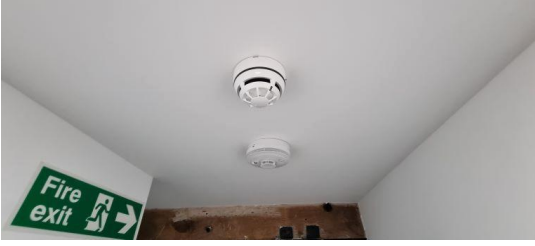
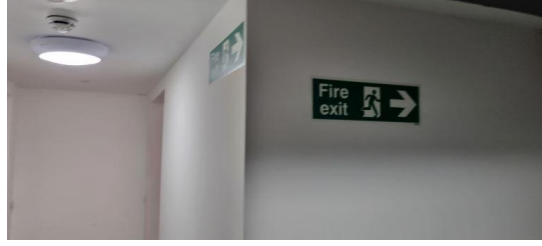
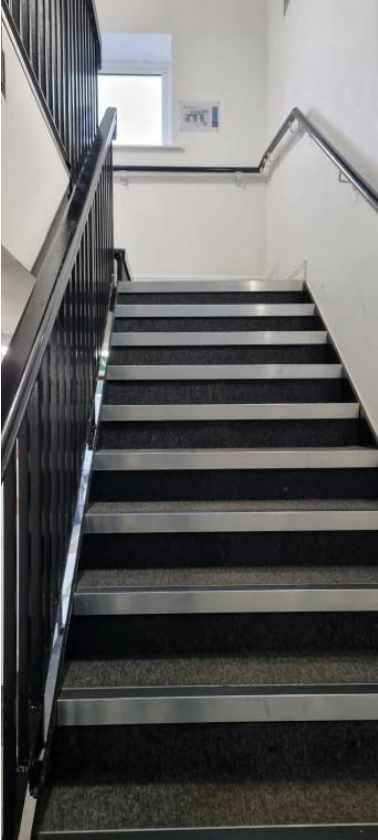
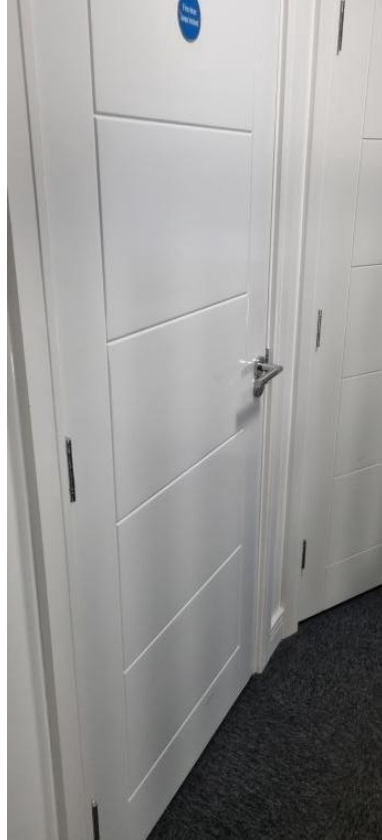
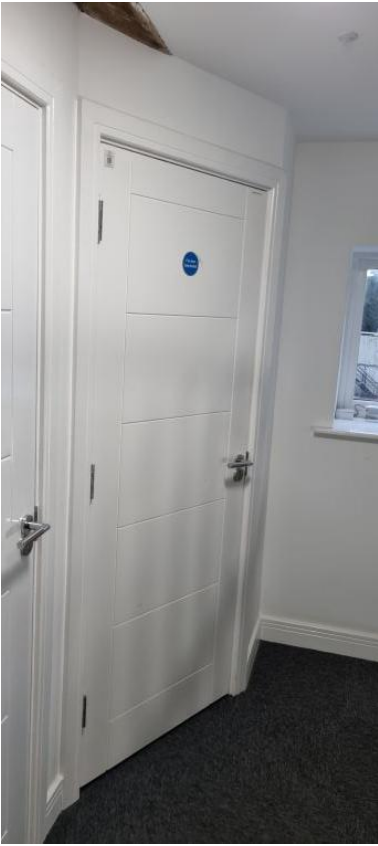
A Fire Action Notice is displayed. Directional signage is displayed and service risers have fire doors signs attached. The FAN notice advises of a simultaneous evacuation. Home Office Guidance usually recommends as Stay Put policy, however common area AFD is installed (Refer to P1).

Depending on the outcome of P1, the FAN may require amending to a Stay Put policy.

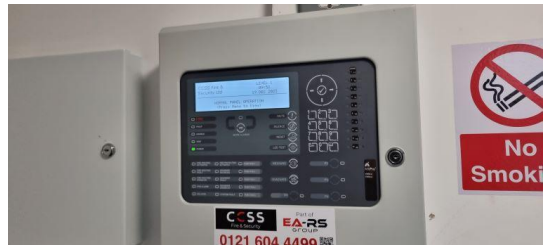
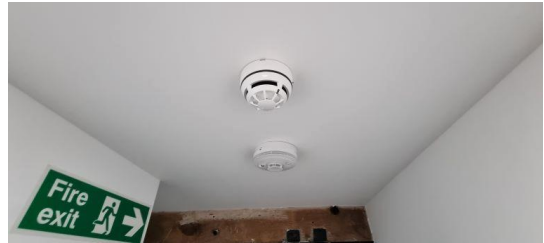
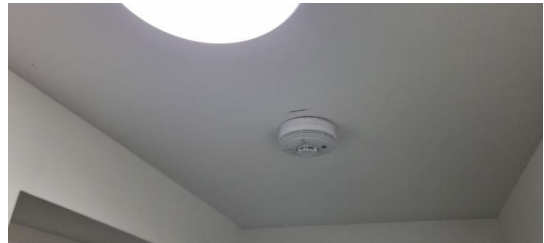
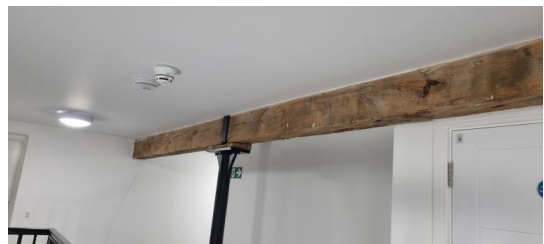
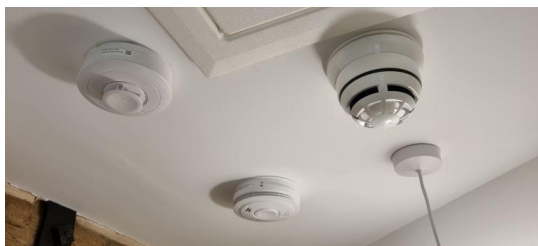
There is no manual fire alarm system however an automatic alarm system with hard wired AFD is installed to common area. "Section 20.4 of the guidance used highlights how in 'general needs' blocks designed to support a 'stay put' policy, it is unnecessary and undesirable for a fire alarm system to be provided. A communal fire detection and alarm system will inevitably lead to a proliferation of false alarms. This will impose a burden on fire and rescue services and lead to residents ignoring warnings of genuine fires. This is dependent on compartmentation within the block. The fire alarm panel is located within the ground floor lobby with no defects visible.

Responsible person to confirm that the installed alarm system is warranted, appropriate and effective. Depending on the outcome modify system accordingly.

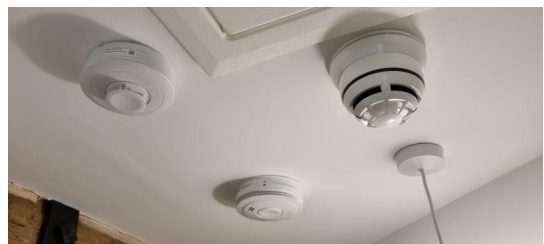
It was not possible to establish the arrangements for silencing and resetting the communal alarm system.

Management should confirm the arrangements for silencing and resetting the communal AFD system and ensure that it is communicated to residents.

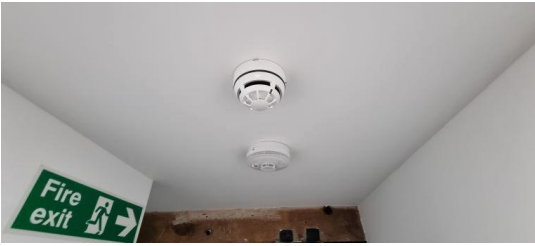
Hard-wired smoke detection and linked detection is installed to the hallway of the dwelling sampled. It was not possible to establish if detection is installed to other rooms within the dwelling (Type 1 Survey). In addition, it was not possible to establish the level of detection to other flats within the block as no other dwellings were accessible.

Management should ensure that hard-wired smoke / heat detection is installed to all flats within the block, in accordance with BS5389-6:2019 (Grade D1, LD2 smoke alarms). If found not to be, install to this standard. All work to be carried out by a third-party accredited fire alarm company.

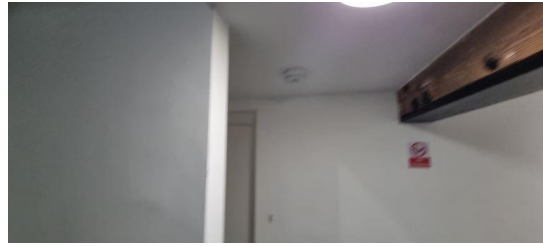
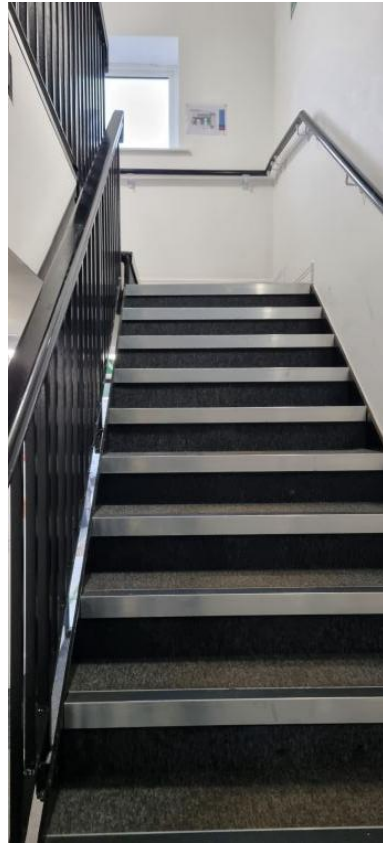
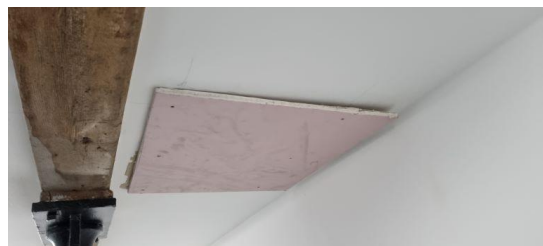
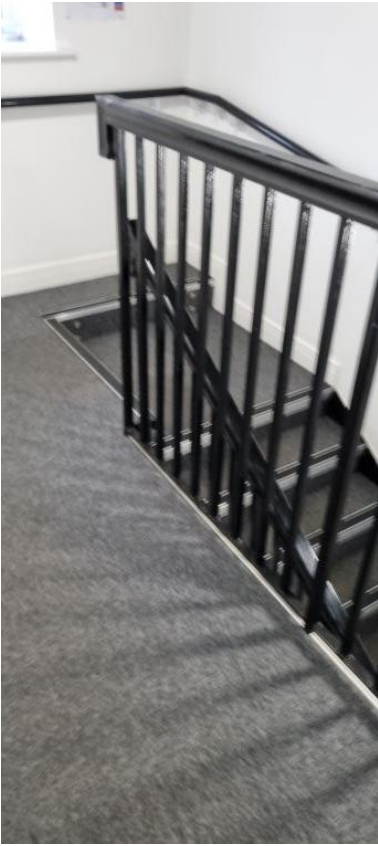
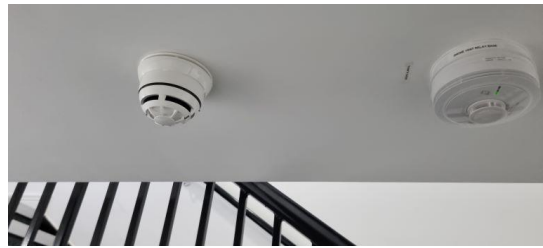
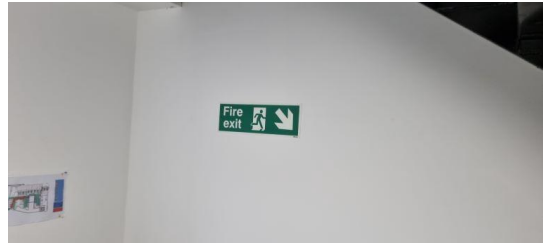
Walls are of solid plastered / plasterboard with emulsion painted finish. Ceilings are plaster / plasterboard with emulsion painted finish. Floors to the first and second floors are wooden construction with a solid ground floor. The stairway is metal construction with plaster boarded underside. There has been some repairs to ceilings (presumed water damage) where plaster board patches have been installed however, there are some gaps present that may allow smoke / flame ingress.

Management should ensure that any ceiling repairs are adequately sealed with fire rated building materials.
