Futures Fire Risk Assessment

Futures Homeway, Greenhill Court: NN6
7PG, - UPRN: 4319990 / 171952 / QA
Approved / Paul Doodson

UPRN:	4319990
JOB NUMBER:	171952
FRA COMPLETED BY:	Pennington Choices Limited
FIRE RISK ASSESSOR NAME:	Lee Grint
INSPECTION DATE:	20 Oct 2023
REPORT STATUS:	QA Approved
REASSESSMENT PRIORITY	High - 1 Year
VALIDATED BY: (QA Use Only)	Paul Doodson

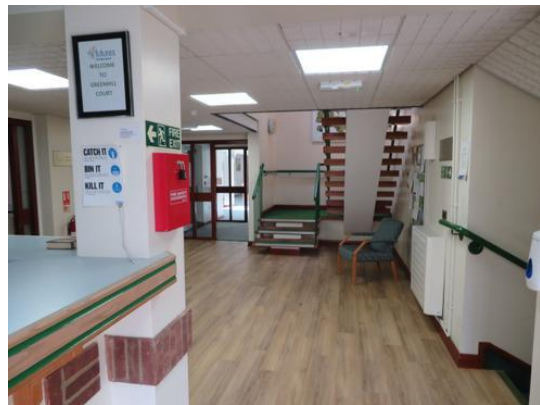
Photo 89	
T4	
Are there suitable arrangements for liaison and calling the Fire Service?	Unknown
Residents are required to call the Fire and Rescue Service in the event of a fire. It has also been recommended that internal smoke detection is connected to the telecare system for external monitoring. See P8 for recommendation.
