Futures Fire Risk Assessment

Futures Homeway, Warwick Court
 Warwick Court: NN11 4XB, - UPRN:
 2729990 / 325660 / QA Approved / Andy
 Cloke

INSPECTION DATE: 16 Apr 2024

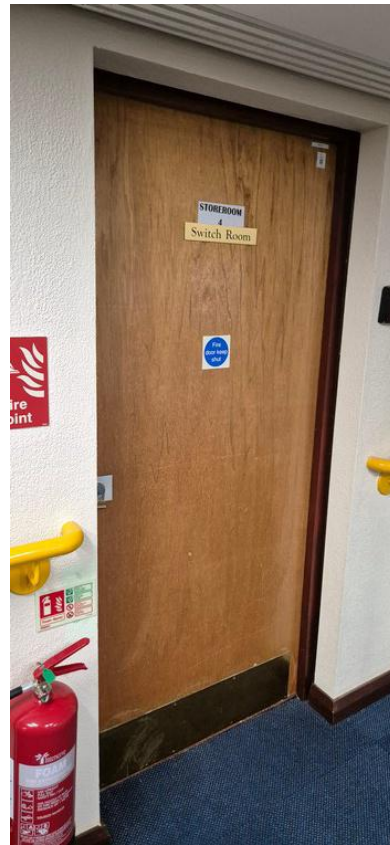
Photo 21

No combustible materials in proximity to ignition sources were identified within common areas however, there are plant / intake rooms that were not accessible. It was not possible to establish if there are any combustible materials stored in proximity of ignition sources within.

Management should inspect plant rooms / electrical intake rooms to ensure that combustible materials are not stored in proximity of ignition sources within.
