## Futures Fire Risk Assessment

Futurse Homescape, Community Centre  
 Hathersage Drive: DE55 1LR, UPRN: 4 /  
 109692 / QA Approved / Piotr Iwan

Futurse Homescape,  
 Community Centre  
 Hathersage Drive: DE55 1LR,  
 UPRN: 4, Fire Risk  
 Assessments, Futures  
 Homescape

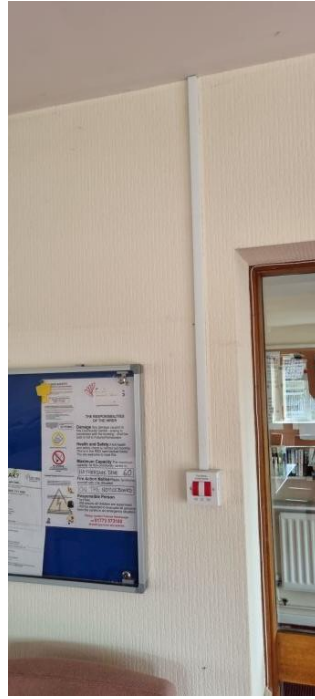
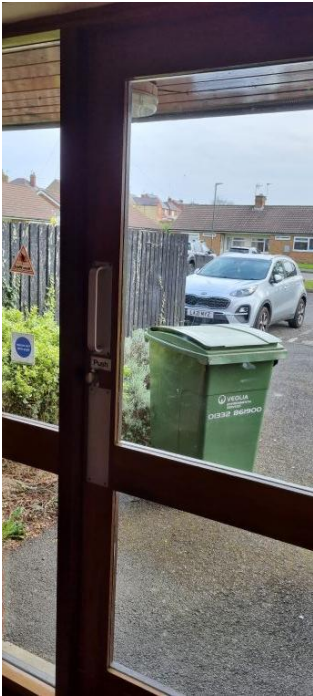
There was no evidence of smoking within the community centre at the time of assessment. There is one 'No Smoking sign' displayed on the notice board that is inconspicuous.

Management should display 'It is against the law to smoke on these premises' sign at the entrance door in order that persons do not walk into the foyer smoking before noticing the sign on the notice board.

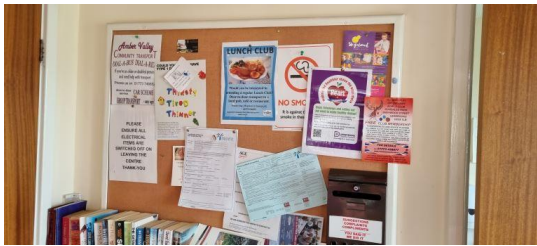
Photo 15

Loose paper items are located on notice board within the entrance foyer.

Management should ensure that loose paperwork / notices are either laminated or placed on a notice board with Perspex screen.

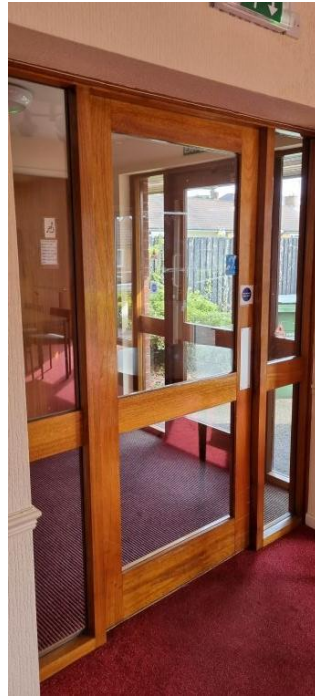
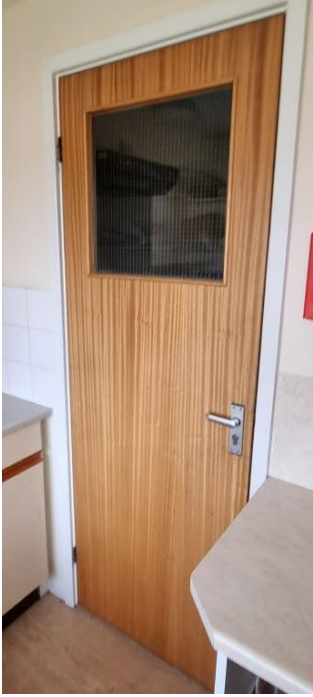
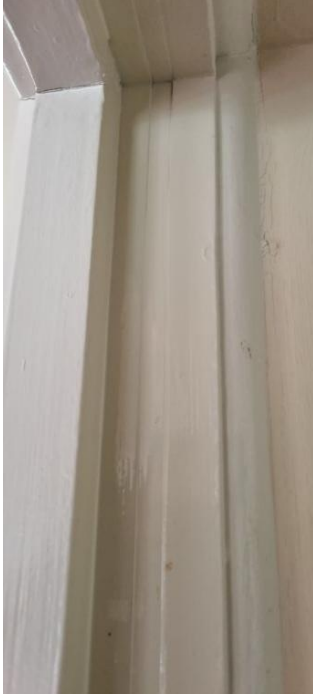
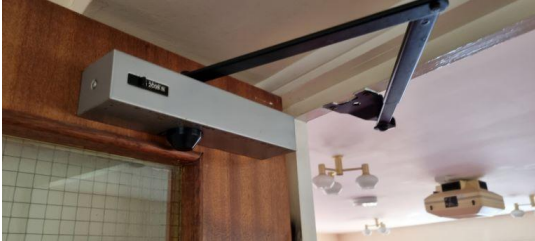
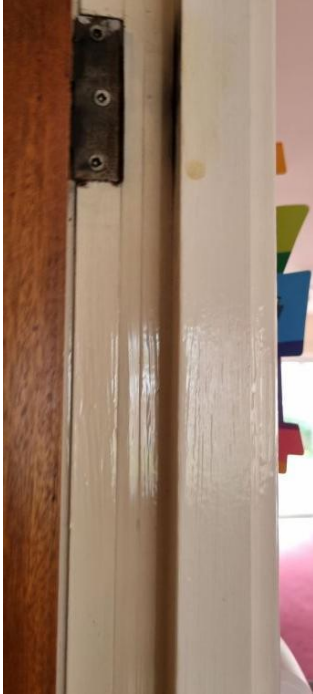
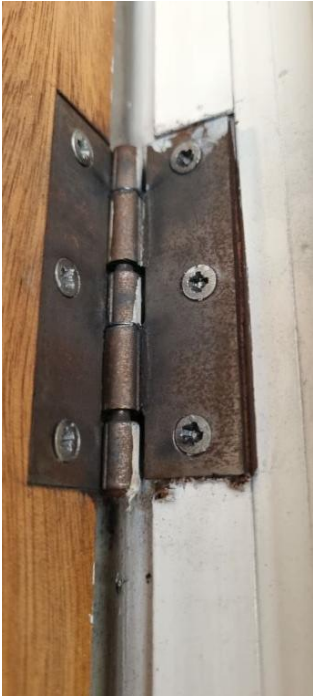
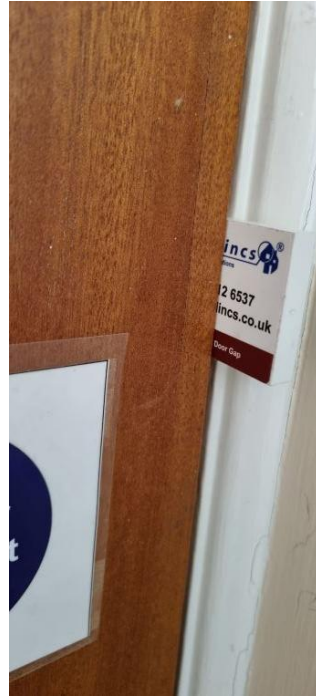
It was not possible to establish fire rating of the separating door or glazing between the community room and the entrance foyer. In addition, the door to the kitchen had intumescent strips painted over and hinges to the door did not appear to be fire rated and the gap to the side of the door was excessive. Self-closure devices are fitted.

Management should inspect fire doors to establish fire rating and condition. Doors should conform to FD30 specification and glazing to the separating door set should be fire rated. Where doors and glazing do not conform they should be replaced with FD30 fire rated doors and fire rated glass. Any installation required should only be completed by a certified third-party contractor.

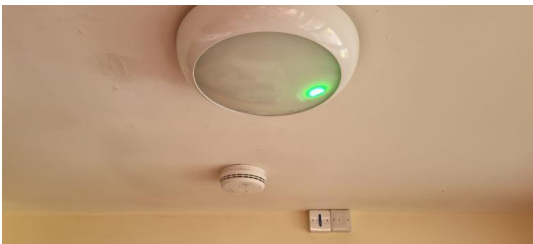
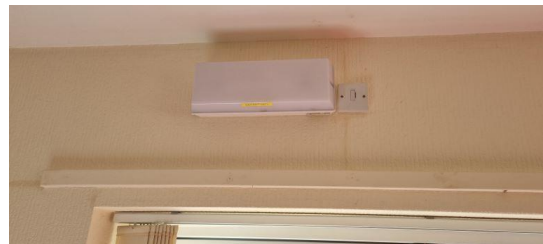
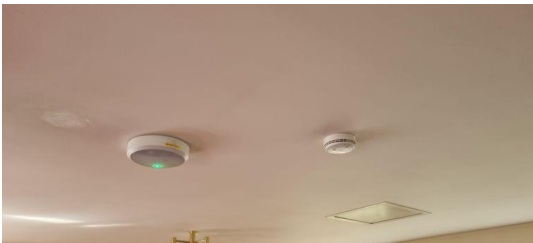
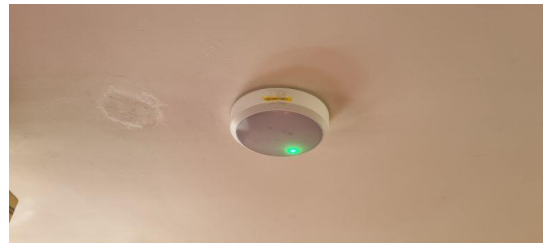
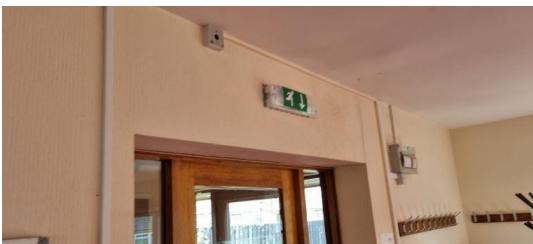
Emergency lighting is fitted to the community room and entrance foyer. The emergency light above the French doors was found to be defective.

Management should ensure that the emergency light unit above the French doors is repaired.

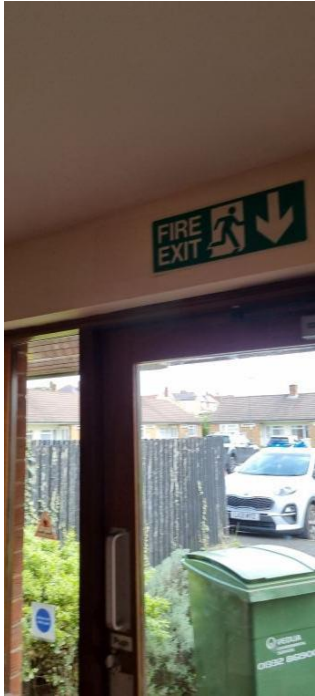
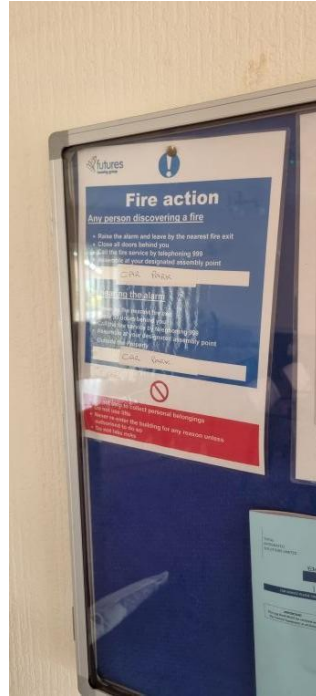
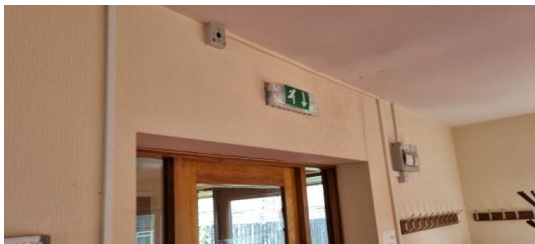
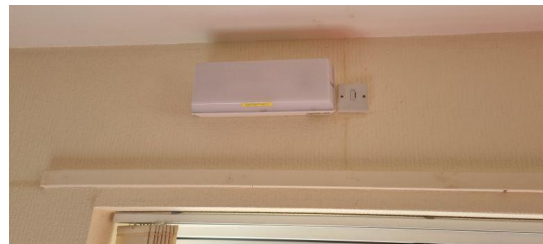
There is a Fire Action Notice displayed within the community room advising of a simultaneous evacuation. There was no fire assembly sign identified in the car park and no exit sign is displayed over the French doors. Exit signs are displayed above the separating door and final exit from the foyer.

Management should ensure that a fire assembly sign is displayed within the carpark. An exit sign should be displayed above the French doors.

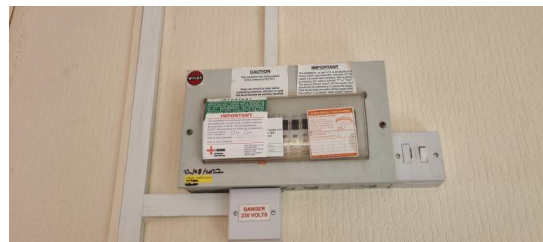
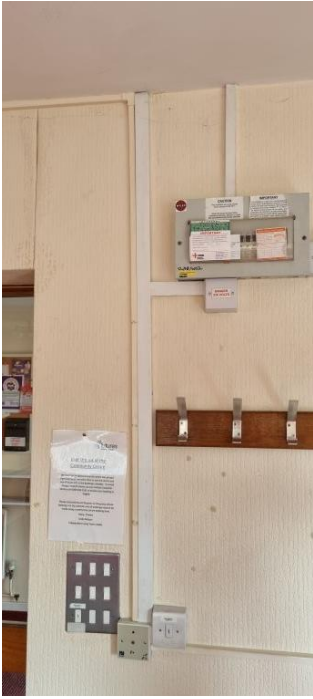
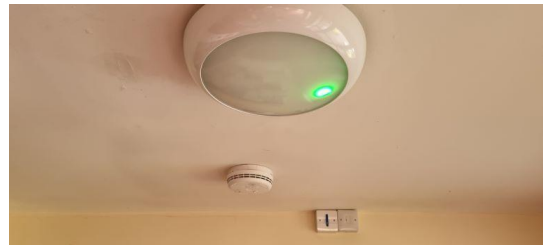
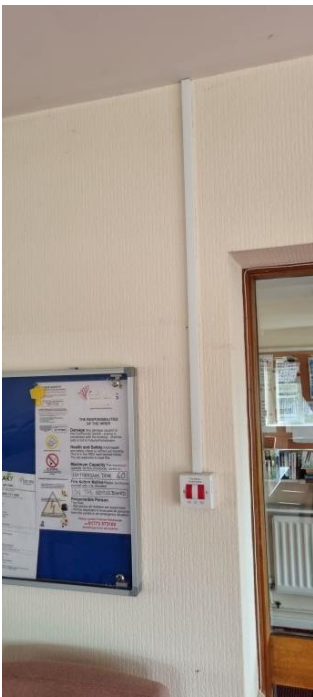
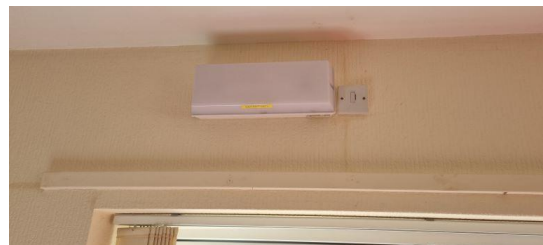
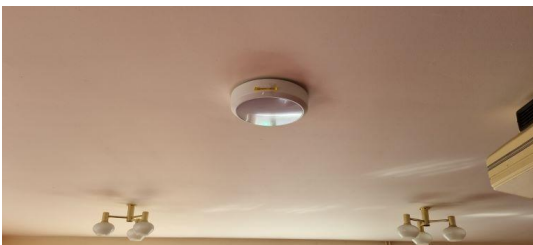
Walls are solid with plasterboard ceilings. Floors are of solid construction. There were no major breaches identified however there is plastic conduit fitted to the community room; it was not possible to establish if there were any penetrations behind conduit or if cabling within is adequately clipped. Conduit does not appear to be fire rated.

Management should replace conduit with fire rated / metal trunking. Any penetrations behind conduit should be fire stopped with fire rated building materials and cables within should be appropriately mechanically clipped. Any work required should only be completed by an approved third-party contractor.

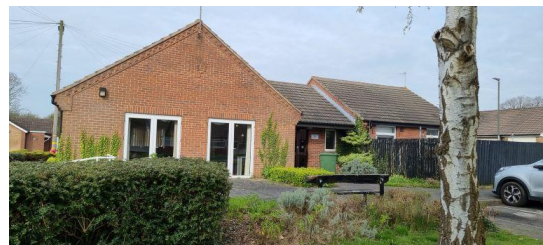
Photo 48

There was no roof access hatch identified to the community centre. It was not possible to establish the level of compartmentation within the roof space between the community centre and attached bungalow next door.

Management should inspect the roof space to ensure that there are no gaps or penetration within the roof space. Any penetrations identified should be fire stopped with fire rated building materials. Any work required should only be completed by a certified third-party contractor.

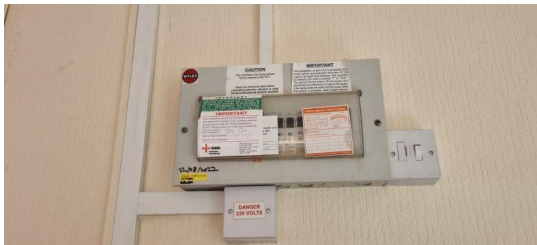
Photo 49

There is an electrical consumer unit within the community rook that is not protected with a fire rated enclosure / cabinet. There are three exits from the premises.

During future works, management may wish to enclose the electrical consumer unit in a fire rated enclosure / cabinet.

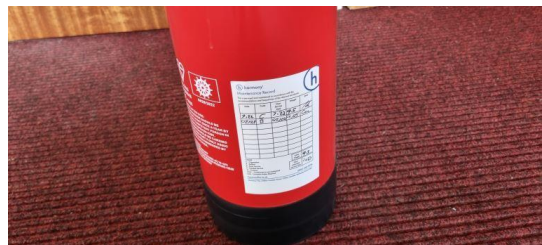
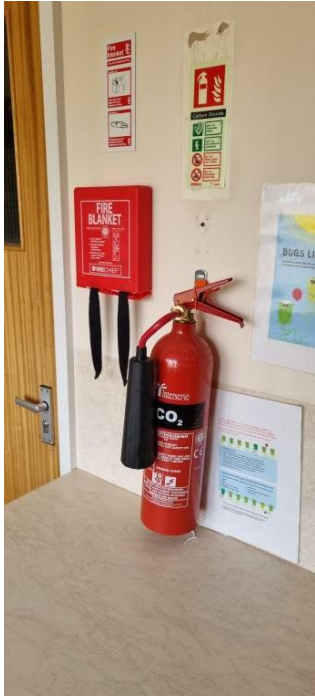
There was only one 21A 6Ltr Foam and one 2kg CO2 extinguishers present. BS5306 part 8 states that a minimum of 2 x 13A rated units should be installed to compartments of up to 400sq metres. In addition there were no signs displayed to say that extinguishers should only be used by trained persons. Extinguishers are maintained under service contract by Harmony; the last service was completed in February 2023.

Management should ensure that an additional 13A 6ltr Water or Foam extinguisher is installed to ensure compliance under BS5306. Signage should be displayed to state 'only to be used by trained persons'
