Futures Fire Risk Assessment

Futures Homescape, 25 Parks Avenue:
DE55 7NL, - UPRN: 25 / 173535 / QA
Approved / Andy Cloke

Futures Homescape, 25 Parks Avenue: DE55 7NL, - UPRN: 25, Fire Risk Assessments, Futures Homescape

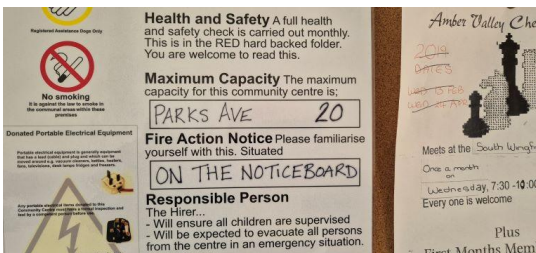
Photo 7

There was no evidence of illicit smoking at the time of assessment. Although there is some signage on the notice board it is inconspicuous and not displayed at the point of entry.

Management should display no smoking signage at the point of entry to state 'It is against the law to smoke on these premises'.

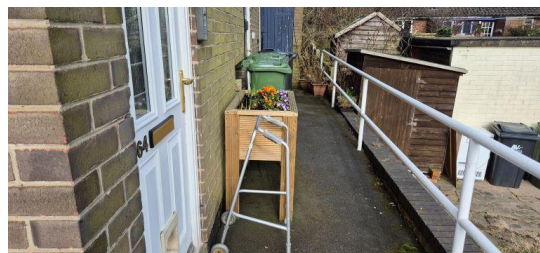
Photo 8

Waste bins are stored directly against the wall of the premise close to the entrance and entrance to the dwelling above.

Management should ensure that waste bins are located in a safe location away from the premises.

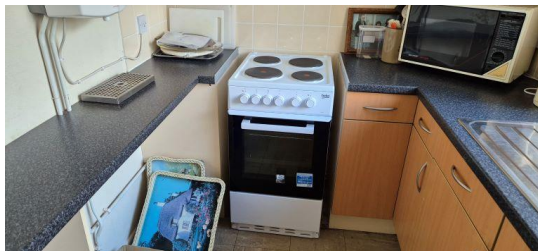
Photo 11

There is a free-standing electric cooker within the kitchen and microwave and kettle. No specific rules for the use of the equipment were identified. Portable electrical appliances within the kitchen are subject to annual PAT test.

Management should ensure that rules on the use of the kitchen are introduced which should include prohibiting high risk cooking activities such as deep fat frying. Any rules provided should be communicated to community centre users.

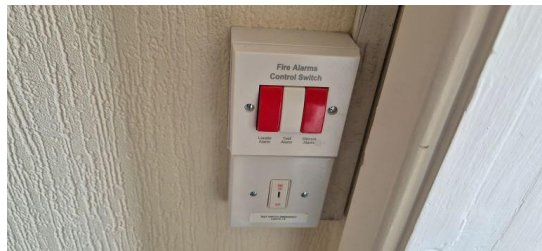
Photo 28

It was not possible to establish the arrangements for silencing and resetting the AFD system. The test and reset button is located within the entrance hallway and is open to abuse / misuse.

Management should confirm the arrangements for silencing and resetting the AFD system and ensure that it is communicated to community centre users. Management should consider locating the test / reset switch within a lockable enclosure.

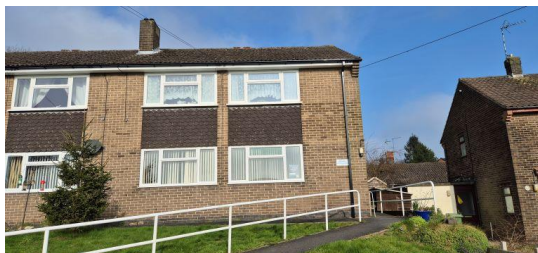
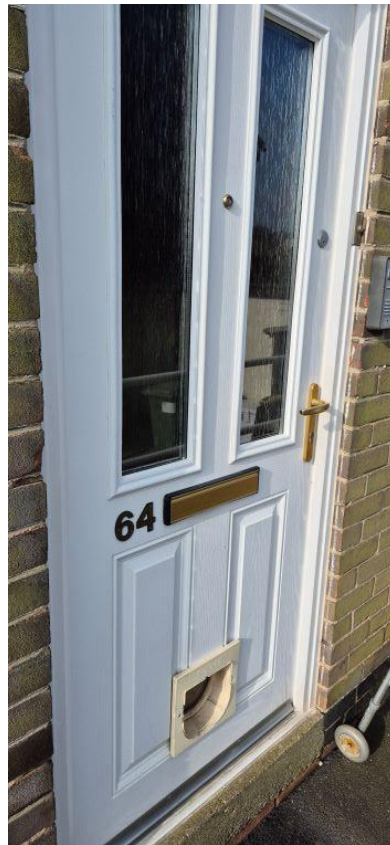
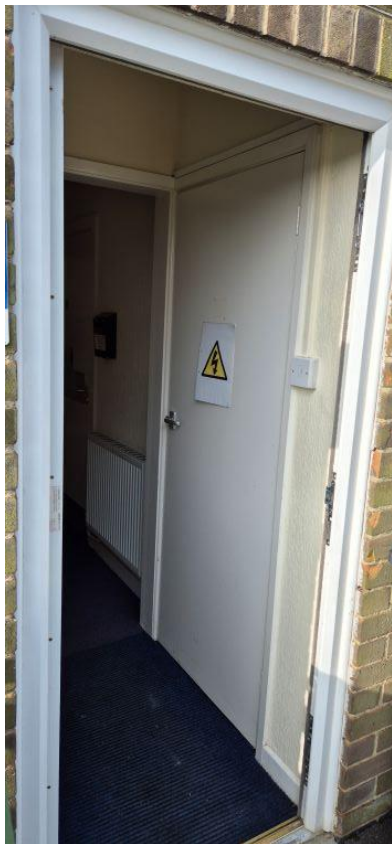
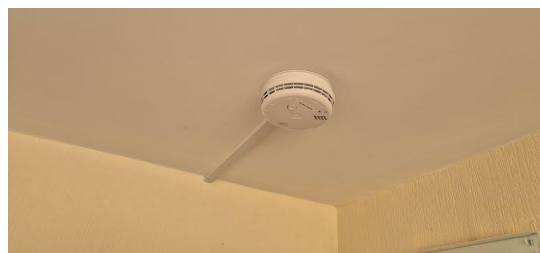
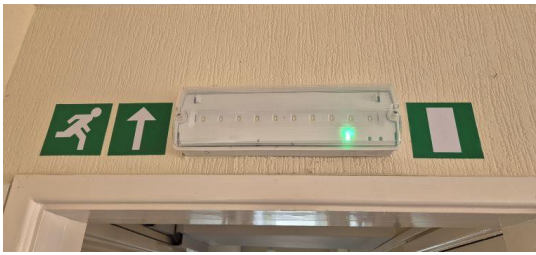
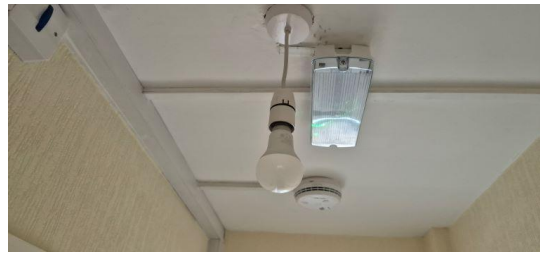
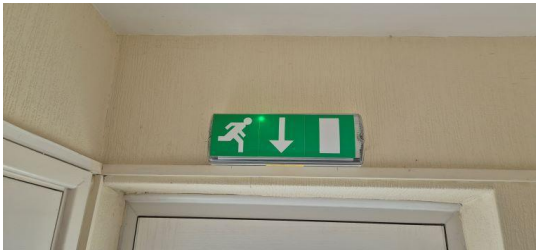
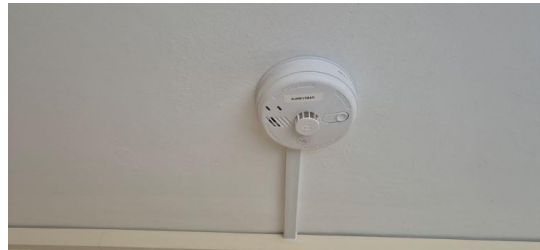
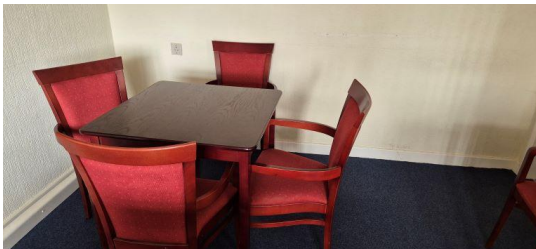
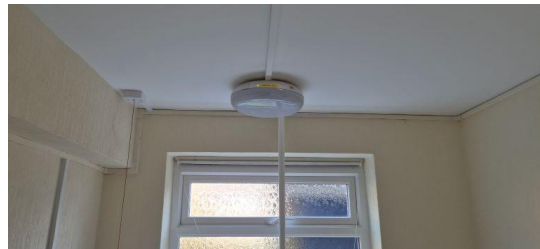
Walls are solid with emulsion painted plaster / wallpaper covering with plaster boarded ceilings and solid floors. No obvious penetrations were identified. It was not possible to determine the level of compartmentation between the community centre and the dwelling above.

Management should ensure that there is adequate compartmentation between the community centre and dwelling above.

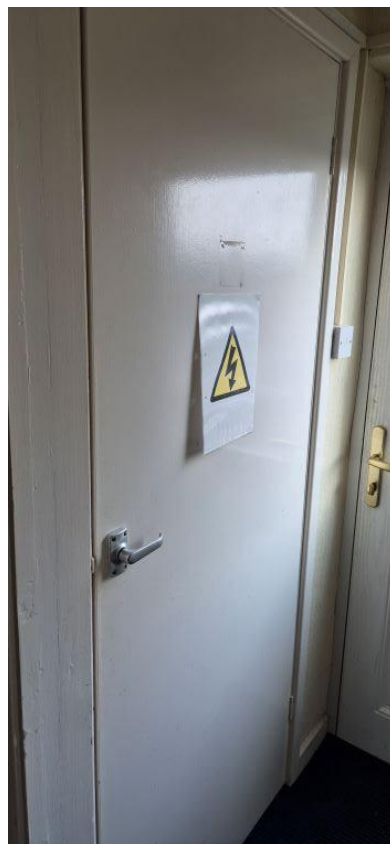
The electrical intake cupboard door is located directly adjacent to the exit door. the door to the cupboard does not appear to be fire rated and the consumer unit is not contained within a fire rated enclosure. Any electrical fire to the consumer unit / cupboard may hamper safe egress.

Management should either replace the door to the electrical cupboard with a certified self closing fire door set or the consumer unit should be contained with a fire rated cabinet / enclosure.

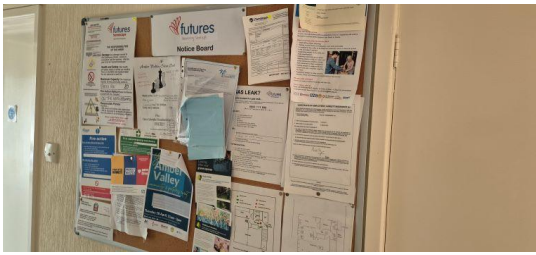
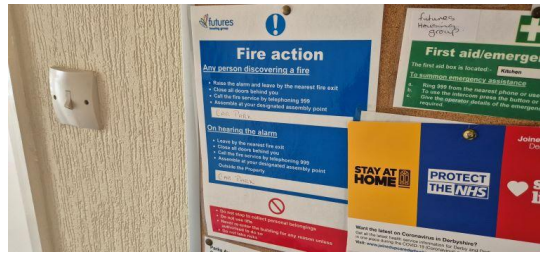
There is a notice board on the escape route. Most notices have been laminated however, there are some loose paper notices.

Management should ensure that all paperwork / notices are either laminated or the notice board is replaced with a Perspex covered type.

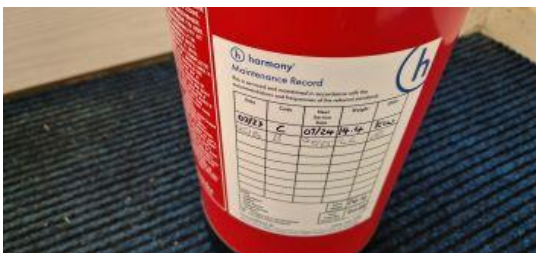
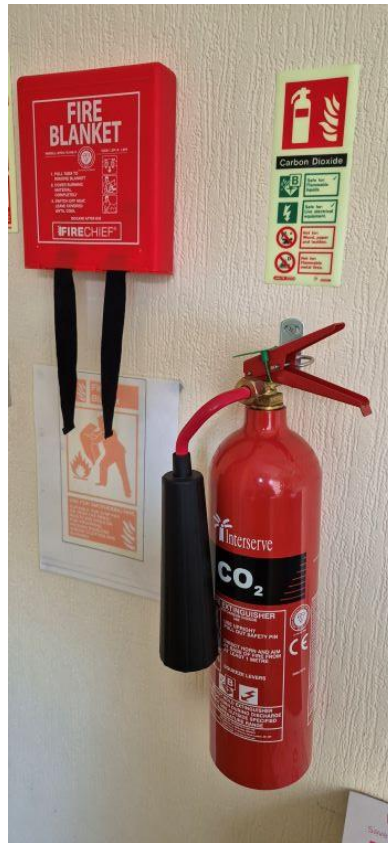
Extinguishers are maintained under service contract with Harmony. The last service was completed in February 2024. There is no signage to state that extinguishers should only be used by trained persons.

Management should display signage at fire points to state 'extinguishers should only be used by trained persons'
