Futures Fire Risk Assessment

Futures Homescape, Flats 1-18 Church Street:
DE75 7WH, - UPRN: FB261 / 173545 / QA
Approved / Andy Cloke

Futures Homescape, Flats 1-18
Church Street: DE75 7WH, -
UPRN: FB261, Fire Risk
Assessments, Futures
Homescape

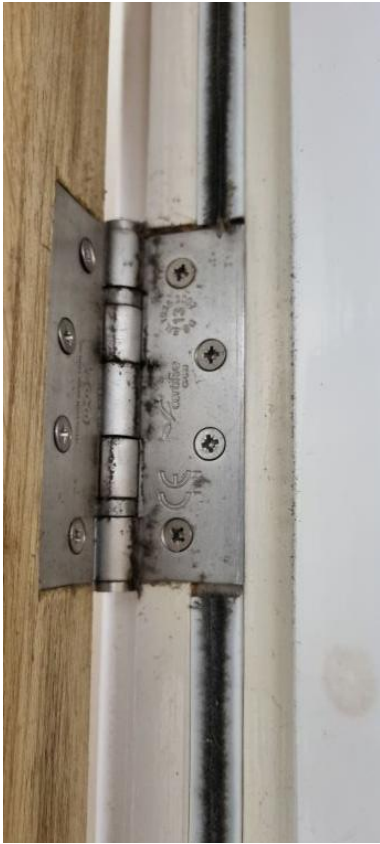
Photo 7

The door opens by using the handle on the inside of the door however, the door appear to have the potential to be locked with a key.

Where the door has the potential to be locked from the inside with a key, the lock should be replaced with a thumb turn device to the inside.

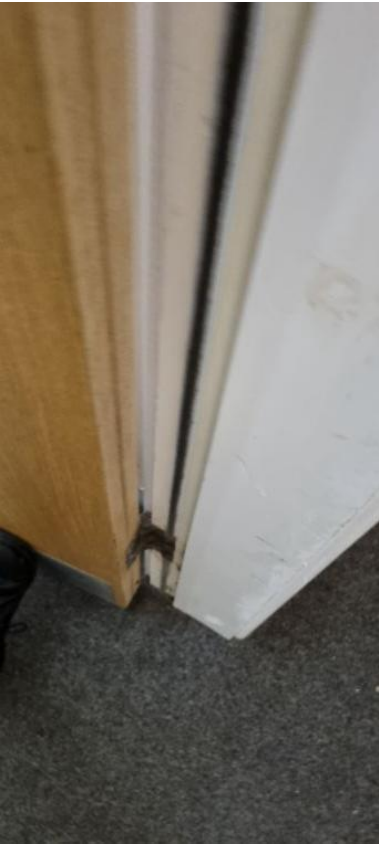
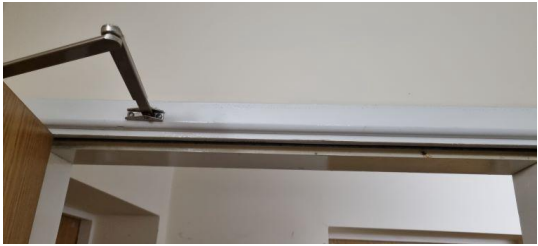
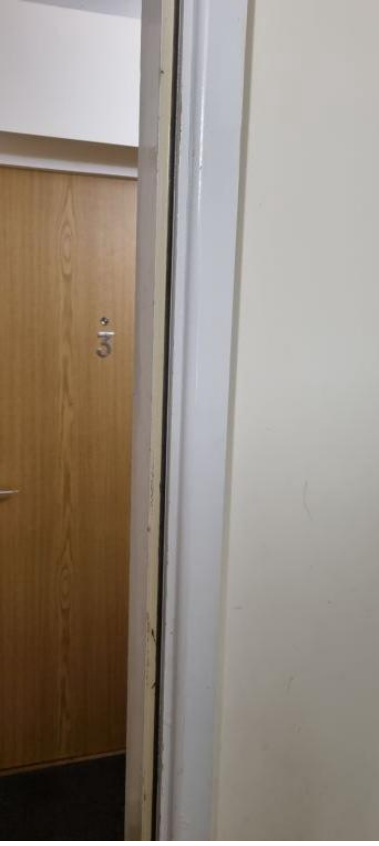
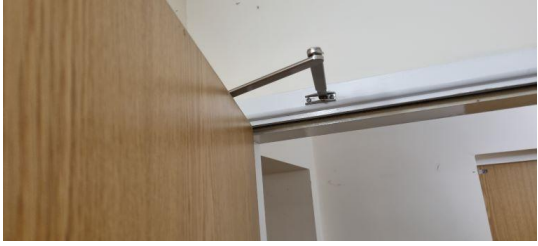
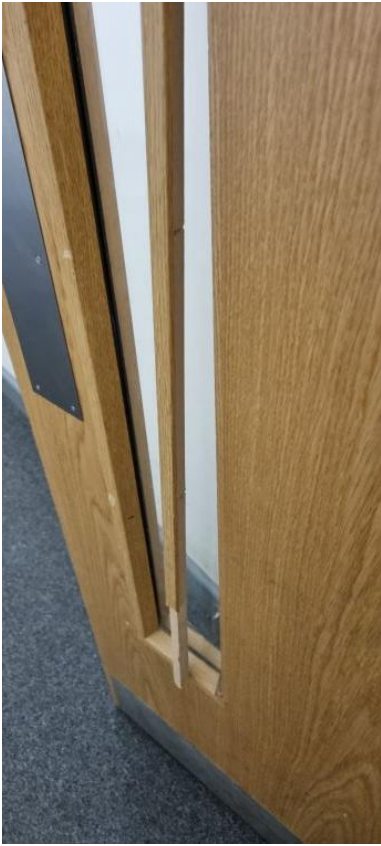
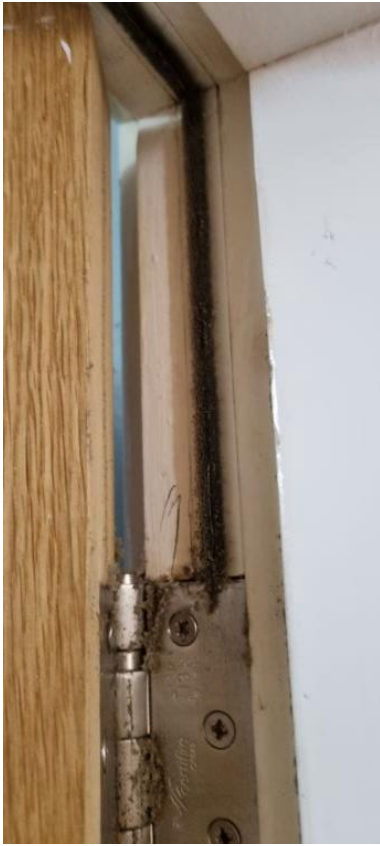
Separating fire doors are fitted to the ground floor. Separating fire doors sets are also installed to the left and right of the first and second floor landing which separates dwellings from the stairway and the corridor on the ground floor. Doors were inspected and were labelled to confirm that they are PWL Fire Doors to FD30 specification. Doors have self closure devices fitted and intumescent seals however some damage was identified and some gaps were excessive.

Management should inspect all separating fire door sets and carry out any necessary repairs or replace the doors as required. Gaps to doors should not exceed 4mm tolerance. Any work required should only be conducted by a certified third-party contractor.

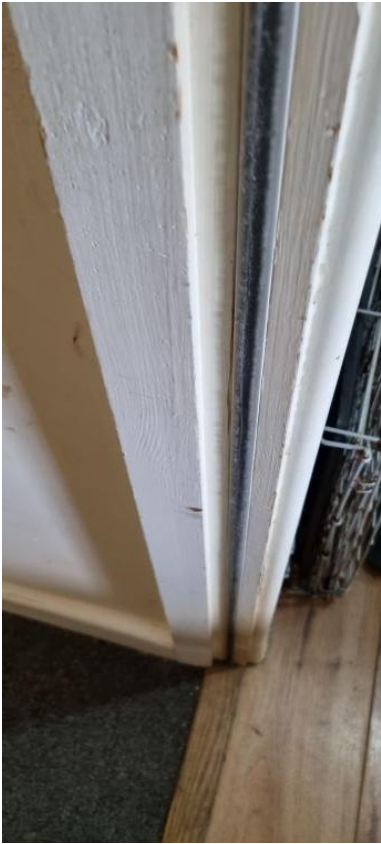
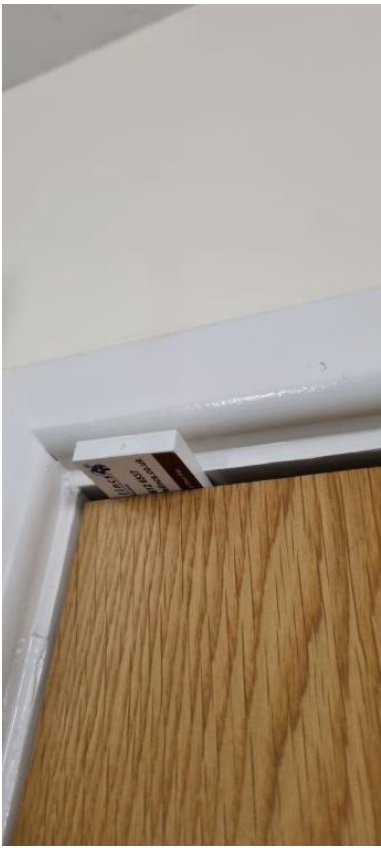
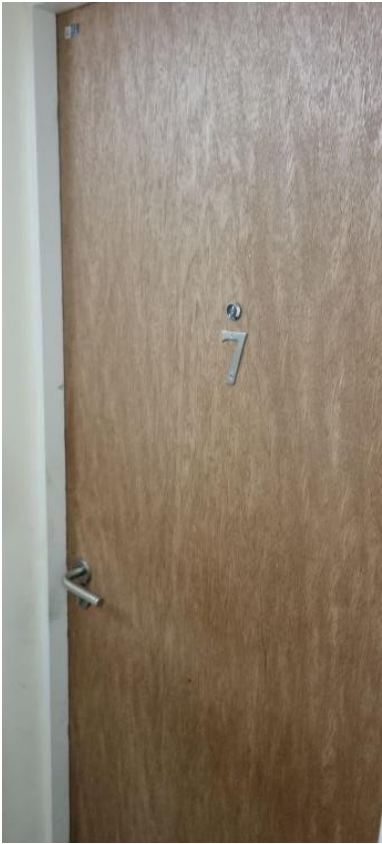
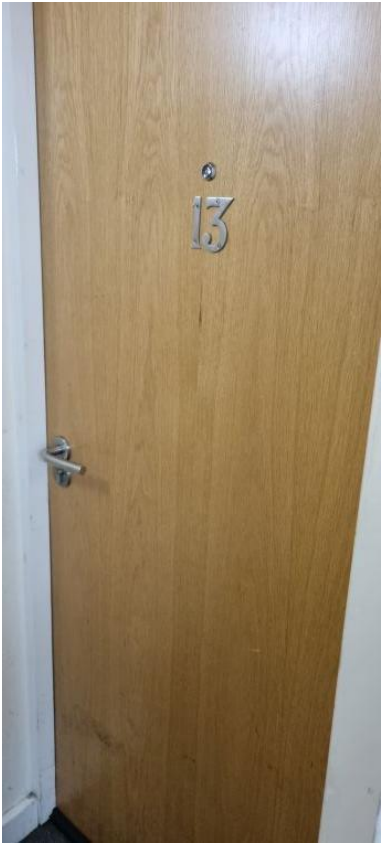
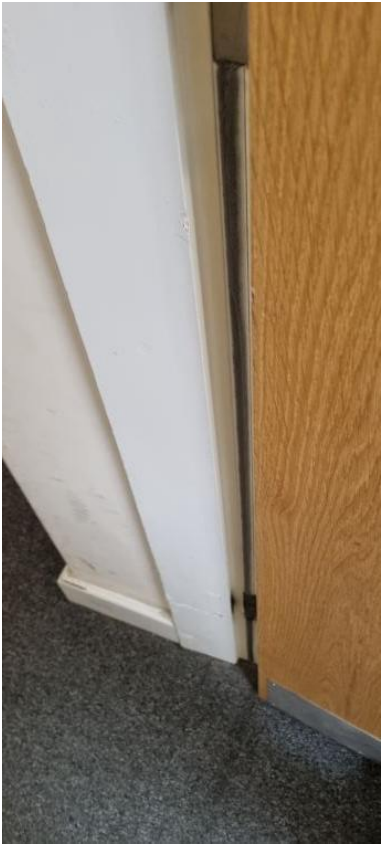
Flats 2 and 13 were sampled. Doors sampled had intumescent strips and self closure devices fitted and were labelled as PWL FD30 fire doors. Gaps to the top of doors sampled were excessive. In addition it was not possible to establish fire rating or condition of other dwelling doors as no other flats were accessible.

Management should inspect door to all other dwellings to confirm fire rating and condition. Where doors do not conform, they should be replaced with a minimum of an FD30 certified self closing fire door set. Any work required should only be completed by a certified third-party contractor.

Management should repair / adjust to the doors to dwellings 2 and 13 to ensure that gaps meet

the required 4 mm tolerance.

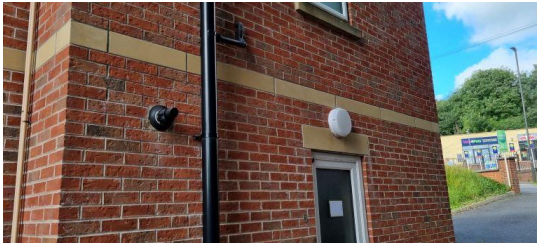
Photo 63

External lighting is fitted however, no emergency lighting was detected. In addition, it was not possible to establish if borrowed lighting is sufficient as the assessment was conducted during daylight hours.

Management should confirm if external emergency lighting is installed. Where there is no fitted, an external emergency light unit should be installed to the exit.
