# **Futures Fire Risk Assessment**

Futures Homescape, 1-6 Sandholes: NG6 8UL, - UPRN: FB265 / 173569 / QA Approved / Andy Cloke

**Futures Homescape, 1-6** Sandholes: NG6 8UL, - UPRN: FB265, Fire Risk Assessments, **Futures Homescape**

UPRN:	FB265
JOB NUMBER:	173569
FRA COMPLETED BY:	Pennington Choices Limited
FIRE RISK ASSESSOR NAME:	Adrian Gallimore
INSPECTION DATE:	4 Oct 2023
REPORT STATUS:	QA Approved
REASSESSMENT PRIORITY	Medium - 2 Years
VALID TO: (QA Use Only)	7 Nov 2025
VALIDATION DATE: (QA Use Only)	7 Nov 2023
VALIDATED BY: (QA Use Only)	Andy Cloke

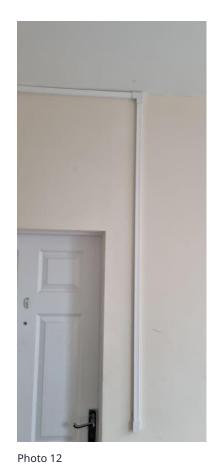
Photo 8

Conduit and cables were noted throughout the common area and it was not possible to confirm that the requirements of Regulation 521.10.202 of the BS 7671 - 18th Edition of The IET Wiring Regulations, which requires all cables to be adequately supported using non-combustible fixings to prevent premature collapse in the event of a fire. The new regulation is not applied retrospectively so any wiring systems fitted before 2019 do not need to be immediately updated. Any new installation or additions and alterations to existing systems, including temporary wiring, have to comply with the regulations.

Management is to consider the requirements of the Regulation 521.10.202 of the BS 7671 - 18th Edition The IET Wiring Regulations which requires all cables to be adequately supported using non-combustible fixings to prevent premature collapse in the event of a fire albeit not retrospective and seek the advice of a suitably qualified competent person or organisation and undertake any remediation identified by the aforementioned competent person or organisation.

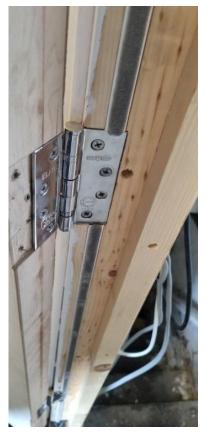
Photo 22

The only common area fire door is that fitted to the cellar entrance which has electrics located within. No label was detected and it was not possible to establish fire rating. Intumescent strips and a self closure device are fitted.

Management should ensure that the door is fire rated to a minimum of FD30 specification. Where the door does not conform, it should be replaced with a certified fire door set to FD30 specification. Any installation should only be completed by a certified fire door installer.
