Futures Fire Risk Assessment

Futures Homescape, Flats 1-16 Cedar Avenue, Flats (Bernard Boam): DE5 3PB, - UPRN: FB168 / 173579 / QA Approved / Piotr Iwan

Futures Homescape, Flats 1-16 Cedar Avenue, Flats (Bernard Boam): DE5 3PB, - UPRN: FB168, Fire Risk Assessments, Futures Homescape

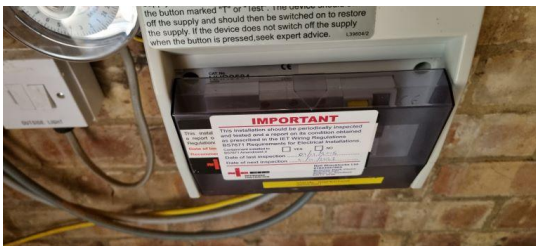
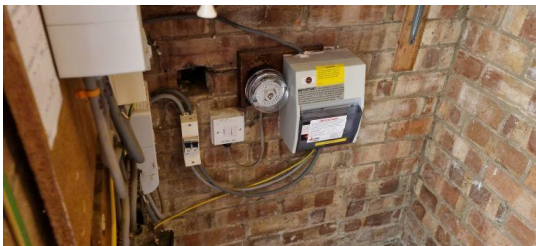
There are 3 electrical consumer units within the electrical intake cupboard / gas intake cupboard. One consumer unit was labelled as last being tested in 2015. The others were tested in Aug 2023. Refer to Policy Principle. A cover was missing from one consumer unit within.

Management should ensure that all fixed wiring has been tested in line with Policy Principle. The cover to the fuses on one consumer unit should be replaced.

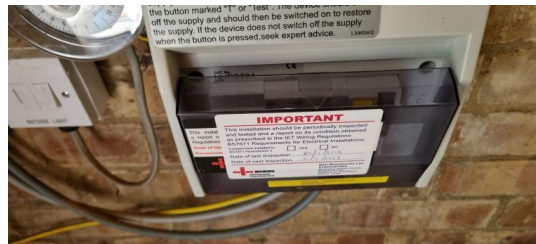
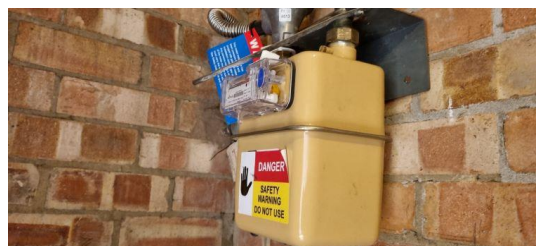
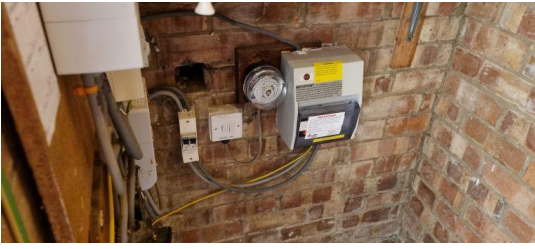
The plant room has gas and electrical infrastructure within. Electrics are not contained within a fire rated cabinet. There was no vent to open air identified within the cupboard to allow potential gas fume to escape.

Gas meters should be segregated from electrical ignition risks. Management should either relocate electrics or ensure that they are contained within a fire rated enclosure. The cupboard should be vented to open air.

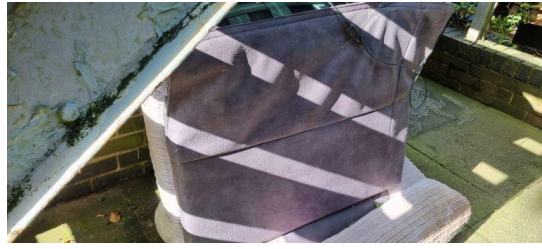
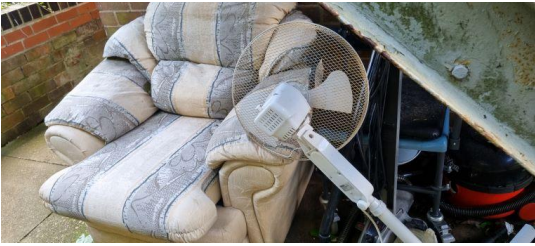
There is old furniture stored under both sets of external escape stairs.

Management should ensure that items of discarded furniture are removed and that escape routes are kept clear at all times.

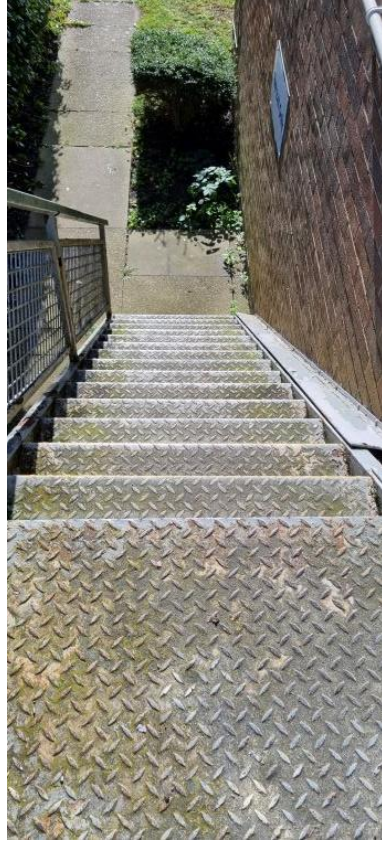
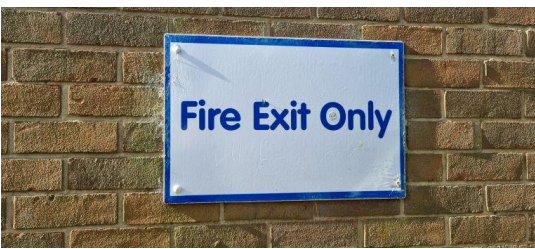
There are external escape stairs located to each end of the building. It was not possible to establish if escape stairs have been formally inspected within the last 5 years or if any annual in-house checks have been completed as the information was not available at the time of inspection.

Management should confirm if external escape stairs have been inspected and maintained within the last 5 years in accordance with BS8210:2020 by a certified third-party contractor. It is also recommended that an annual visual inspection is completed in order to monitor any damage, corrosion or stability issues.

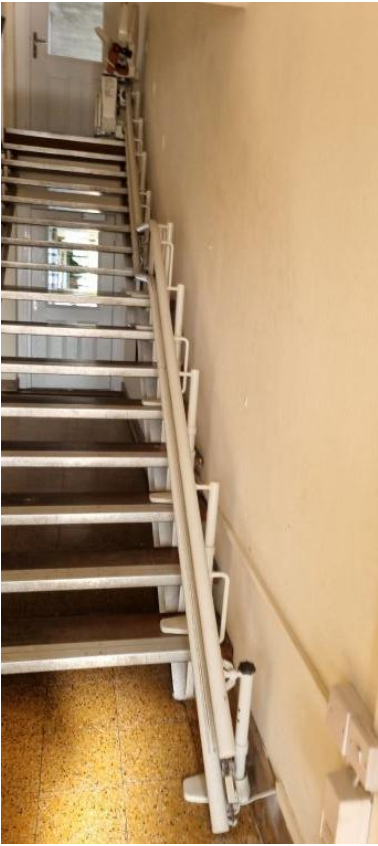
Photo 16

There is a hard wired stairlift within common area. It was not possible to establish if the equipment is maintained. There was no sign to say 'not to be used in the event of fire'.

Management should ensure that the equipment is maintained and that adequate records are maintained. In addition, signage should be displayed to say 'not to be used in the event of fire'.

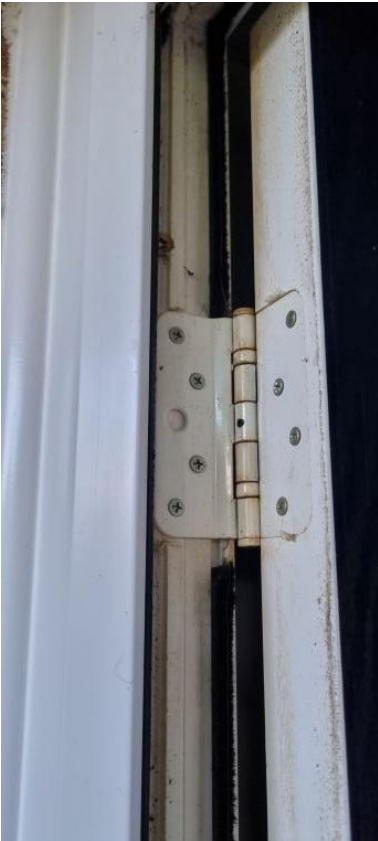
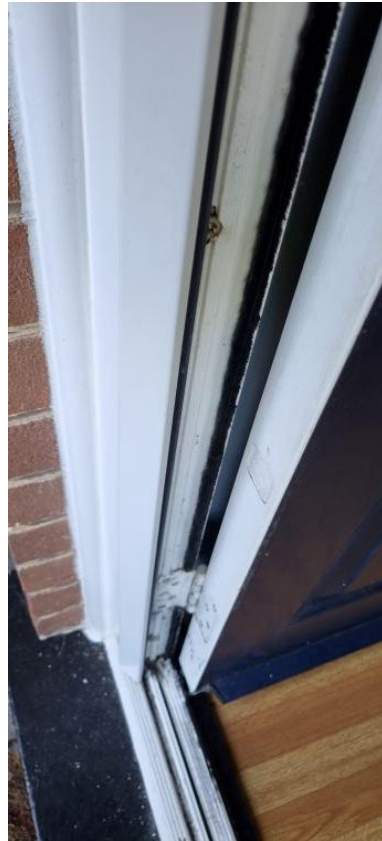
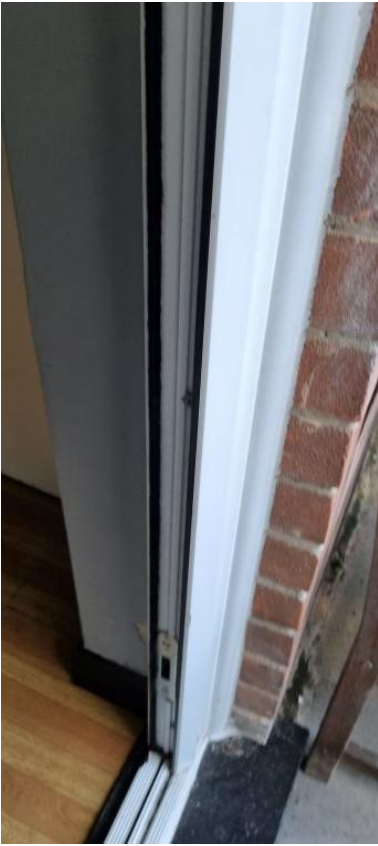
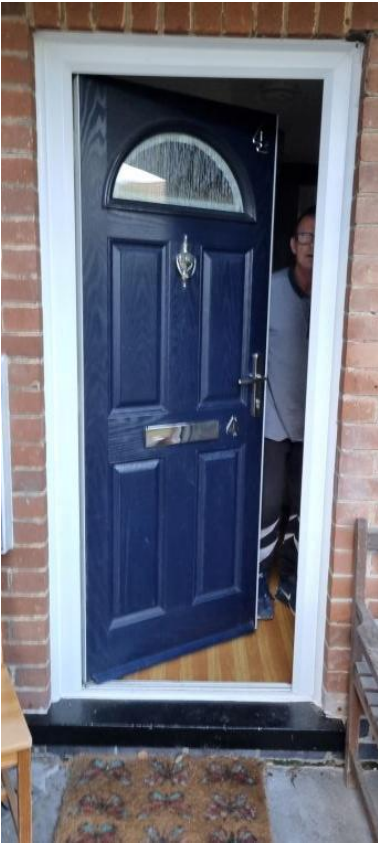
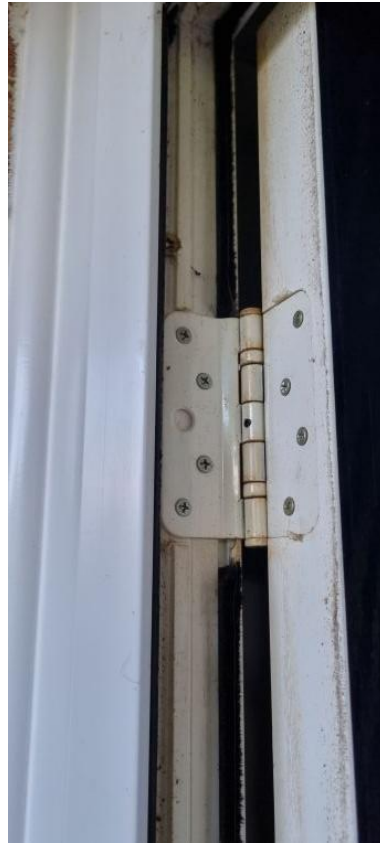
Flat 9 and flat 4 were sampled. Flat 9 was in good order and was labelled to confirm that it is a certified BM Trada fire door. Intumescent strips and a self closure device are fitted. The door to flat 4 was not labelled and did not appear to be fire rated. No other flats were sampled as access could not be gained.

Management should also inspect all other dwelling doors to establish fire rating and condition. Where doors have a passing fire risk and they do not conform to a minimum of FD30S specification, they should be replaced with certified self-closing fire door sets to a minimum of FD30S specification. Any repairs or installation should only be completed by a certified third-party contractor.

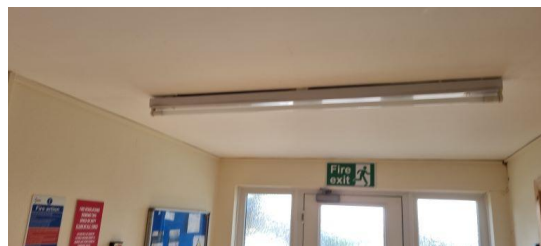
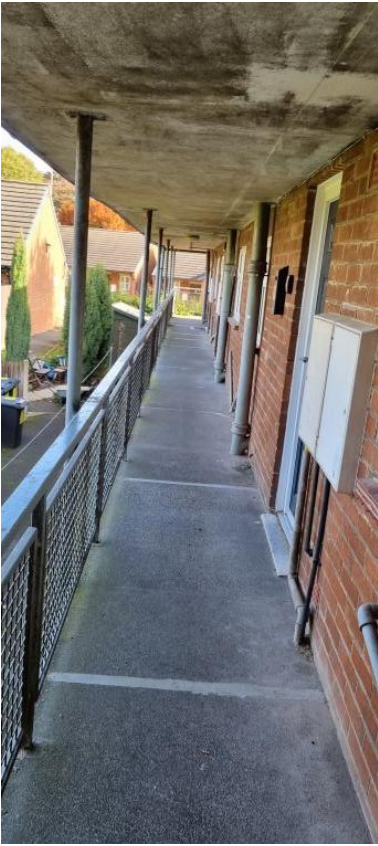
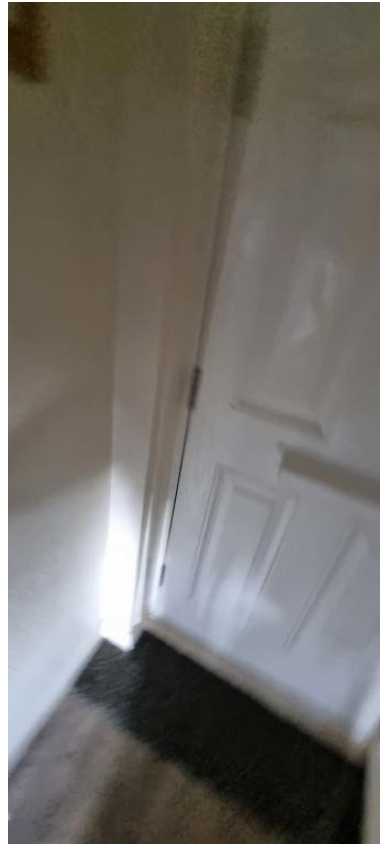
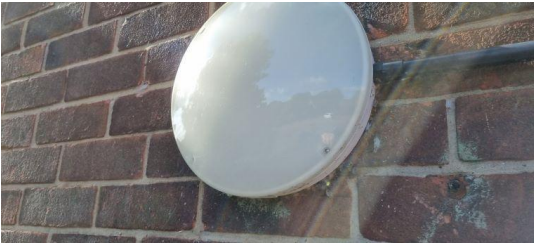
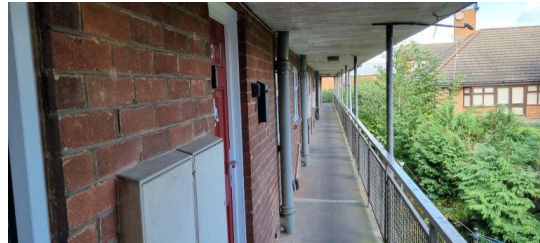
No emergency lighting was detected to internal or external areas.

Management should conduct an emergency lighting survey with a view to installing emergency lighting to the external walkways, traffic routes, emergency stairs and internal common area. External emergency lighting should be installed to both front and rear exits.

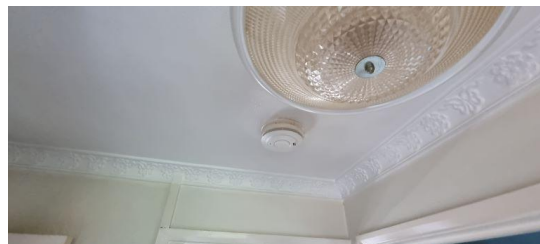
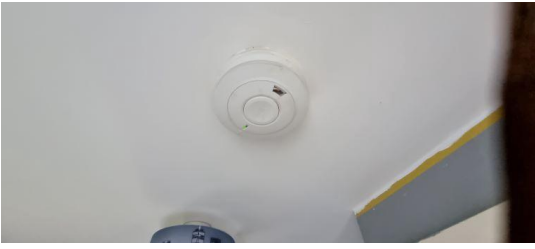
Hard-wired detection is installed to the hallway of the dwellings sampled (9 and 4). It was not possible to establish if detection is installed to other rooms within the dwelling (Type 1 Survey). In addition, it was not possible to establish the level of detection to other dwellings as no other flats were sampled.

Management should ensure that hard-wired smoke / heat detection is installed to all flats within the block, in accordance with BS5389-6:2019 (Grade D1, LD2 smoke alarms). If found not to be, install to this standard. All work to be carried out by a third-party accredited fire alarm company.

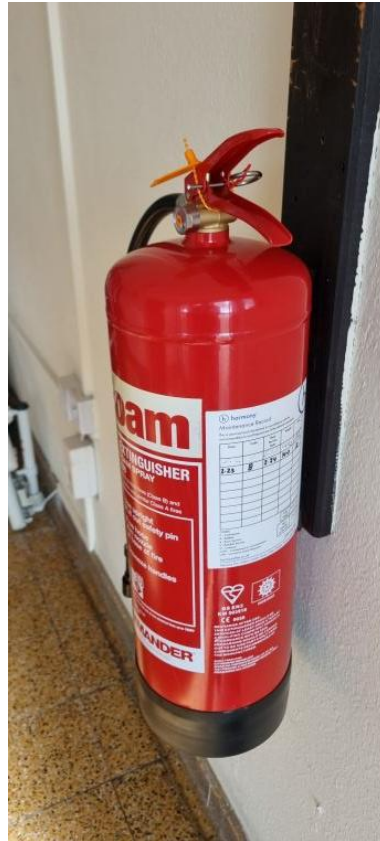
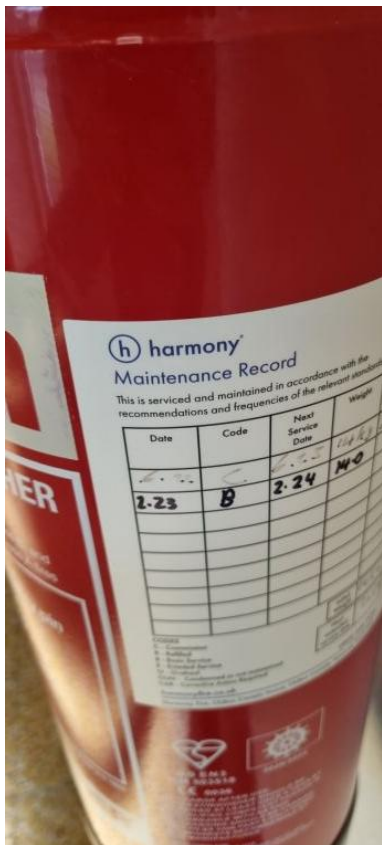
There is a 9ltr 27A Foam and a 2kg CO2 unit installed to the common area. Extinguishers are not recommended for purpose built, general needs block as there are unlikely to be trained persons present and they are open to misuse / abuse.

Management are advised to remove extinguishers from the common area. The CO2 unit may be utilised within the electrical intake room which is accessible to FHG employees.
