Futures Fire Risk Assessment

Futures Homeway, New Croft (55): NN7 4RJ, - UPRN: 5910002 / 171907 / QA Approved / Andy Cloke

Futures Homeway, New Croft (55): NN7 4RJ, - UPRN: 5910002, Fire Risk Assessments, Futures Homeway

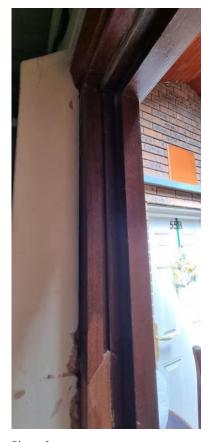
Photo 8

Gas boilers are located within the same cupboard as the electrical consumer unit which is not contained within a fire rated cabinet. In addition, the cupboard door was not labelled to confirm fire rating and some damage / repair was noted to the frame. The door is also vented. The cupboard was open and accessible at the time of assessment.

The electrical consumer unit must be contained within a fire rated cabinet or re-located. The door to the cupboard should be replaced with a certified self closing fire door set to FD30 specification. The cupboard will require venting to open air instead of common areas. The door should be locked and only accessible to authorised persons.

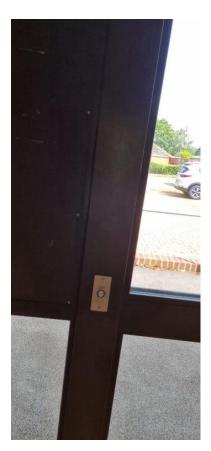
Photo 18

Door release buttons are fitted to the front and rear exit doors. It was not possible to establish if door release buttons fail to safety in the event of mains power failure.

Management should confirm if door release buttons fail to safety. Where they do not fail to safety, green 'break glass' devices should be fitted.

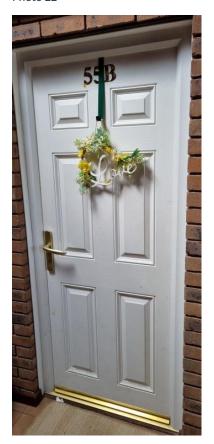
Photo 22

It was not possible to establish fire rating or condition or dwelling doors as no flats were accessible at the time of assessment.

Management should inspect all doors to the premises to establish condition and fire rating and repair or replace doors with certificated FD30S self-closing fire door(s) and frame sets where necessary. These should be fitted by an approved, third party certified installation contractor.

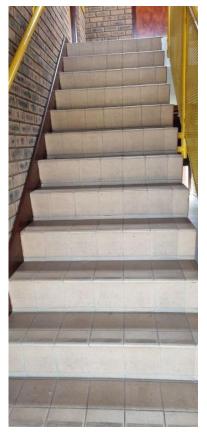
Photo 34

Walls are solid bare brick. Ceilings are solid to the ground floor with some wooden cladding to the second floor (refer to K2). Floors and stairs are solid construction. No major breaches were identified. There are

some blanking plates to walls within the common area; it was not possible to establish fire rating.

Management should confirm if blanking plates within common areas are fire rated with a view to replace them with fire rated types where they are found not to comply.

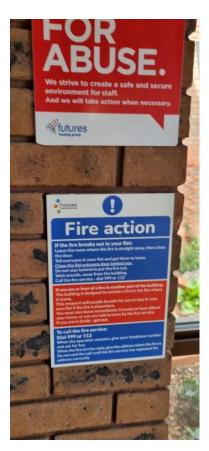
Action/Recommendation Required? Recommendation - No Timescale **Action Priority:** T3 Are there appropriate documented fire safety arrangements Yes and procedures in place in the event of fire? A Fire Action Notice is displayed within the common area advising of a 'Stay Put' policy. Photo 48 T4 Are there suitable arrangements for liaison and calling the Yes Fire Service? Residents would call the Fire Service. **T5** N/A Are there suitable fire assembly points away from any risk? Not required. T6 1 action Are there adequate procedures in place for the evacuation Unknown of disabled people who are likely to be present? Although this is a general needs block, it was not possible to establish if there were any disabled persons present. Open | Priority: Low | Created by: Adrian Gallimore T6 Management should establish if there are any persons with disabilities or special needs that may require assistance, require a PEEPs and/or PCFRA. An appropriate procedure should be put in place once a PEEPS or PCFRA has been completed. **Action/Recommendation Required?** Recommendation - No Timescale **Action Priority:** T7 N/A Are staff nominated and trained on the use of fire
