Futures Fire Risk Assessment

Futures Homescape, Community Centre
Fairfield Road: DE7 6DD, - UPRN: 6 /
173582 / QA Approved / Paul Doodson

**Futures Homescape,
Community Centre Fairfield
Road: DE7 6DD, - UPRN: 6, Fire
Risk Assessments, Futures
Homescape**

INSPECTION DATE:	14 Nov 2023
------------------	--------------------

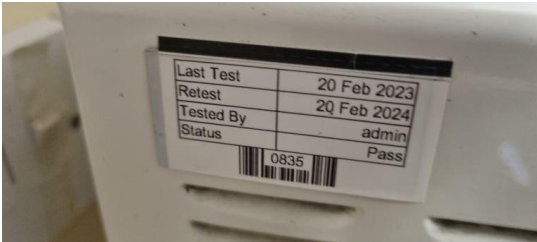
Photo 6

The label to the microwave shows that the the last PAT on the appliance was completed February 2023, however, there is a kettle in the kitchen that was not labelled.

Management should ensure that all portable electrical appliances are PAT tested in line with Policy Principle.

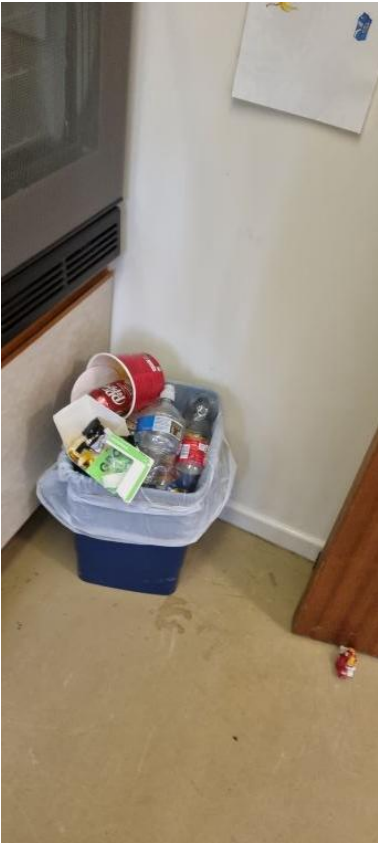
Photo 7

The kitchen waste bin was overflowing at the time of assessment.

Management should ensure that waste bins are emptied after use or on a regular basis.

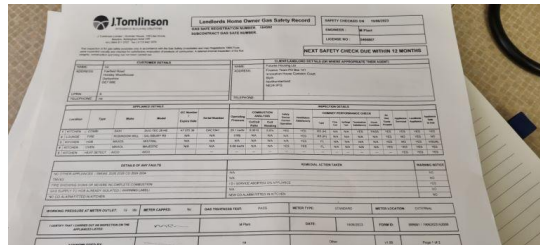
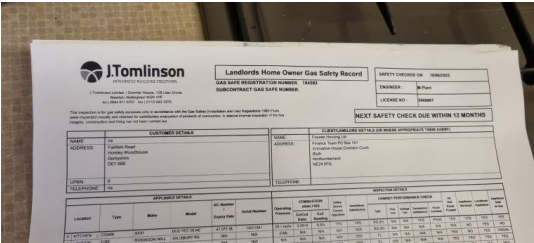
The landlord's Certificate within the kitchen states that the last gas safety inspection was completed on 19/06/2023. However, the resident from the dwelling above complained as the assessor was leaving the premises that the UPRN on the certificate relates to 6 Fairfield Road, which is a dwelling of the local housing scheme (apparently available on-line). The UPRN on the certificate is indeed 6.

Management should liaise with approved contractor to ensure that the certificate is correct and that a gas safety inspection has been completed within the last 12 months.

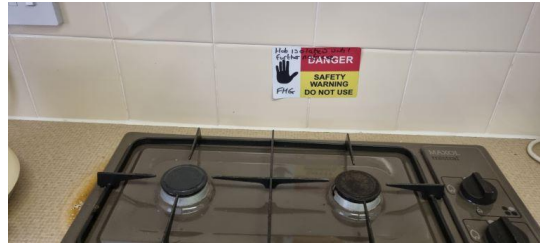
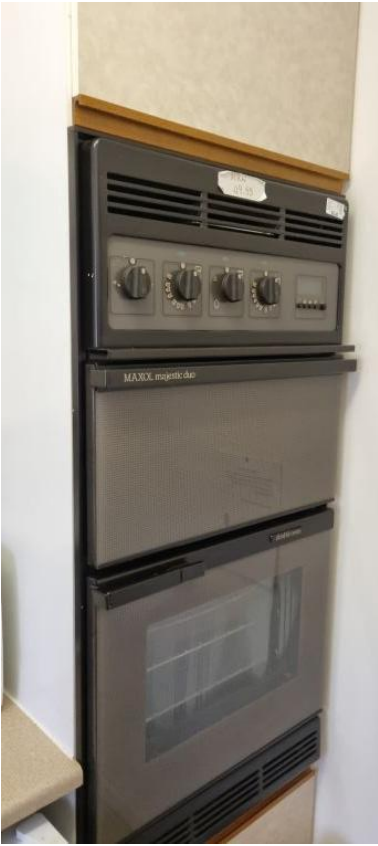
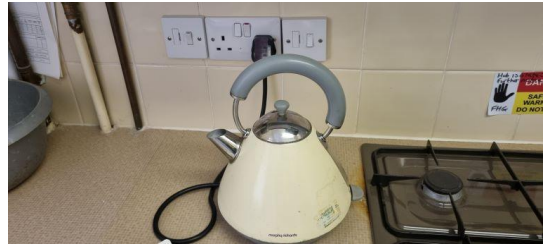
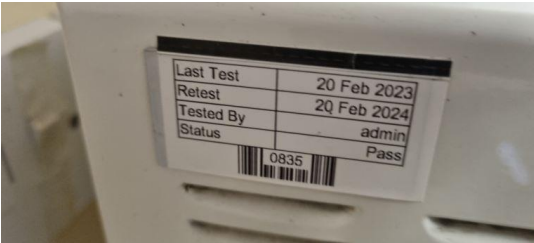
There is an electrical cooker within the Community Centre kitchen. There is also a gas cooker that has been isolated. It was not possible to establish how often the kitchen is used or what rules are in place for cooking etc. The microwave has been PAT tested however, there is no PAT test evident to the kettle (see A2).

Management should ensure that there are rules in place for using the electric cooker and that rules are communicated to Community Centre users.

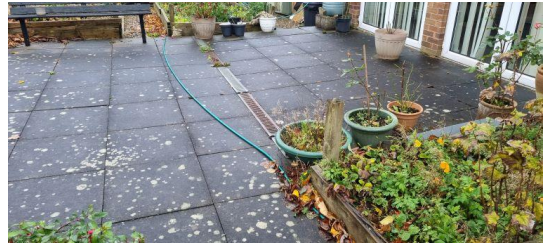
Photo 14

A trailing hosepipe is located on the paved area outside of the rear exit doors.

Management should ensure that the hosepipe is removed and that external escape routes are kept clear of trip hazards.

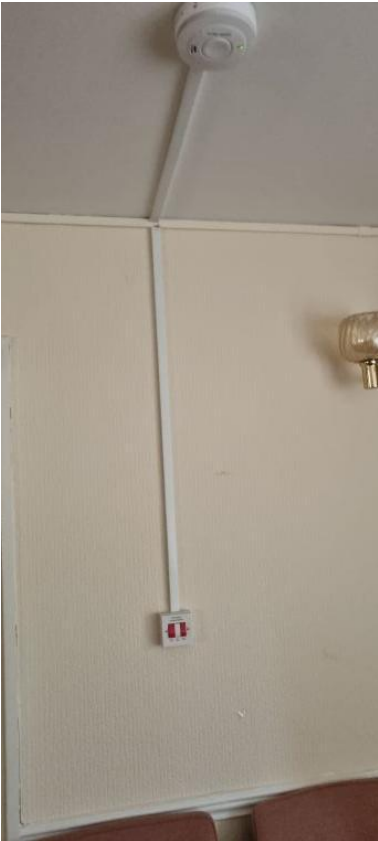
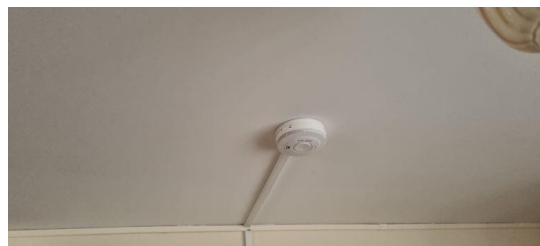
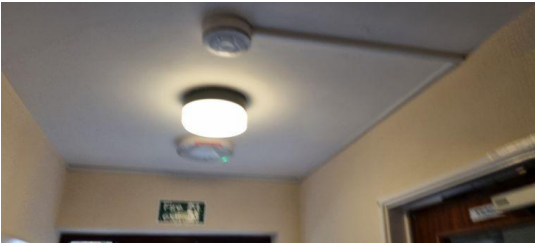
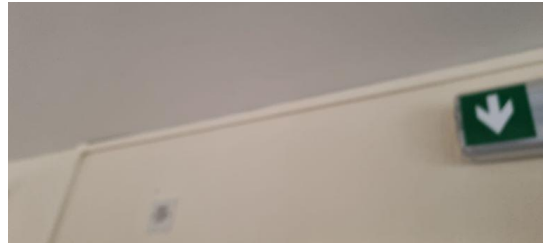
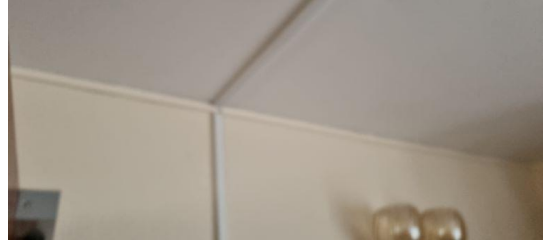
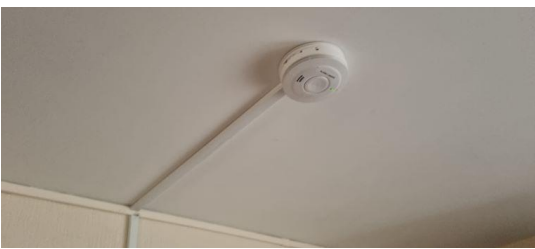
Conduit and cables were noted throughout the premises and it was not possible to confirm that the requirements of Regulation 521.10.202 of the BS 7671 - 18th Edition of The IET Wiring Regulations, which requires all cables to be adequately supported using non-combustible fixings to prevent premature collapse in the event of a fire. The new regulation is not applied retrospectively so any wiring systems fitted before 2019 do not need to be immediately updated. Any new installation or additions and alterations to existing systems, including temporary wiring, have to comply with the regulations.

Management is to consider the requirements of the Regulation 521.10.202 of the BS 7671 - 18th Edition The IET Wiring Regulations which requires all cables to be adequately supported using non-combustible fixings to prevent premature collapse in the event of a fire albeit not retrospective and seek the advice of a suitably qualified competent person or organisation and undertake any remediation identified by the aforementioned competent person or organisation.

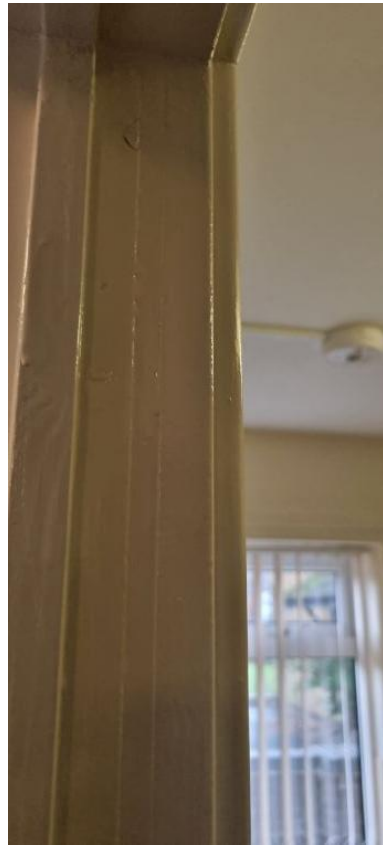
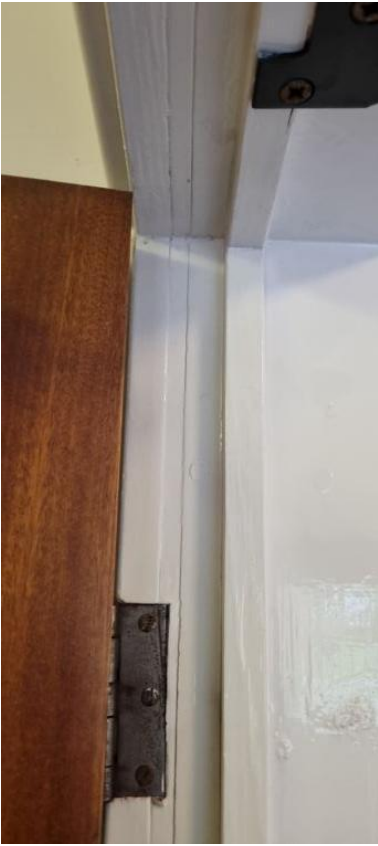
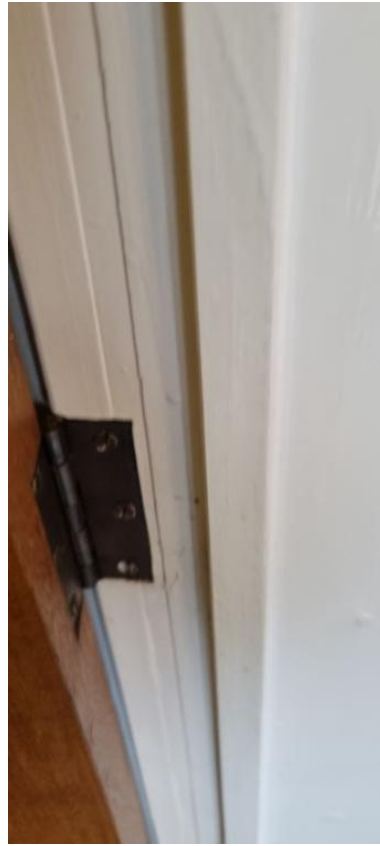
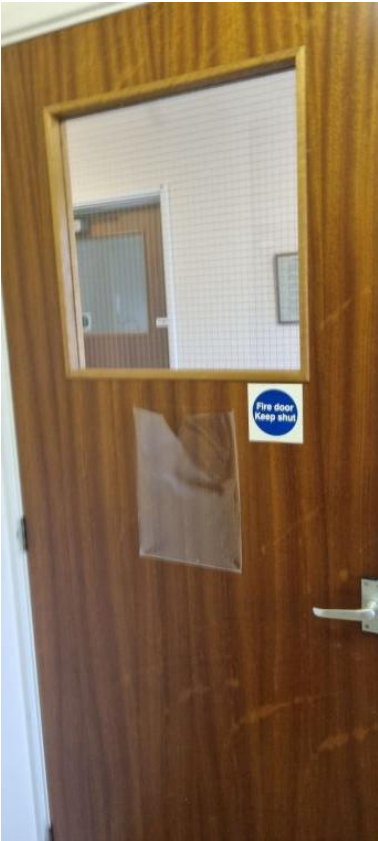
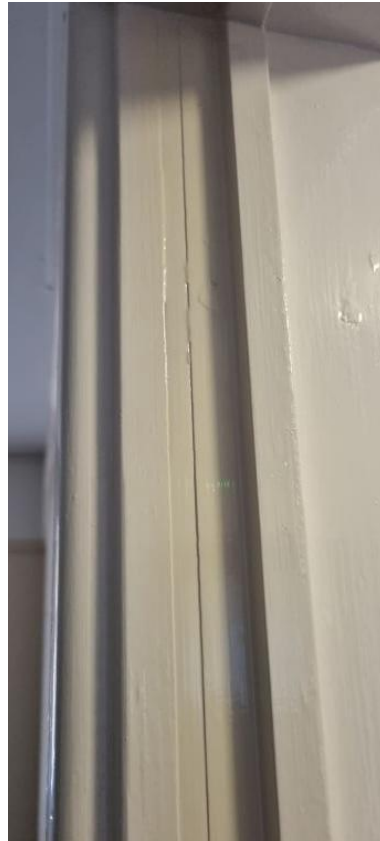
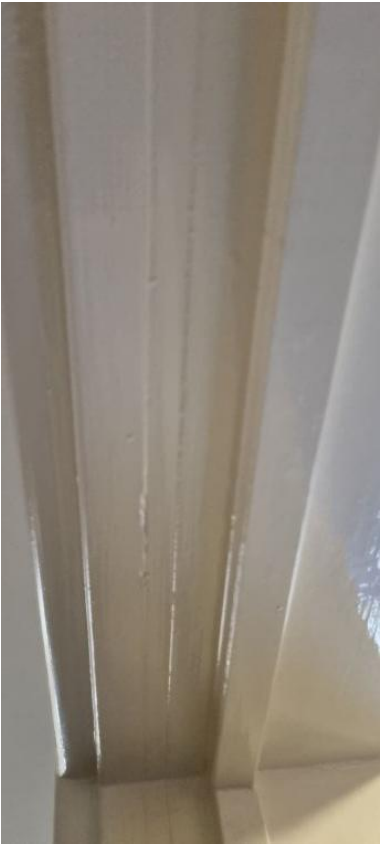
Fire doors are fitted to sitting rooms and the kitchen. Doors are not labelled and it was not possible to confirm fire rating. Intumescent strips, self closure devices and reinforced glass viewing panels are fitted. However, intumescent strips are painted over, this will affect the integrity of the seal in a fire. Hinges do not appear to be fire rated.

Management should ensure that fire doors are repaired. Where they cannot be repaired, they should be replaced with certified self closing fire door sets to FD30 specification. Any installation or repair should only be completed by a certified third-party fire door contractor.

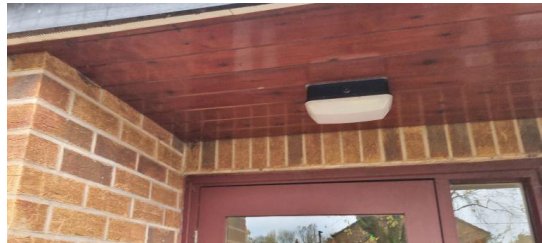
Photo 46

No external emergency lighting was detected. It was not possible to establish if borrowed lighting is sufficient as the assessment was completed during daylight hours.

Management should ensure that there is external emergency lighting installed above exits. Any work necessary to be carried out by a third party accredited contractor.
