Futures Fire Risk Assessment

Futures Homescape, Flats 3-8 Orchard Court: NG16 4BD, - UPRN: N/A / 325659 / QA Approved / Andy Cloke

Futures Homescape, Flats 3-8 Orchard Court: NG16 4BD, -UPRN: N/A, Fire Risk Assessments, Futures Homescape

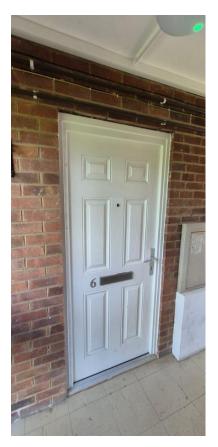
Photo 19 Photo 20

Some conduit and cables were noted within the common area and it was not possible to confirm that the requirements of Regulation 521.10.202 of the BS 7671 - 18th Edition of The IET Wiring Regulations, which requires all cables to be adequately supported using non-combustible fixings to prevent premature collapse in the event of a fire. The new regulation is not applied retrospectively so any wiring systems fitted before 2019 do not need to be immediately updated. Any new installation or additions and alterations to existing systems, including temporary wiring, have to comply with the regulations. Some cables are contained within metal trunking.

Management is to consider the requirements of the Regulation 521.10.202 of the BS 7671 - 18th Edition The IET Wiring Regulations which requires all cables to be adequately supported using non-combustible fixings to prevent premature collapse in the event of a fire albeit not retrospective and seek the advice of a suitably qualified competent person or organisation and

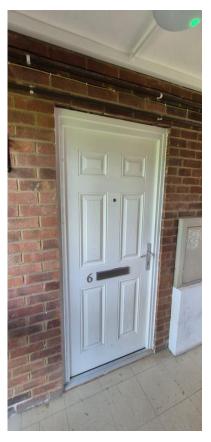
Photo 25

Flat 5 was sampled and was the only flats accessible at the time of assessment. The flat was under refurbishment. The door is arrow labelled to confirm that it is fire rated to FD30 specification. Intumescent strips and a self closure device are fitted. It was not possible to establish fire rating and condition of other dwelling doors. It was noted that the door sampled was wedged open by contractors as a temporary measure

Management should inspect all other flat doors to establish fire rating and condition. Where doors do not conform to a minimum of FD30 specification, they should be replaced with self closing certified fire door sets to a minimum of FD30 specification. Any work required should only be completed by a certified third-party contractor

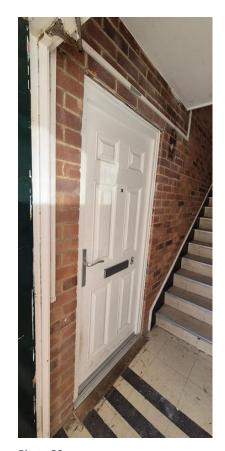
Photo 36

There is no manual fire alarm system however hard wired AFD is installed to common area. "Section 20.4 of the guidance used highlights how in 'general needs' blocks designed to support a 'stay put' policy, it is unnecessary and undesirable for a fire alarm system to be provided. A communal fire detection and alarm system will inevitably lead to a proliferation of false alarms. This will impose a burden on fire and rescue services and lead to residents ignoring warnings of genuine fires. This is dependent on compartmentation within the block. Sounders present within common area which are presumed to be interlinked with the flats."

Responsible person to confirm that the installed alarm system is warranted, appropriate and effective. Depending on the outcome modify system accordingly.

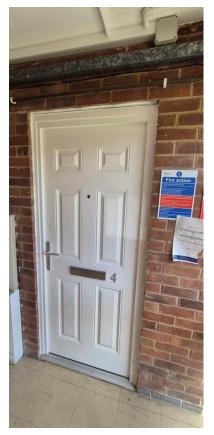
Photo 54

The electrical consumer unit is not located within a fire rated cabinet. There are embedded meter enclosures to the common area that were not accessible and it was not possible to establish fire rating or if there are any penetrations within.

The electrical consumer unit should be located within a fire rated cabinet / enclosure. Management should also inspect embedded meter enclosure to establish fire rating and condition. Where they are not fire rated, the should be replaced with fire rated types. Any penetrations identified within should be fire stopped using fire rated building materials. Any work required should only be conducted by a certified third-party contractor.
