Futures Fire Risk Assessment

Futures Homeway, Saxon House Saxon House (Includes TD): NN6 9NJ, - UPRN: 0529990 / 171939 / QA Approved / Paul Doodson

INSPECTION DATE: 30 Oct 2023

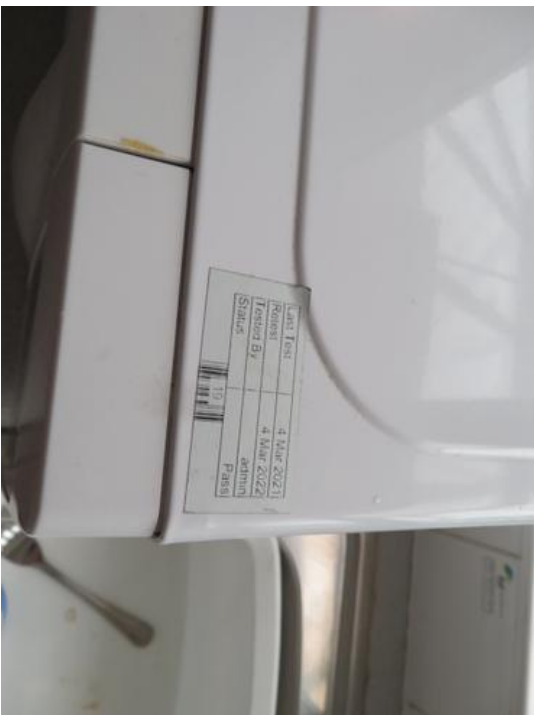
Photo 4

Portable appliances noted in the communal areas had no PAT testing labels attached. The microwave in the communal kitchen had an expired PAT testing label. See Policy Principle.
