## Futures Fire Risk Assessment

Futures Homescape, Community Centre Manor Farm, Queen Street: DE56 1NR, - UPRN: 8 / 173529 / QA Approved / Andy Cloke

Futures Homescape,  
Community Centre Manor  
Farm, Queen Street: DE56 1NR,  
- UPRN: 8, Fire Risk  
Assessments, Futures  
Homescape

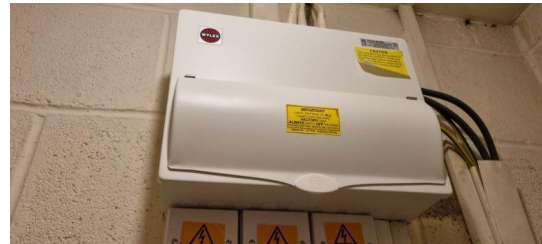
Photo 4

There was no date label on the electrical consumer unit to confirm the last fixed wiring test. Refer to Policy Principle.

Management should ensure that the fixed wiring has been tested inline with Policy Principle.

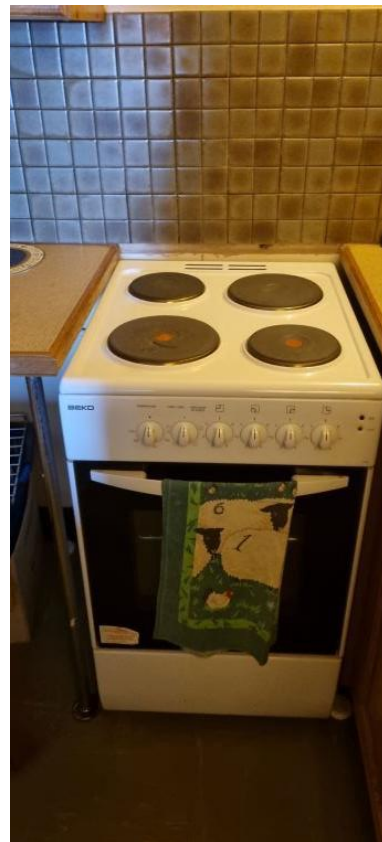
Photo 10

There is an electrical cooker within the community centre kitchen. It was not possible to establish how often the kitchen is used or what rules are in place for cooking etc.

Management should consider removing the electric cooker in favour of a microwave only if cooking is not frequent. Where the cooker is to remain it is advisable that it is only used for low risk activities and that high risk (deep fat frying etc) is prohibited. Rules for the use of the kitchen should be disseminated to users.

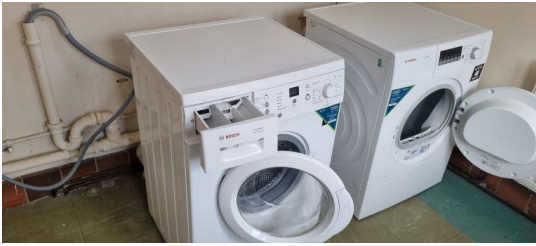
Photo 11

There is a tumble dryer and washing machine within the laundry. Both appliances are PAT tested however there is no information in relation to the cleaning of tumble dryer filters.

Management should establish arrangements of cleaning out of tumble dryer filters such as after use by each user. Arrangements should be communicated to laundry users.

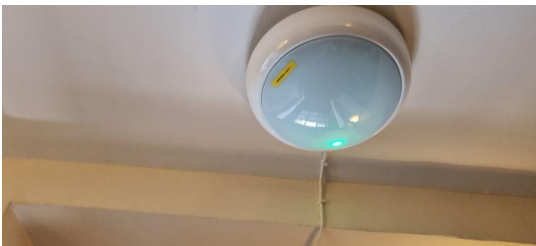
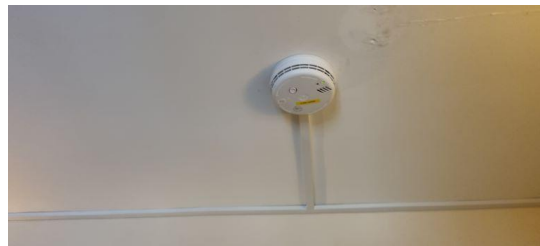
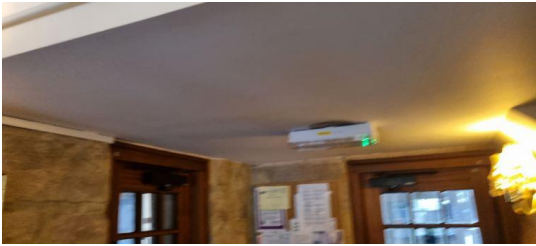
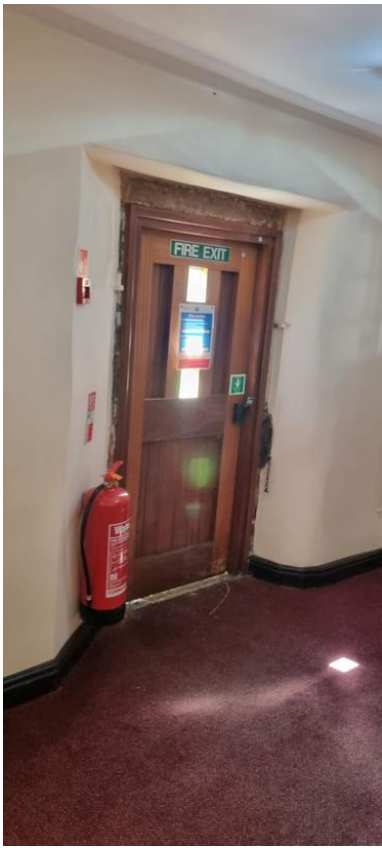
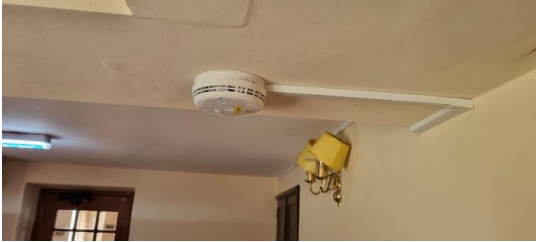
Conduit and cables were noted and it was not possible to confirm that the requirements of Regulation 521.10.202 of the BS 7671 - 18th Edition of The IET Wiring Regulations, which requires all cables to be adequately supported using non-combustible fixings to prevent premature collapse in the event of a fire. The new regulation is not applied retrospectively so any wiring systems fitted before 2019 do not need to be immediately updated. Any new installation or additions and alterations to existing systems, including temporary wiring, have to comply with the regulations.

Management is to consider the requirements of the Regulation 521.10.202 of the BS 7671 - 18th Edition The IET Wiring Regulations which requires all cables to be adequately supported using non-combustible fixings to prevent premature collapse in the event of a fire albeit not retrospective and seek the advice of a suitably qualified competent person or organisation and undertake any remediation identified by the aforementioned competent person or organisation.

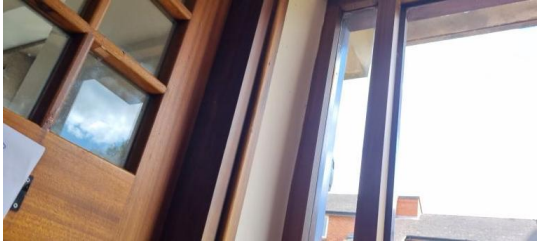
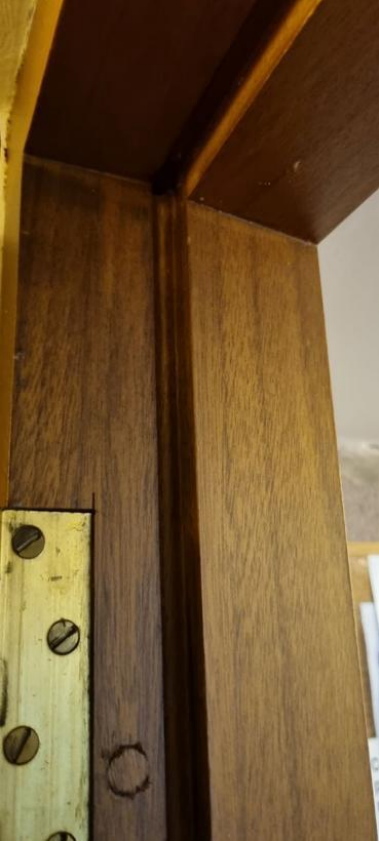
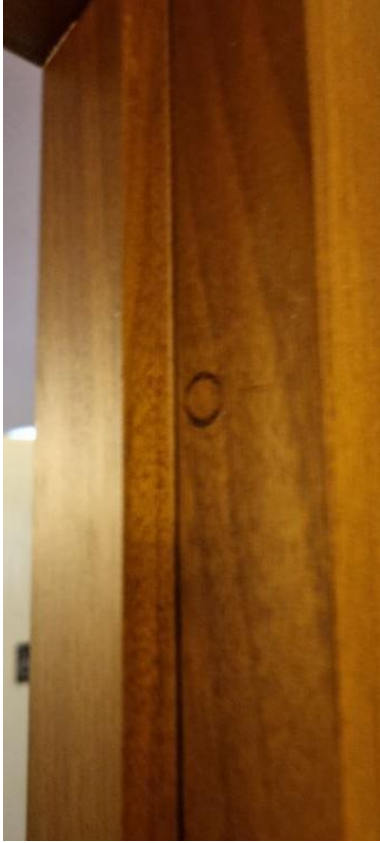
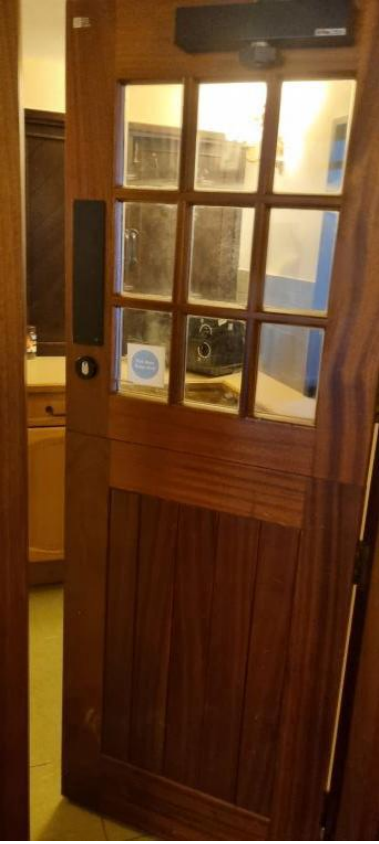
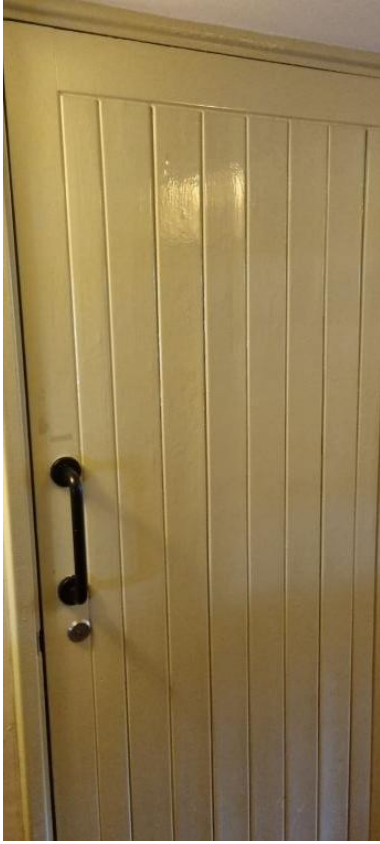
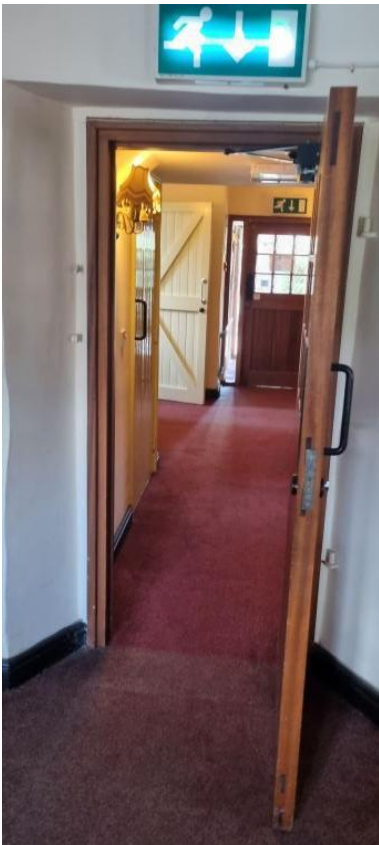
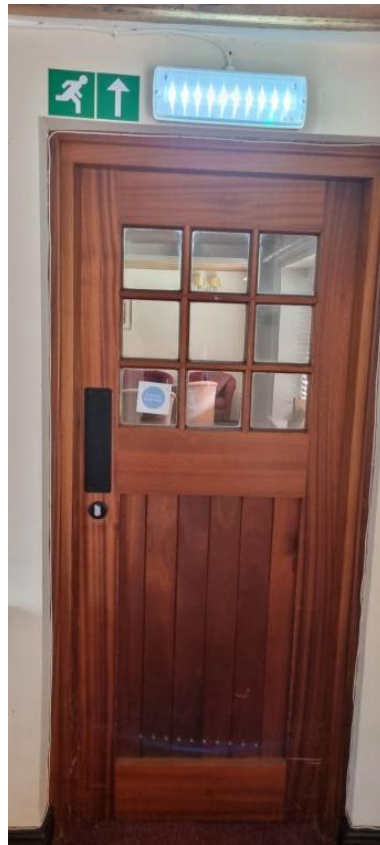
Doors between sitting rooms and the kitchen are hardwood doors however they did not appear to be fire rated. In addition, it was not possible to determine fire rating. The kitchen has a serving hatch so compartmentation within could not be maintained. In addition, it was not possible to establish if the electrical intake cupboard or laundry doors are fire rated.

Management should confirm fire rating of doors to the kitchen, sitting room, electrical intake room and laundry. Where doors do not conform they should be replaced with certified self closing doors to FD30 specification. Any installation should only be conducted by a certified fire door installer.

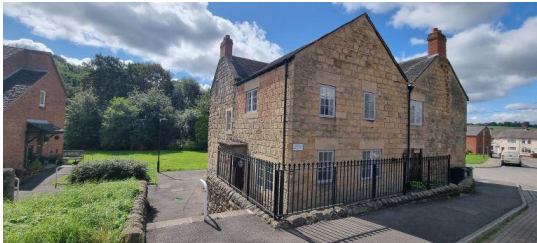
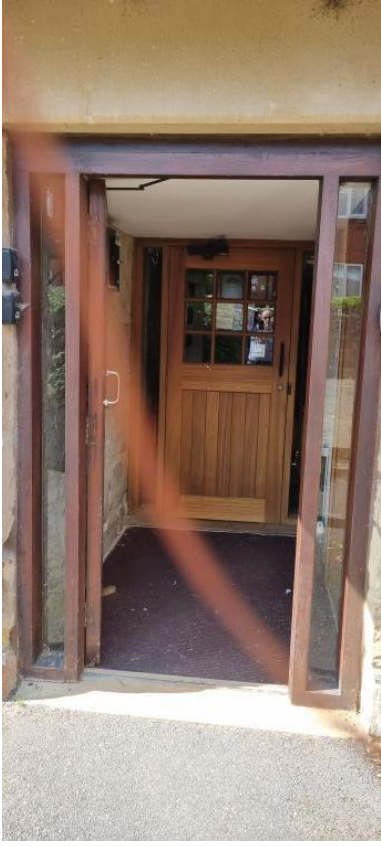
There is no external emergency lighting present. It was not possible to establish if borrowed lighting is adequate as the assessment was conducted during daylight hours.

Management should ensure that external emergency lighting is installed above exits.

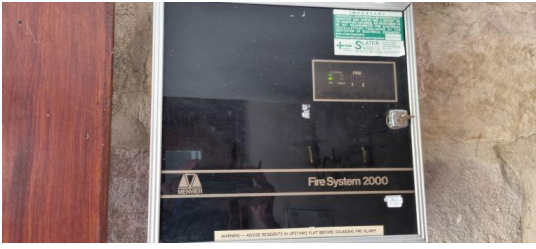
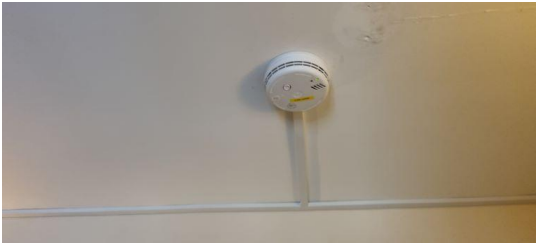
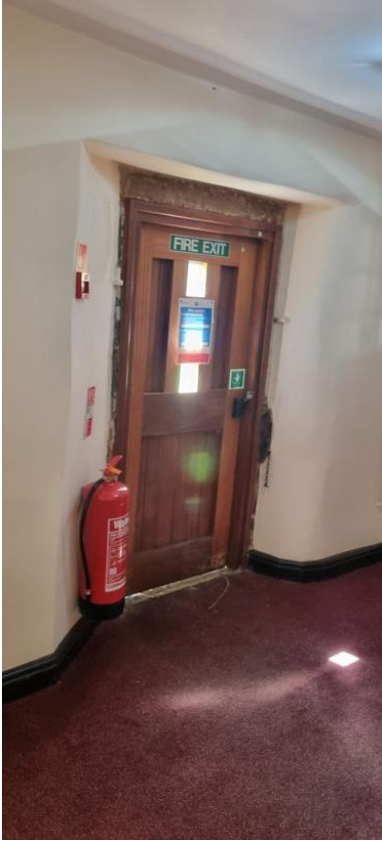
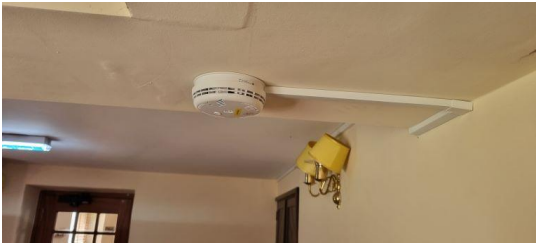
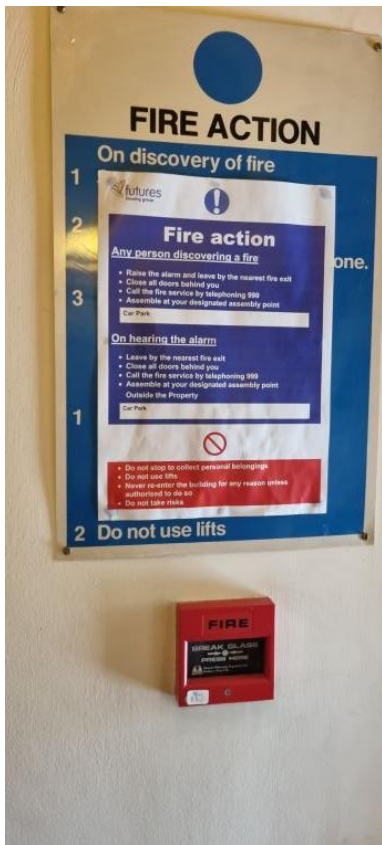
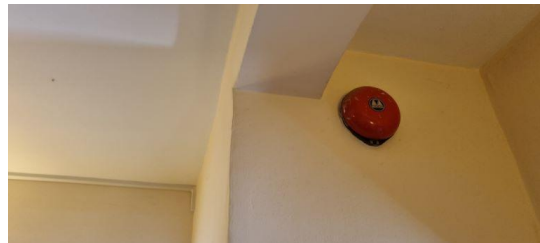
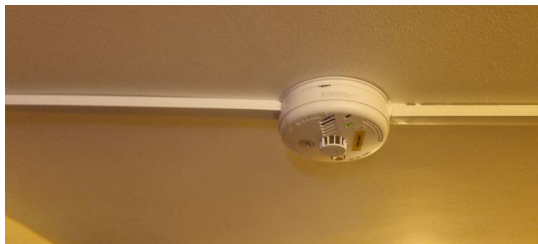
There is an automatic alarm system with AFD installed to all rooms (presumed BS5839:L2/L3 Specification). The alarm panel is installed to the entrance lobby and was in a health condition at the time of assessment.

Management should confirm the specification of the alarm installation.

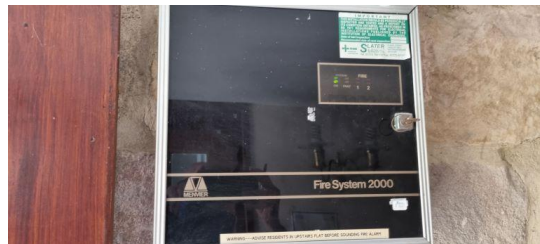
Photo 48

There is no alarm zone plan displayed. The alarm system appears to be basic and it is likely that there is only one zone however the assessor was not able to confirm with the information available. .

Management should confirm how many zone are present on the alarm system. If there is more than one zone then a zone plan should be devised and displayed.

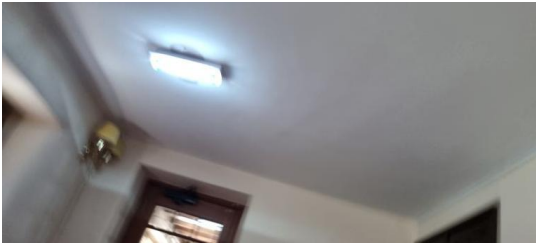
Walls are solid with emulsion painted finish. Ceilings are emulsion painted plastered with some having wooden beams. No major compartment breaches were identified however, it was not possible to confirm if compartmentation between the community centre and the dwelling above is adequate.

Management should inspect compartmentation between the community centre and dwelling above to establish if it is adequate.

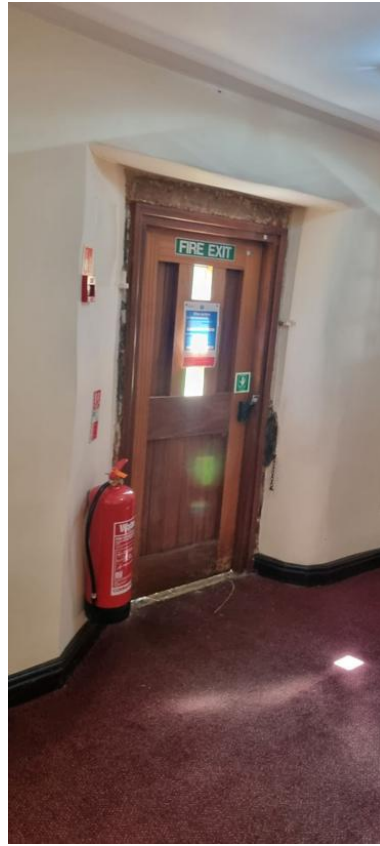
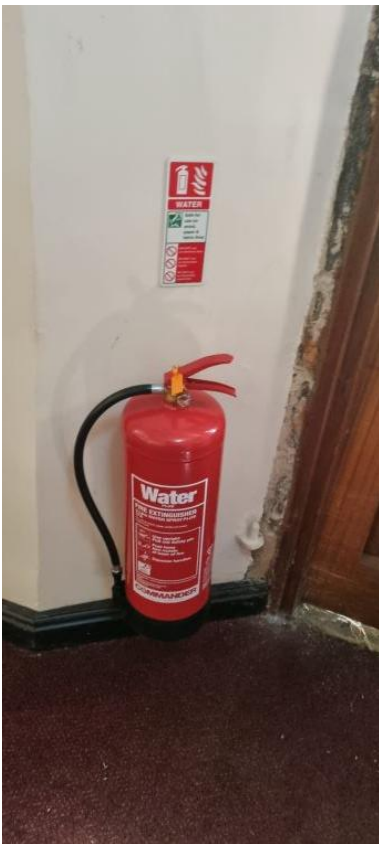
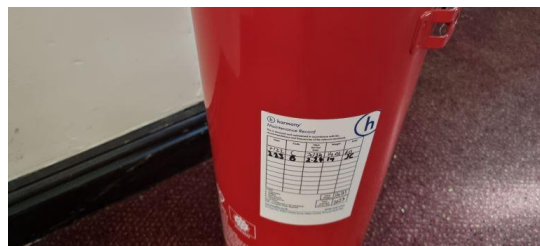
Extinguishers are installed in accordance with BS5306:Part 8. There are 2 x 6L 21A Water units and 1 x 2KG CO2 which is adequate for the compartment size. Extinguishers are maintained under service contract by Harmony with the last service completed in 02/23. Community centre users are unlikely to be trained on the use of FFE and no signage is displayed to state 'only to be used by trained persons'.
