## Futures Fire Risk Assessment

Futures Homescape, Flats 16-14 Yellow  
Hammer House: NN4 9DQ, - UPRN:  
YEL601-BLK / 173604 / QA Approved /  
Rizwan Tanveer

Futures Homescape, Flats 16-14  
Yellow Hammer House: NN4 9DQ,  
- UPRN: YEL601-BLK, Fire Risk  
Assessments, Futures Homescape

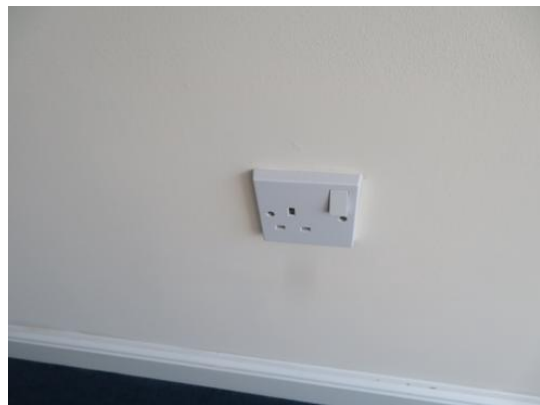
Photo 4

Standard wall mounted sockets were located in the common area. No evidence of a policy in place to restrict their use by residents.

Consideration should be given to the installation of security sockets that prevent resident use of communal 3 pin electrical sockets.

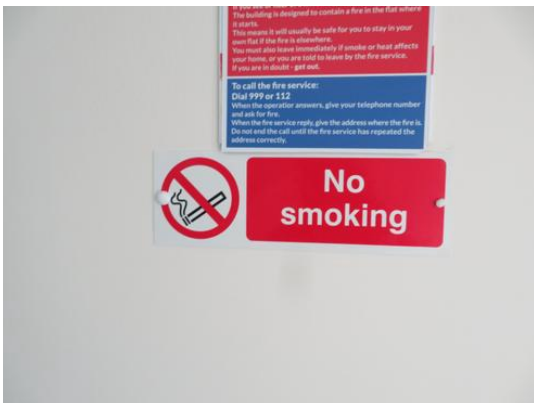
Photo 5	
C - Arson	
2 actions	
C1	
<b>Are premises secure against arson by outsiders? (Please</b>	All of the entrances into the building are secured locked shut.

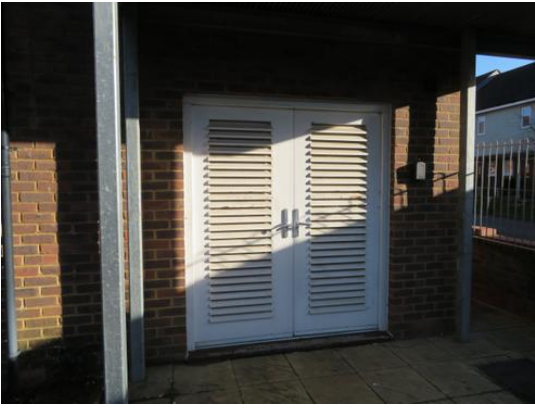
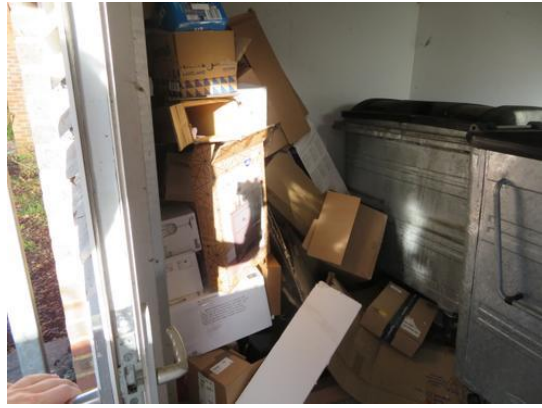
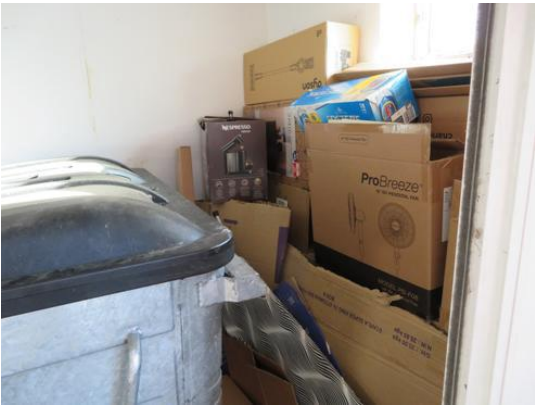
The bin store is located to the front of the block and was found to be unsecured at the time of the assessment.

Fire loading within the bin store was noted to be excessive with large amounts of cardboard discarded outside of provided waste receptacles.

Excess waste materials should be removed from the bin store as soon as is reasonably practicable. The client should instruct residents that if waste does not fit in bins, it must be discarded elsewhere. Regular checks should be made to ensure compliance.

It is recommended that the bin store is installed with a coded locking mechanism and overhead self closing devices to prevent unauthorised access.

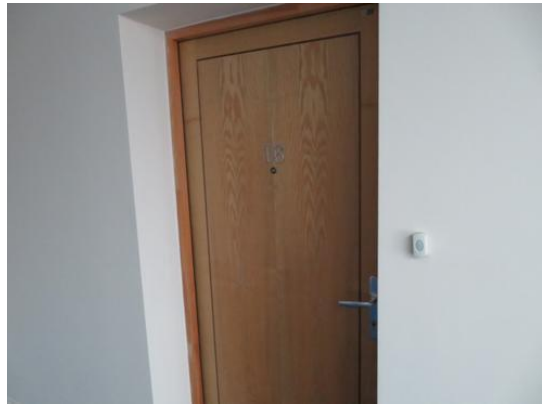
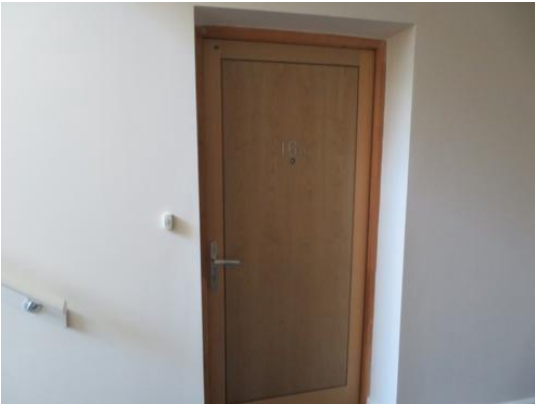
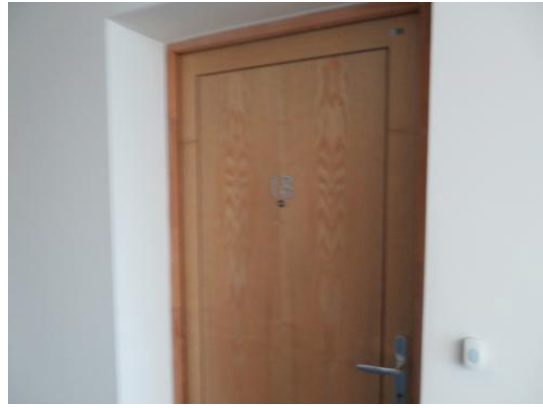
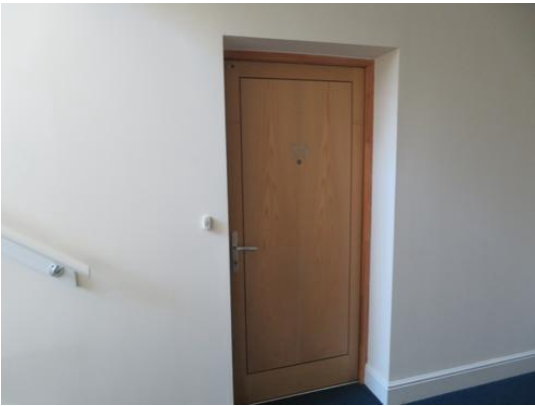
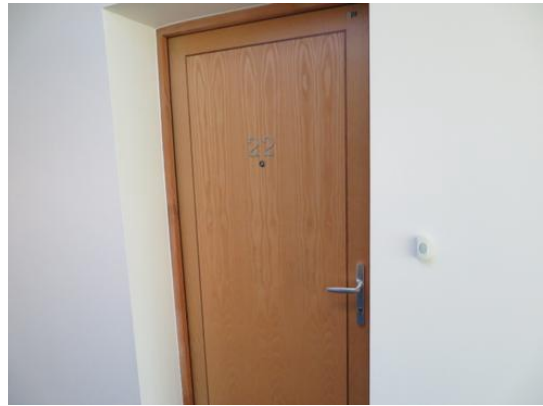
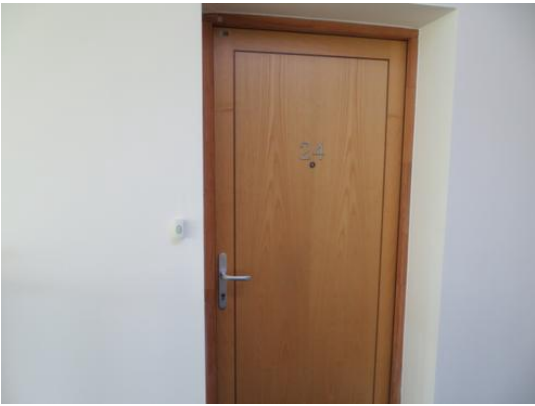
Flat entrance doors were seen to be FD30/S timber fire doors. (NB. - from limited visual inspection, certification not seen; adequacy of installation not confirmed).

The fire rated flat entrance doors appear to be in good condition.

There is no glazing present to any flat entrance doors in this property.

There are no fanlights over the flat entrance doors in this property.

Management should establish an ongoing programme of rolling checks to flat entrance doors to ensure they are installed with combined intumescent strips/cold smoke seals and positive action self-closing devices.

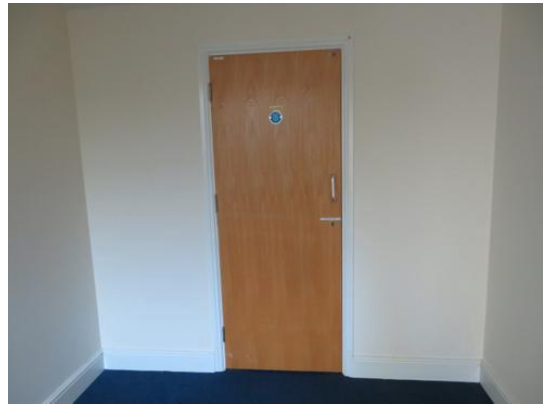
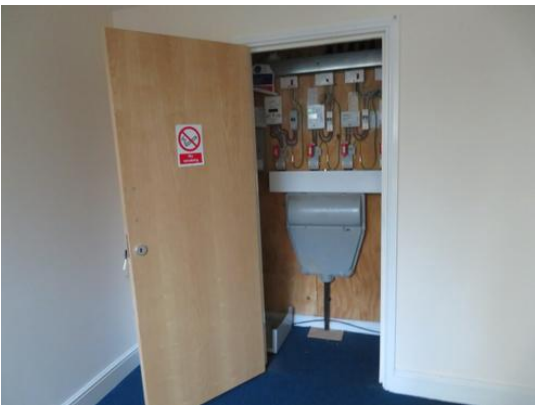
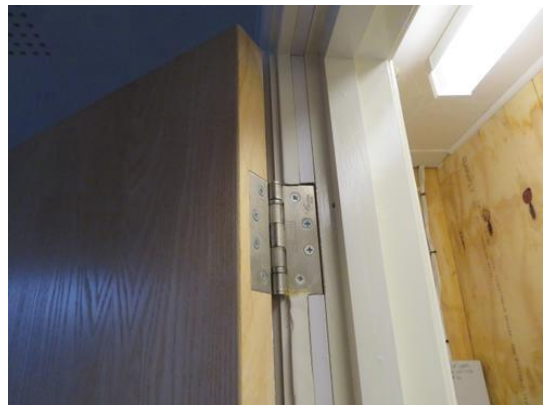
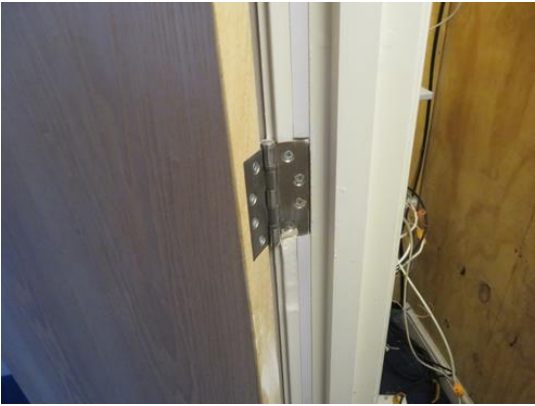
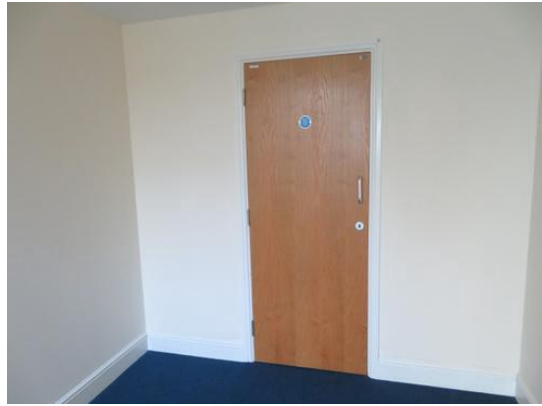
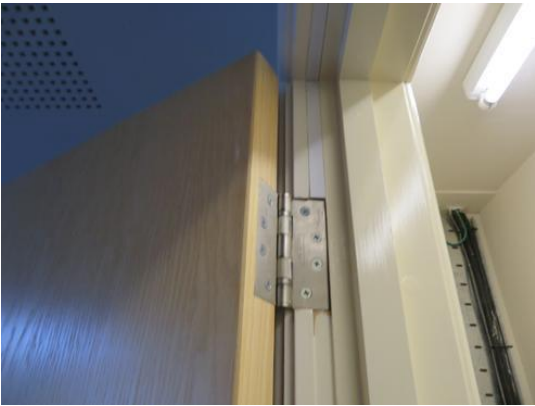
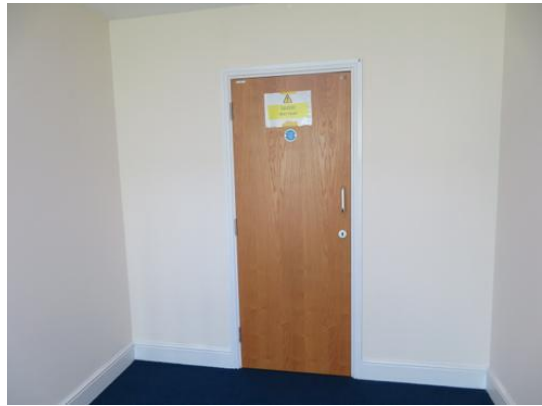
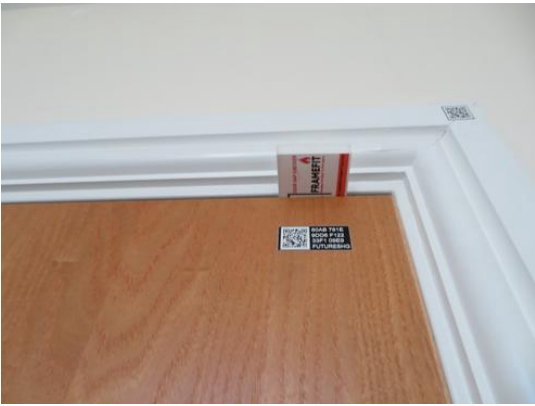
Riser cupboard doors were noted to be 44mm thick solid core timber fire doors. The doors were kept locked at the time of the assessment and were installed with intumescent strips only.

It is advised that the client replace the intumescent strips with a combined intumescent strip and cold smoke seal. This is to prevent the passage of cold smoke and other products of combustion between the electrical riser cupboards and the communal escape route.

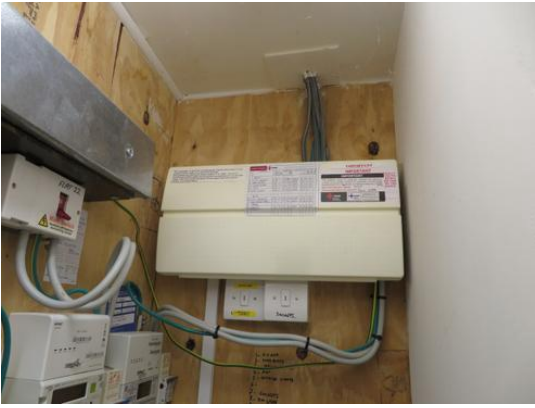
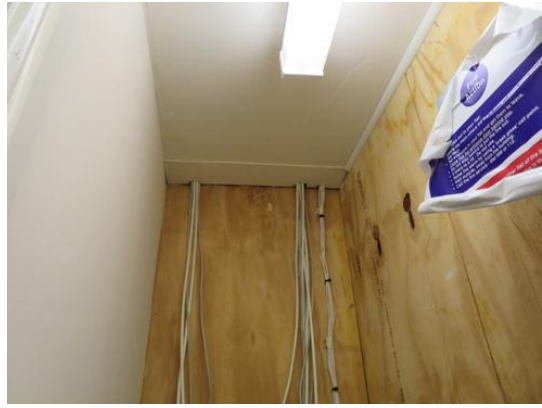
Penetrating services noted in the electrical intake cupboard and service riser cupboards were not adequately fire stopped.

The penetrating services noted should be adequately fire stopped. Remedial works should be completed by a competent third party accredited contractor.

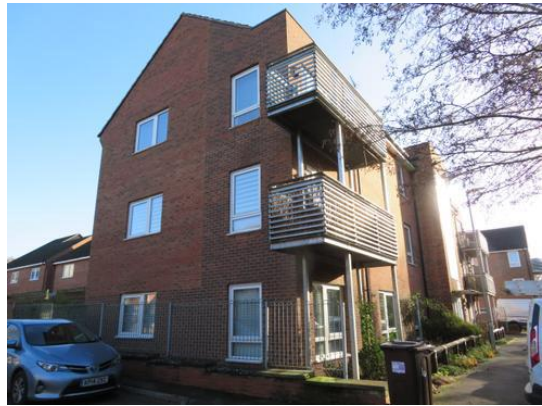
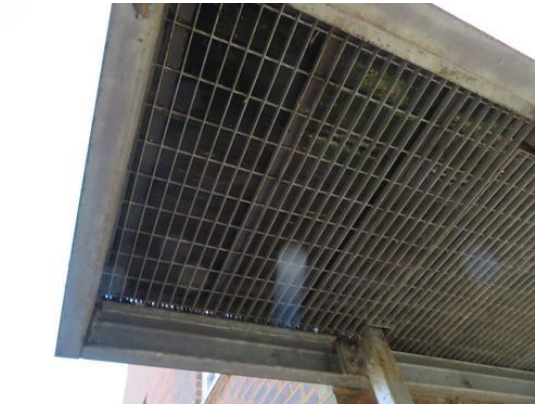
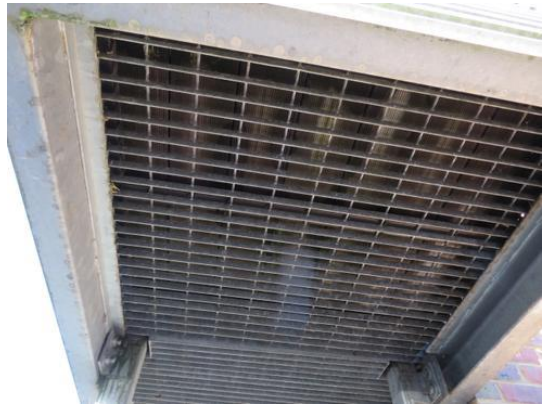
The front elevation of the building is installed with a large glazed section. This covers the communal area only of which the sources of ignition are negligible. The glass is deemed low risk and suitable of being assessed as part of this fire risk assessment.

Balconies are installed to the LHS and RHS of the block. These appear to be constructed from a steel frame with timber decks.

The external wall construction of the building appears to be of sufficiently low risk that it can be assessed visually as part of this Type 1 assessment. The external wall is constructed from traditional brick and block under a pitched and tiled roof.

It is recommended that the client commission an FRAEW due to the external wall items noted that could promote external fire spread. This should be conducted by a third party accredited contractor.
