Futures Fire Risk Assessment

Futures Homescape, 44 King Street:
NG16 6NL, - UPRN: IL11520 / 173591 / QA
Approved / Andy Cloke

**Futures Homescape, 44 King
Street: NG16 6NL, - UPRN:
IL11520, Fire Risk Assessments,
Futures Homescape**

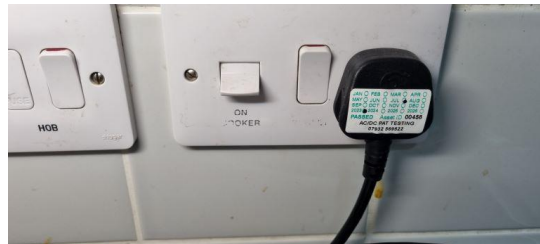
Photo 4

Labels on appliances confirmed that PAT testing was completed in July 2023.

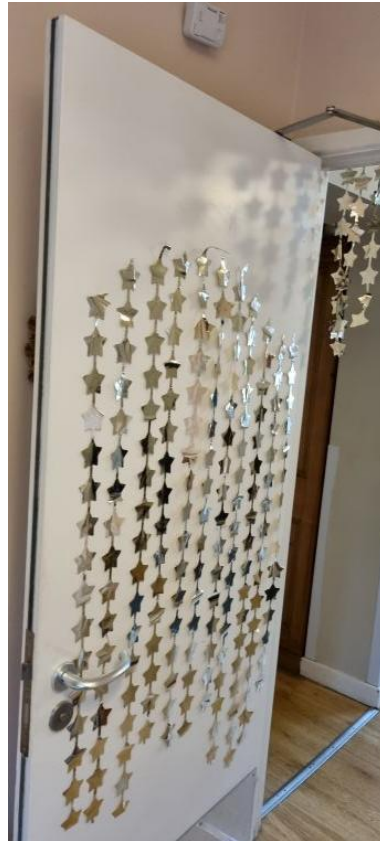
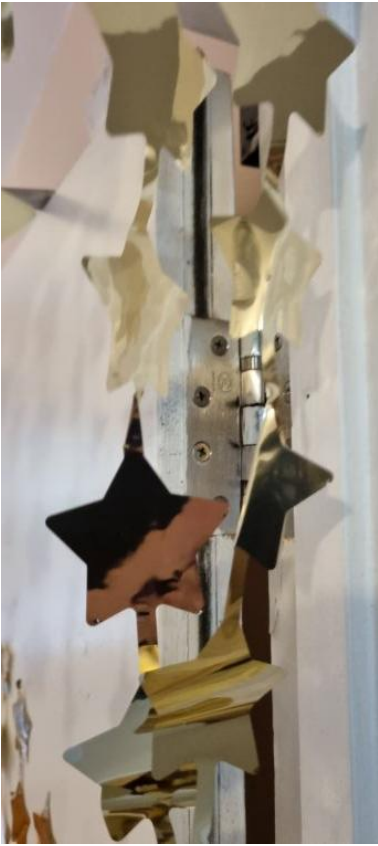
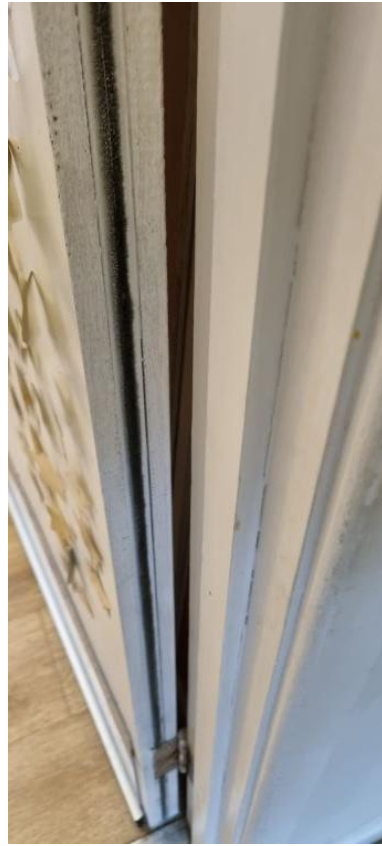
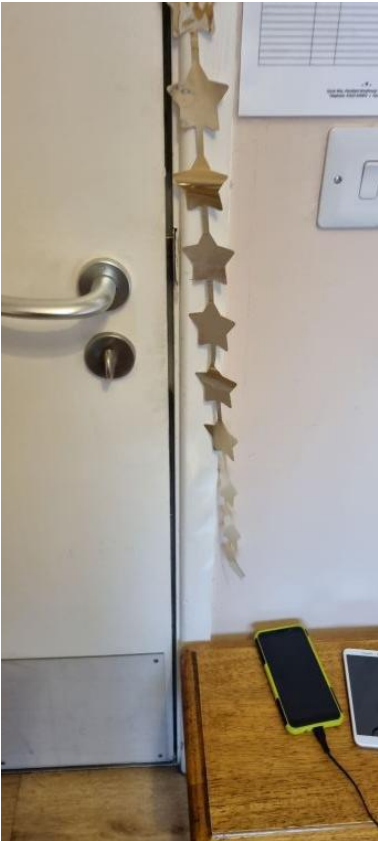
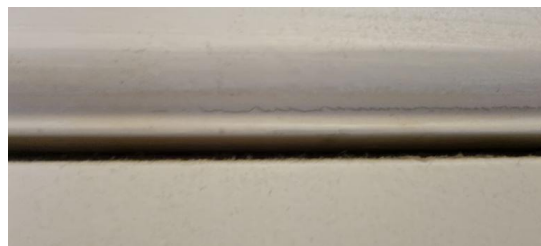
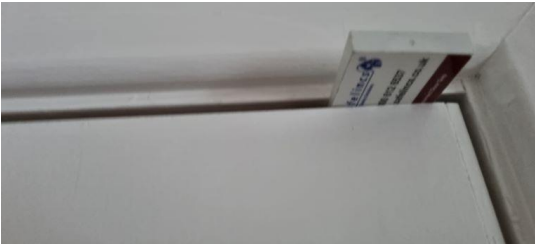
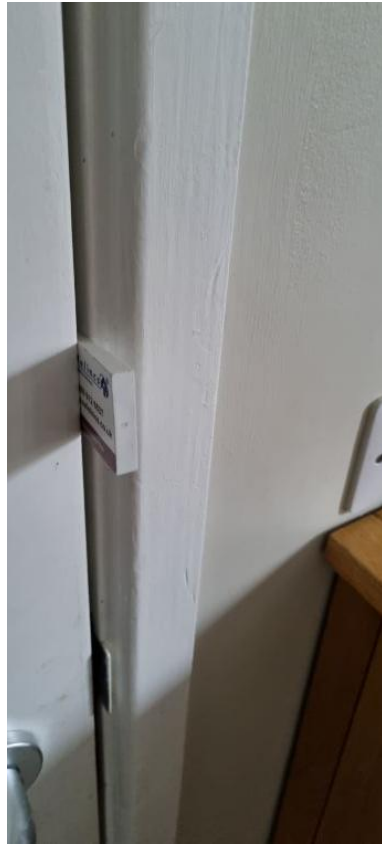
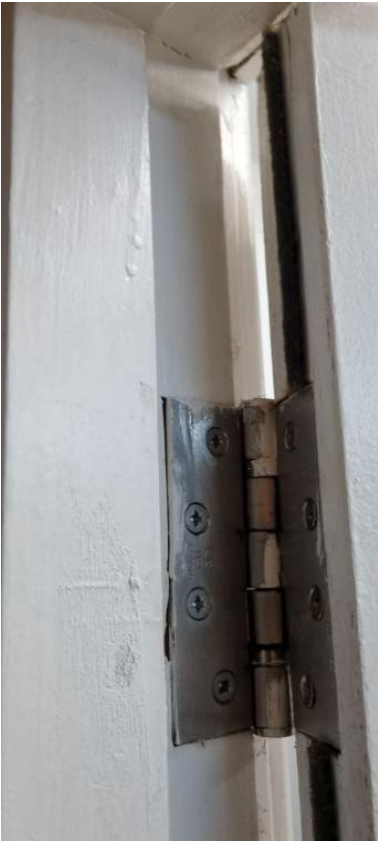
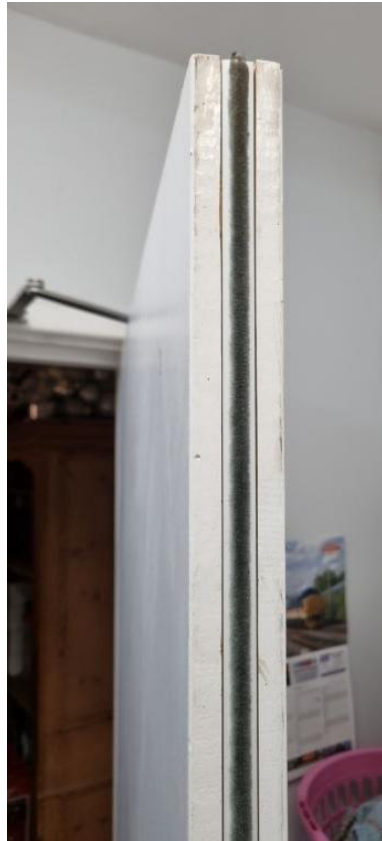
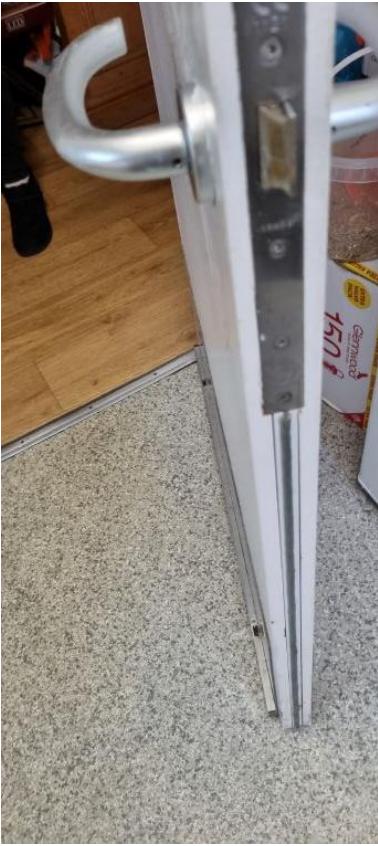
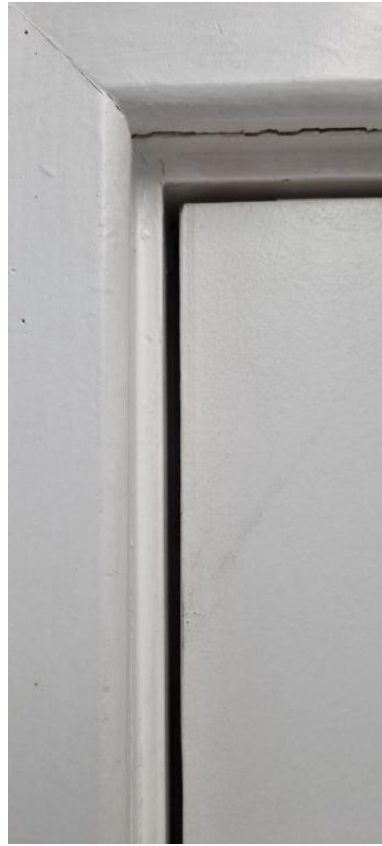
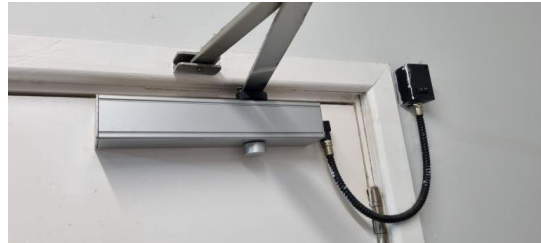
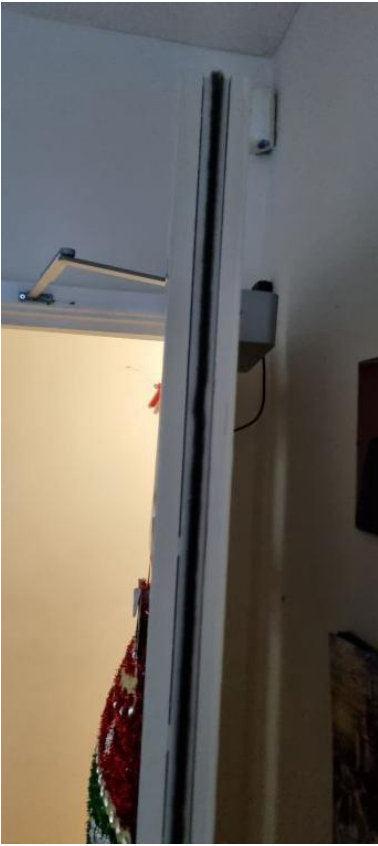
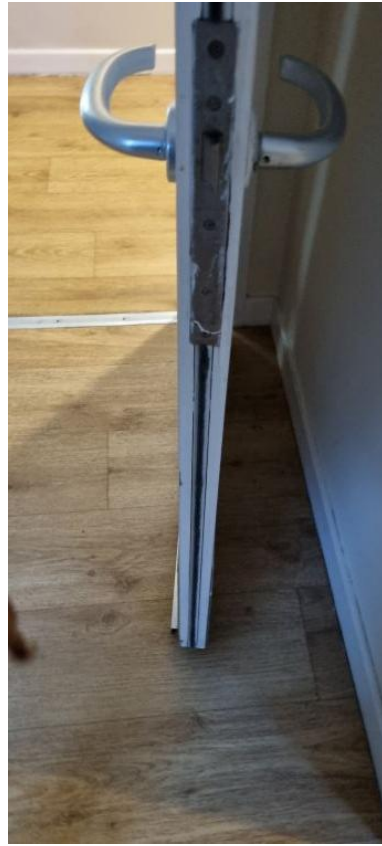
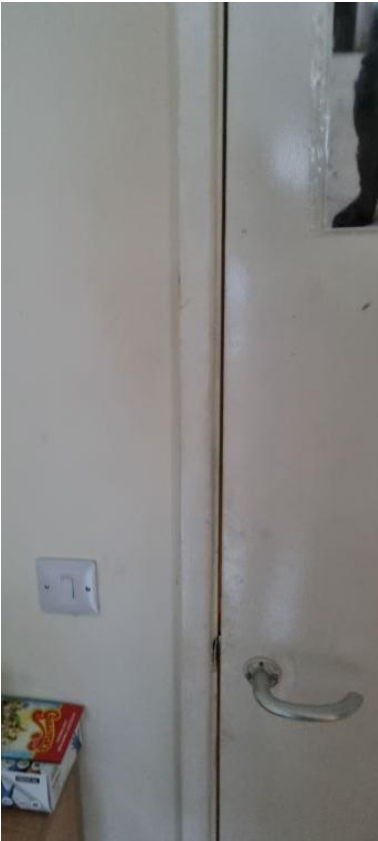
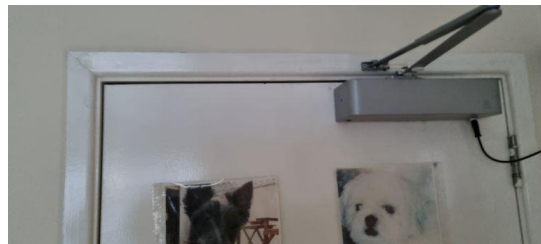
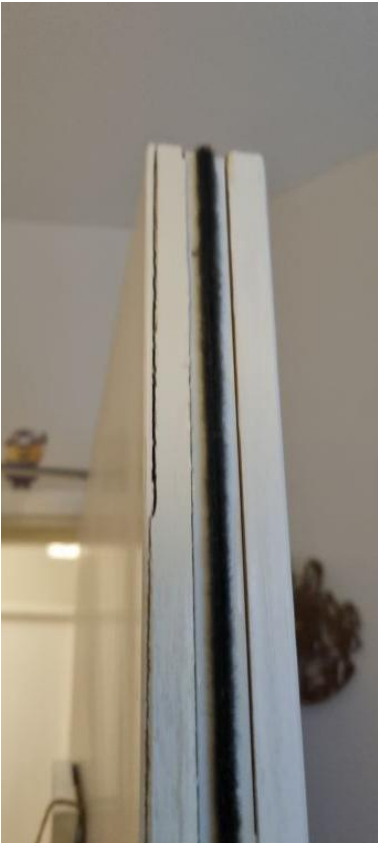
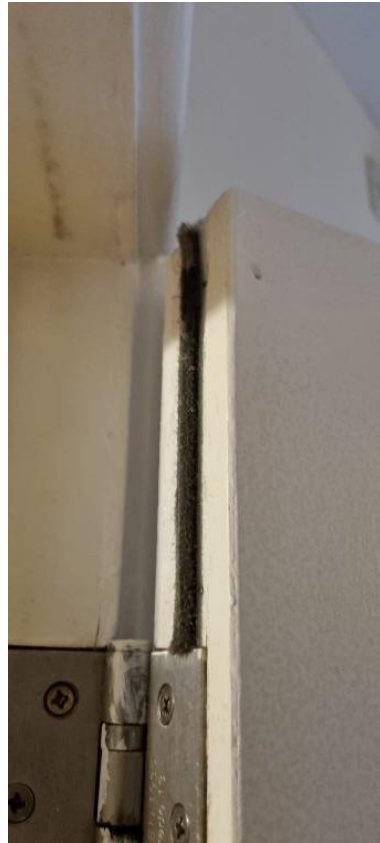
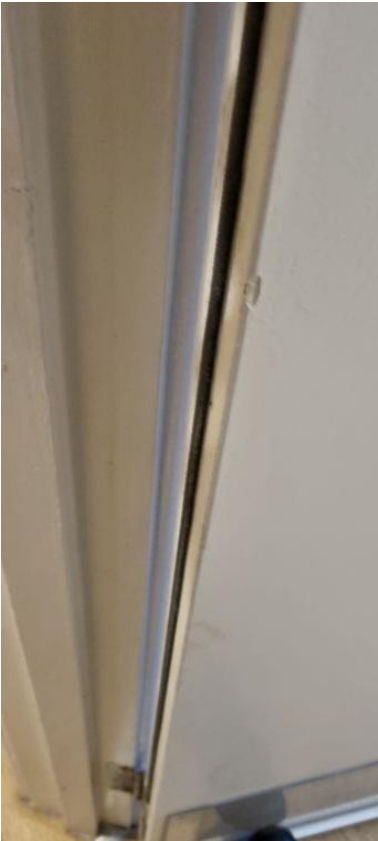
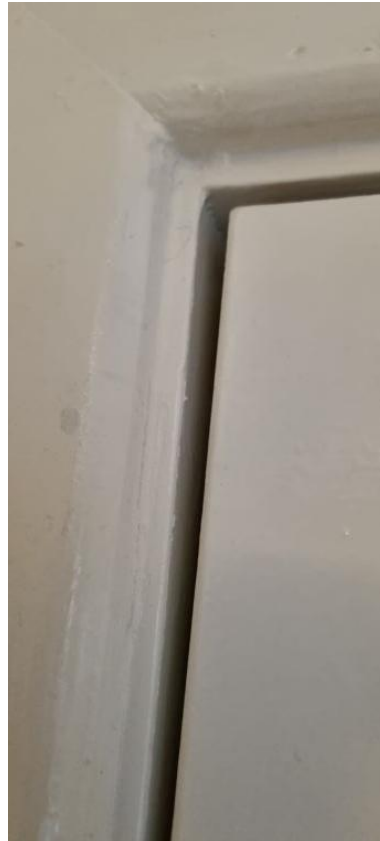
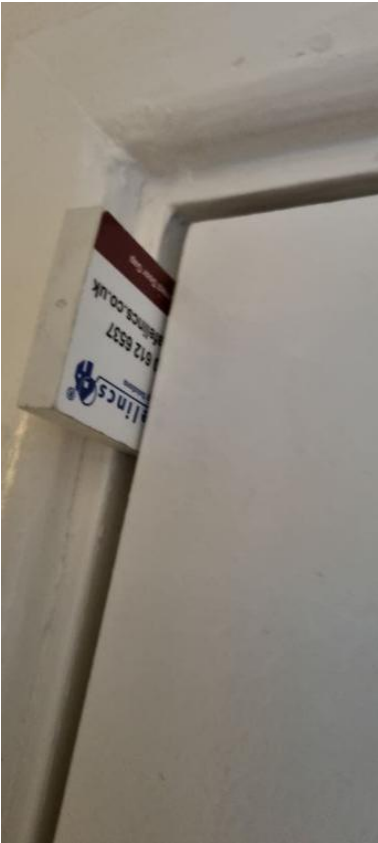
Fire doors are fitted to all rooms. Doors are not labelled and it was not possible to confirm fire rating. All doors have automatic closure devices fitted and intumescent strips fitted however, gaps to doors were excessive throughout.

Management should inspect all doors to the premises to establish condition and fire rating and repair or replace doors with certificated FD30S self-closing fire door(s) and frame sets where necessary. These should be fitted by an approved, third-party certified installation contractor.

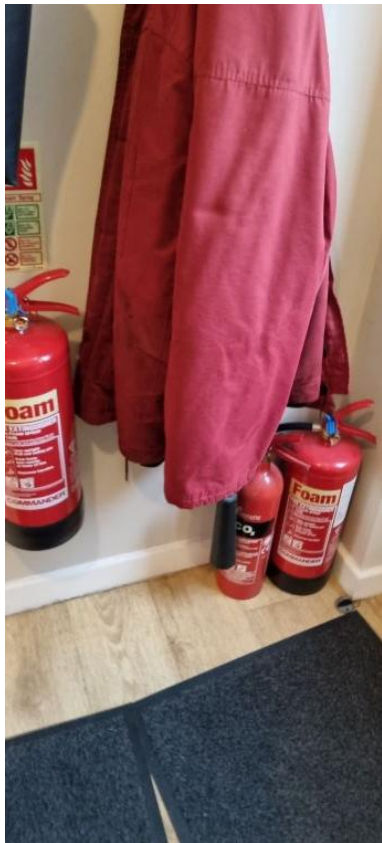
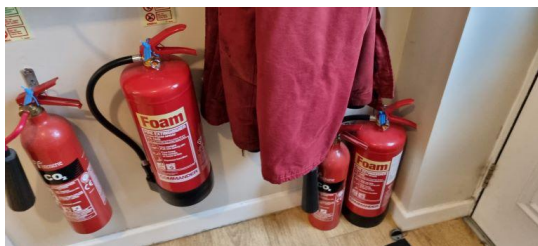
There are 3 x 6Ltr 21A Foam fire extinguishers and 2 x 2Kg CO2 units. Extinguishers are maintained under service contract with Harmony. The last inspection was completed in February 2023. Some unit within the entrance hallway are not appropriately mounted / signed. There is no extinguisher located within the laundry.

Management should ensure that extinguishers are appropriately mounted on wall brackets or floor stand with signage displayed. It is advisable that a CO2 unit within the hallway is relocated to the laundry.
