## Futures Fire Risk Assessment

Futures Homeway, Flats 70-86 Abbortbury Drive:  
NN11 2PB, - UPRN: FB266 / 171924 / QA Approved  
/ Andy Cloke

Futures Homeway, Flats 70-86  
Abbortbury Drive: NN11 2PB, -  
UPRN: FB266, Fire Risk  
Assessments, Futures  
Homeway

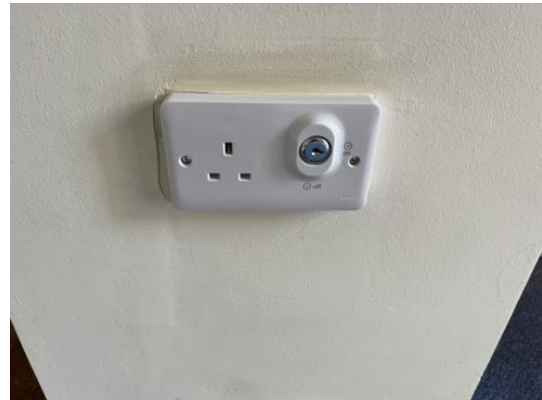
Photo 4

No portable appliances noted. The communal sockets have a restriction device installed, this appears to have been left in the off position allowing unauthorised use.

The communal sockets should remain isolated when not in use. Staff who use sockets should be informed of this policy. Regular checks should be conducted to ensure compliance.

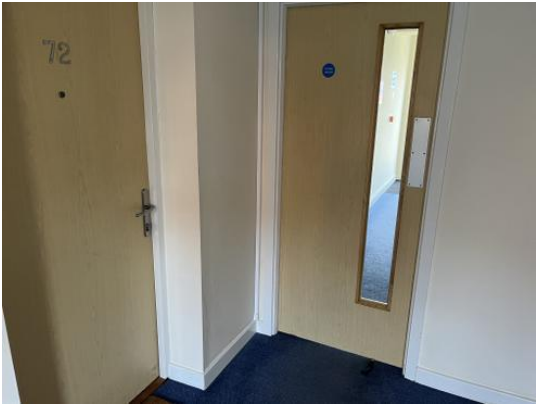
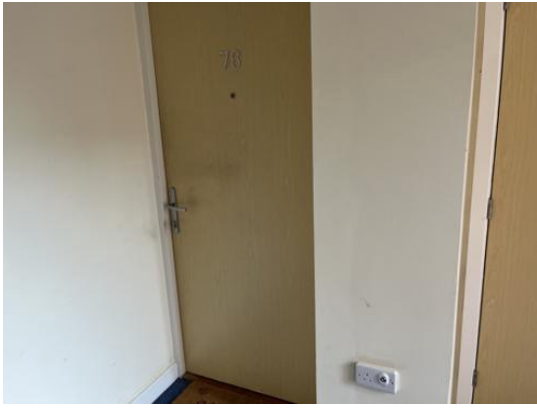
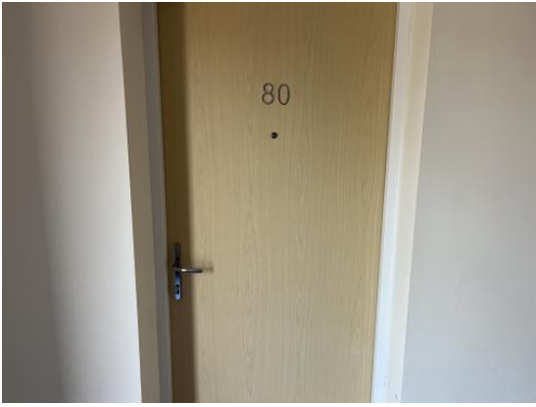
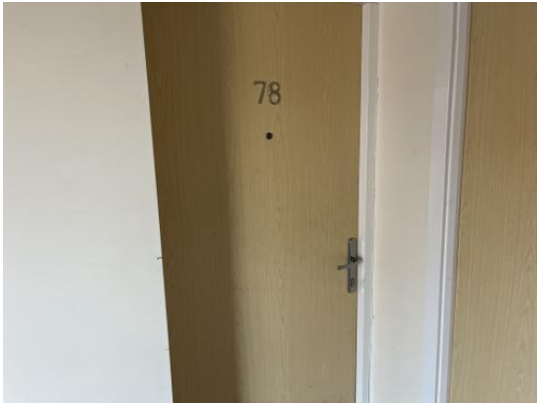
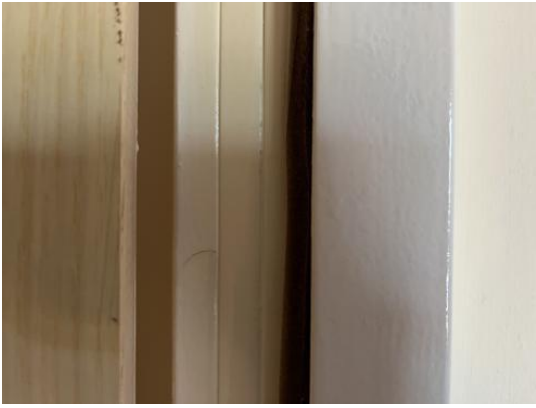
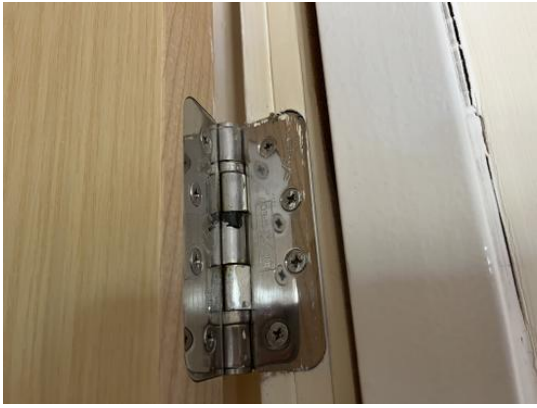
Sample inspection of flat 80 entrance door found it to be an FD30 certified timber fire door installed to a timber frame. The door was installed with an overhead positive action self closing device and intumescent strips.

It was noted that flat 82 entrance door had significant damage to the door leaf and frame, likely from a destructive forced entry. The damage is not repairable.

Flat 82 entrance door should be replaced as soon as is reasonably practicable. The replacement door should be FD30/S standard and installed by a competent third party accredited contractor.

It is recommended that the intumescent strips installed to flat 80 are replaced with combined intumescent strips/cold smoke seals. Flats not inspected at the time of the assessment should also be checked and if found to only be installed with intumescent strips, these should also be changed for combined strips/seals.

Management should establish an ongoing programme of rolling checks to flat entrance doors to ensure they are installed with combined intumescent strips/cold smoke seals and positive action self-closing devices.

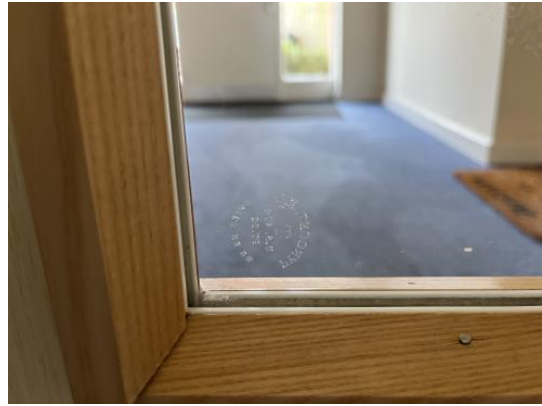
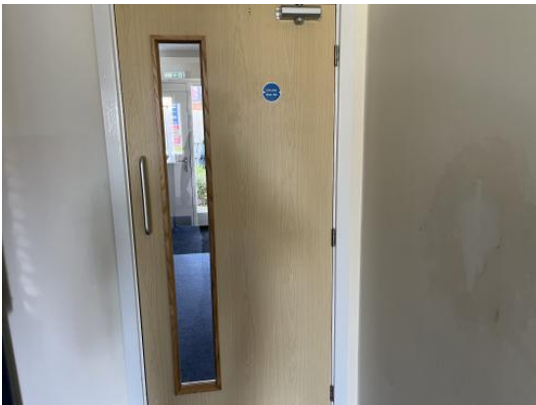
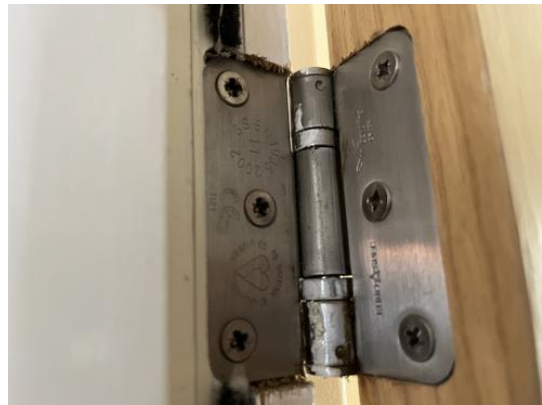
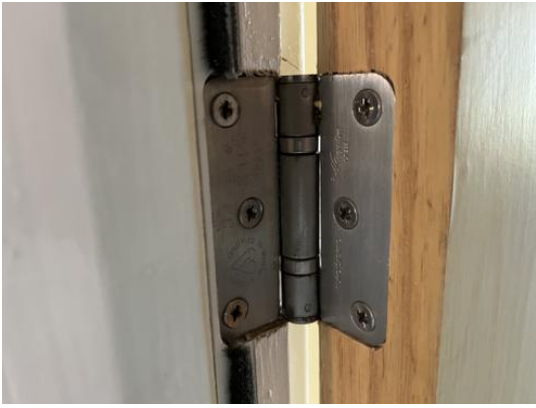
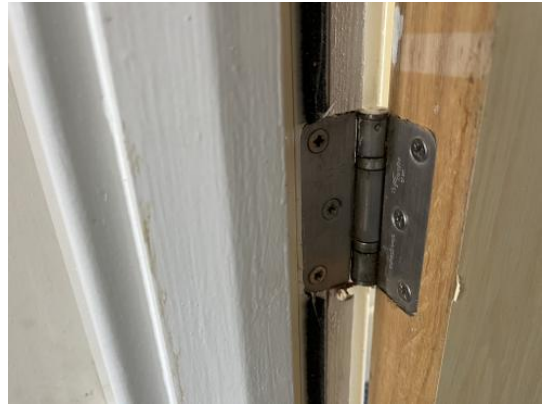
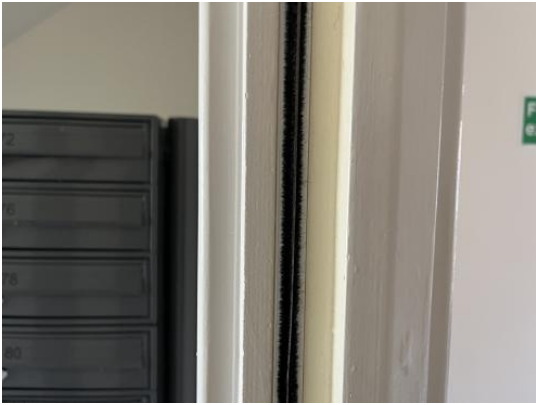
Communal fire doors were noted to be FD30/S timber fire doors either solid core or glazed. Doors were noted to be installed with combined intumescent strips/cold smoke seals and were in good condition from a visual inspection.

The ground floor electrical intake cupboard was unlocked at the time of the assessment.

Risers and electrical intakes should be kept locked at all times when not in use. Regular checks should be conducted to ensure compliance.

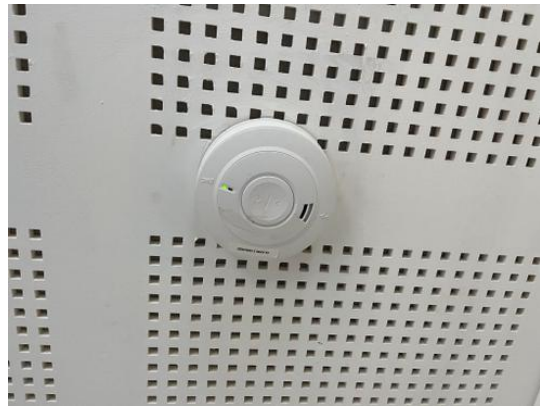
Photo 54

A grade D smoke detection system was installed to the common areas. This is conflicting with the 'Stay Put' evacuation strategy.

The client should consider removal of the Grade D smoke detection system installed to the common escape route. There is no requirement for a smoke detection and alarm system in the common areas of purpose built blocks of flats operating a 'Stay Put' evacuation strategy.
