Futures Fire Risk Assessment

Futures Homescape, Office The Ropewalk: DE75
7BL, - UPRN: 16 / 173543 / QA Approved / Andy
Clope

Futures Homescape, Office The
Ropewalk: DE75 7BL, - UPRN:
16, Fire Risk Assessments,
Futures Homescape

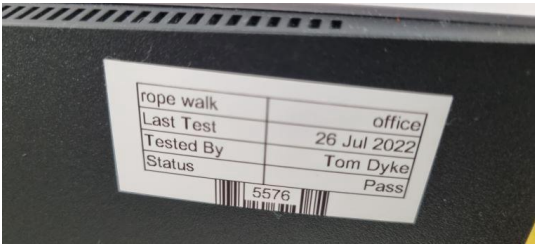
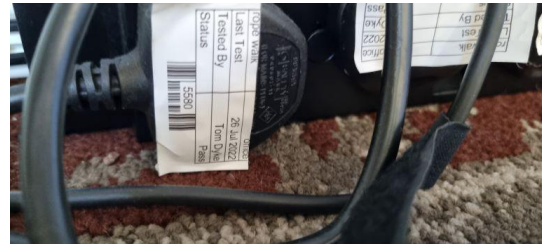
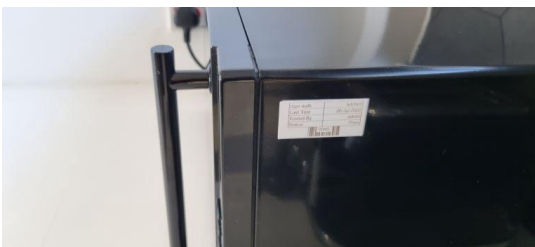
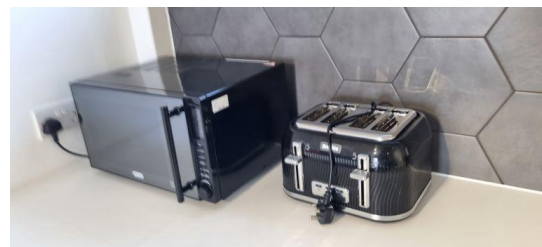
Is PAT testing in common areas carried out?

No

Labels on portable electrical appliances confirmed that the last PAT test was completed on 26/07/2022 and is now overdue.

Management should arrange for PAT re-test.

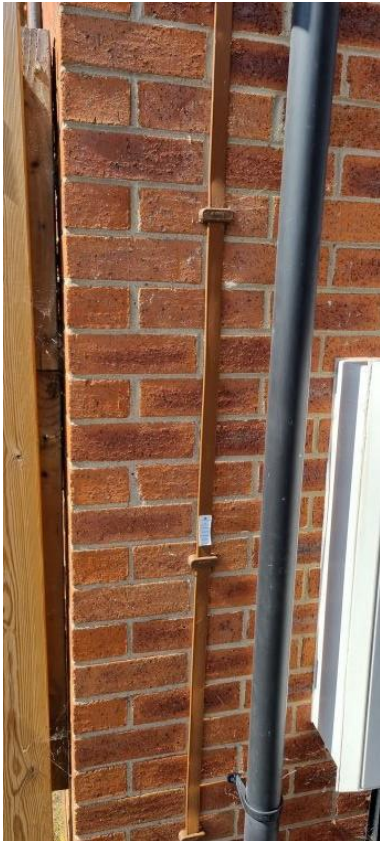
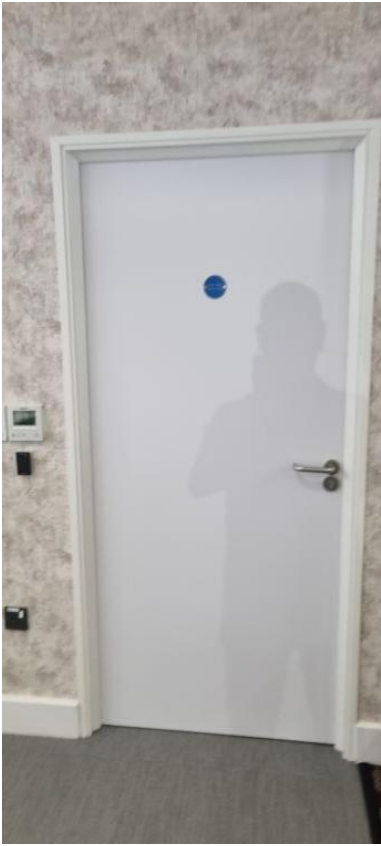
Does the building have a lightning protection system?

Lighting protection strips are present to the property. It was not possible to establish if lightning protection has been tested in accordance with BS62305. Where lightning protection is provided it should be tested within a maximum of 12 monthly intervals however, it is recommended that testing is completed at 11 monthly intervals to allow variations in seasons tested over time.

Management should confirm that lightning protection is tested in accordance with BSEN: 62305. Where testing has not been carried out, management should ensure that LPT is conducted by a certified third-party contractor and that adequate records are maintained.

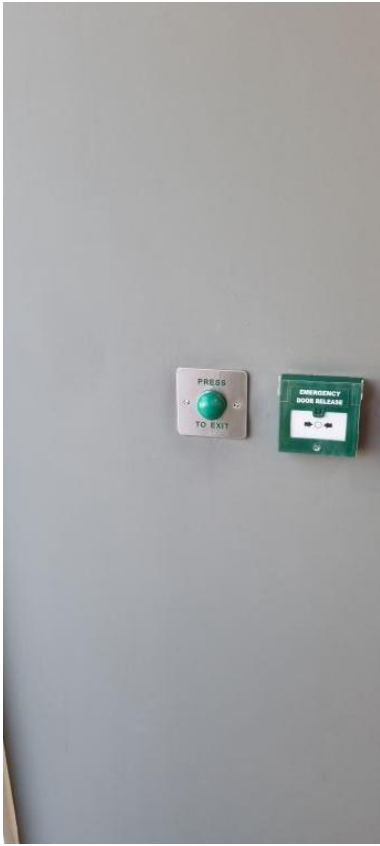
Are combustible materials kept away from any sources of ignition, including gas and electrical intake cupboards?

The IT server room was not accessible at the time of assessment as it can only be accessed by FHG IT department. It was not possible to establish if there are any combustible materials stored within. In addition, it was not possible to establish fire rating or condition of the server room door or if there are any compartmentation penetrations within.

Where ignition sources are present, server room doors should conform to a minimum of FD30

specification. Where doors do not conform, they should be replaced with certified FD30 fire door sets. Any penetrations identified within should be fire stopped with fire rated building materials. Any work required should only be conducted by a certified third-party contractor.

Management should ensure that no combustible materials are stored in proximity of ignition sources such as IT servers and other electrical ignition risks.

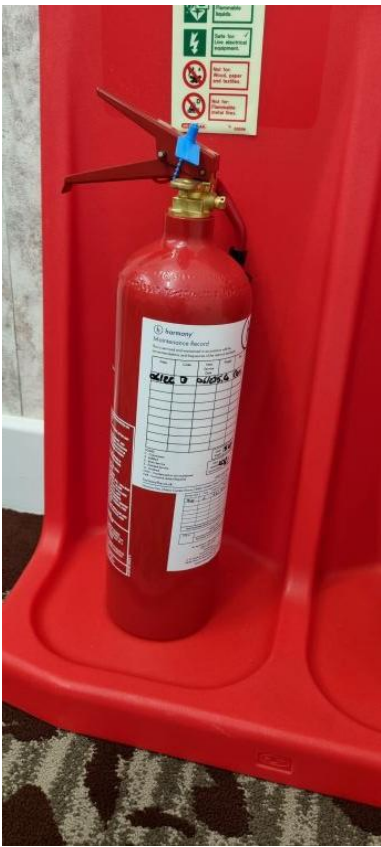
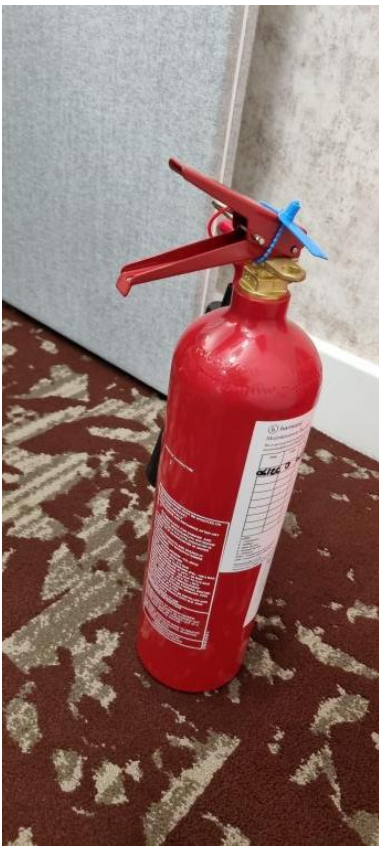
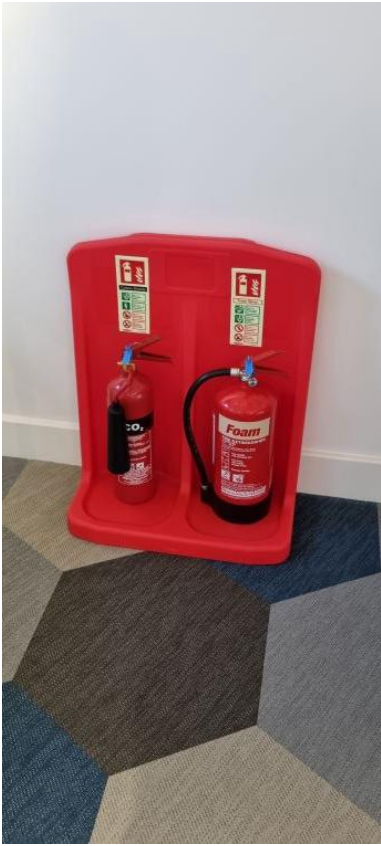
If required, is there reasonable provision of accessible portable fire extinguishers?

Extinguishers are installed in accordance with BS5308:Part 8. There are 2 x 6L 21A Foam and 2 x 2KG CO2 units installed. Extinguishers are located by exits on appropriate floor stands with signage attached. Extinguishers are maintained under service contract with Harmony. The last service was completed in June 22 and is now overdue.

Management should contact service provider and arrange annual service.
