Futures Fire Risk Assessment

Futures Homescape, Community Centre Firs
Gardens: DE55 7FU, - UPRN: 21 / 173560 / QA
Approved / Andy Cloke

Futures Homescape,
Community Centre Firs
Gardens: DE55 7FU, - UPRN: 21,
Fire Risk Assessments, Futures
Homescape

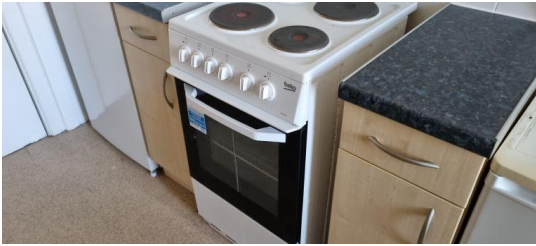
Photo 9

There is a free-standing electric cooker within the kitchen. The assessor was not able to establish if the cooker is used / how often. No rules for cooking were displayed.

Management should ensure that there are suitable rules for using the cooker. Rules should prohibit high risk cooking such as deep fat frying etc. Any rules should be communicated to community centre users.

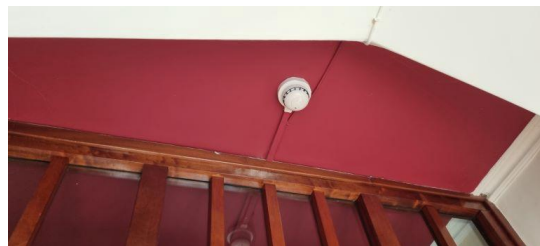
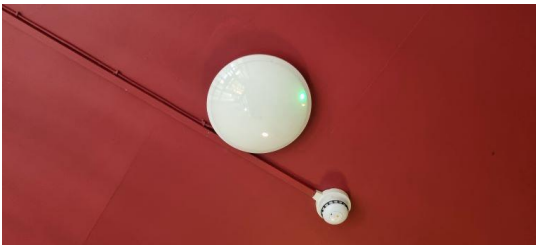
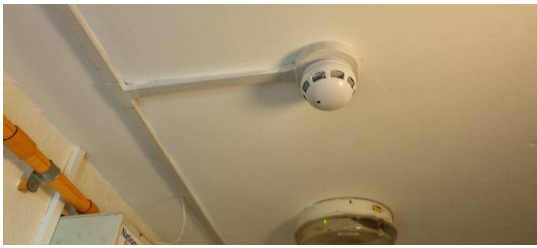
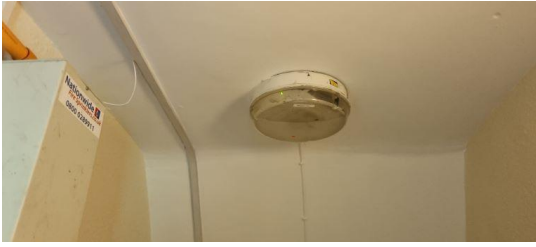
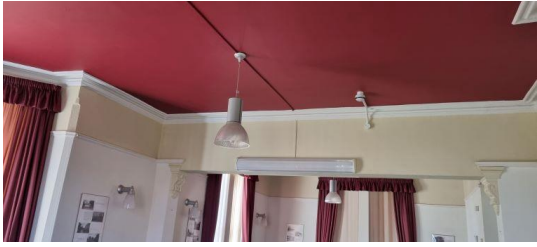
Conduit and cables were noted throughout and it was not possible to confirm that the requirements of Regulation 521.10.202 of the BS 7671 - 18th Edition of The IET Wiring Regulations, which requires all cables to be adequately supported using non-combustible fixings to prevent premature collapse in the event of a fire. The new regulation is not applied retrospectively so any

wiring systems fitted before 2019 do not need to be immediately updated. Any new installation or additions and alterations to existing systems, including temporary wiring, have to comply with the regulations.

Management is to consider the requirements of the Regulation 521.10.202 of the BS 7671 - 18th Edition The IET Wiring Regulations which requires all cables to be adequately supported using non-combustible fixings to prevent premature collapse in the event of a fire albeit not retrospective and seek the advice of a suitably qualified competent person or organisation and undertake any remediation identified by the aforementioned competent person or organisation.

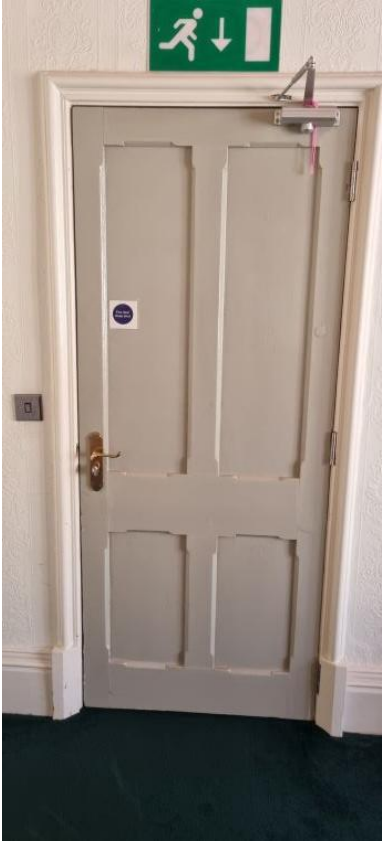
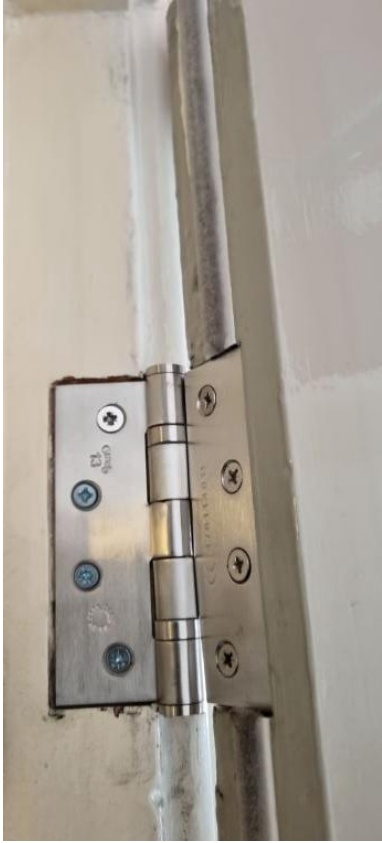
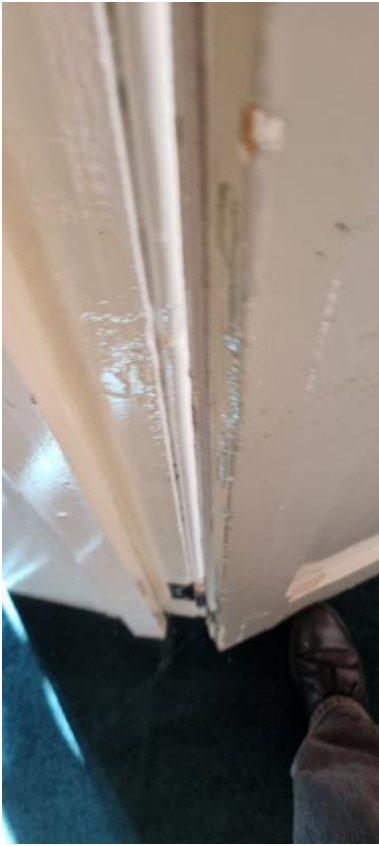
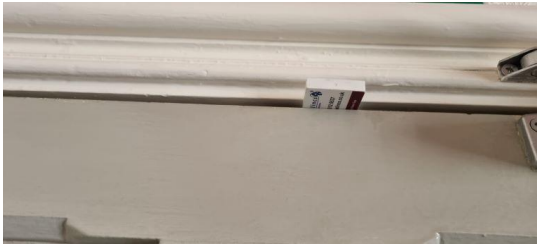
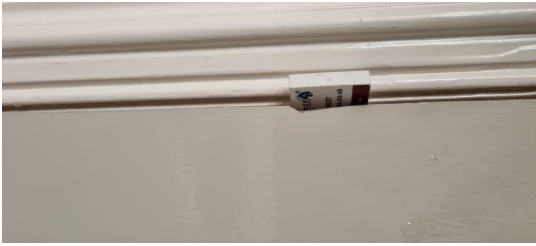
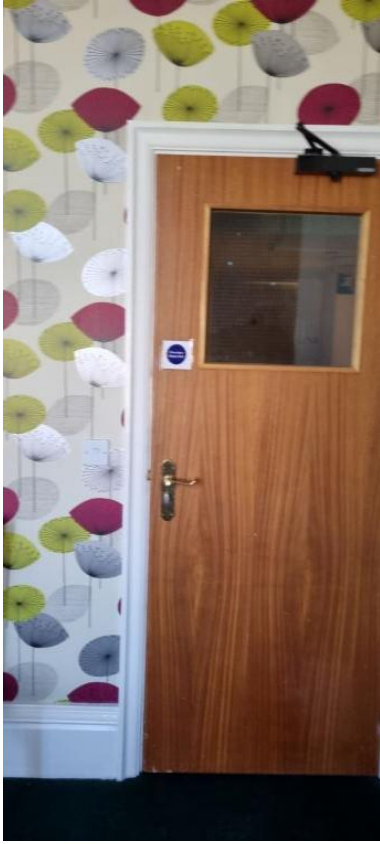
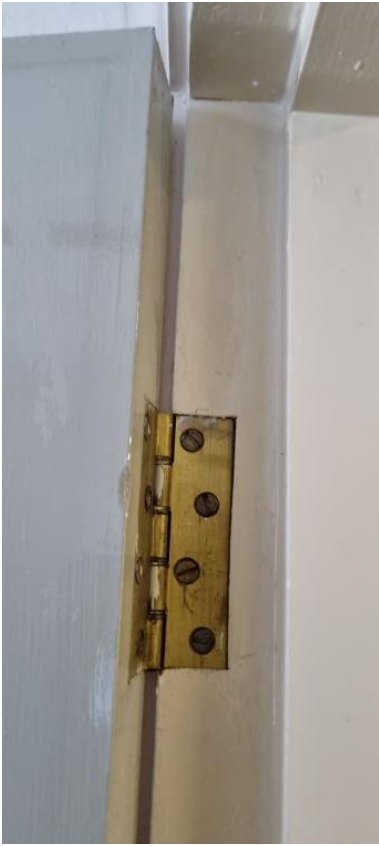
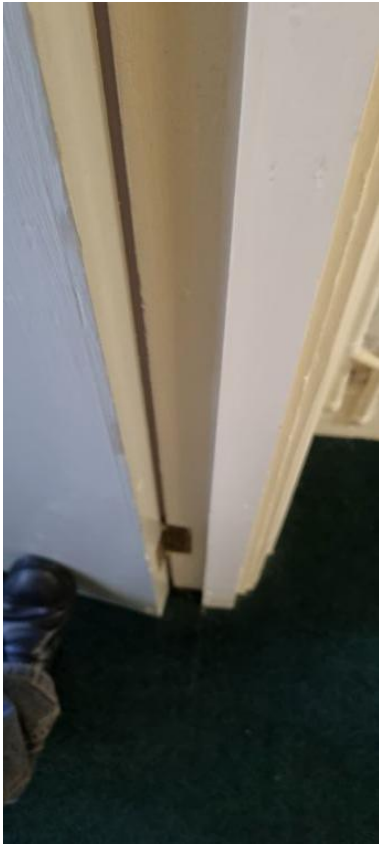
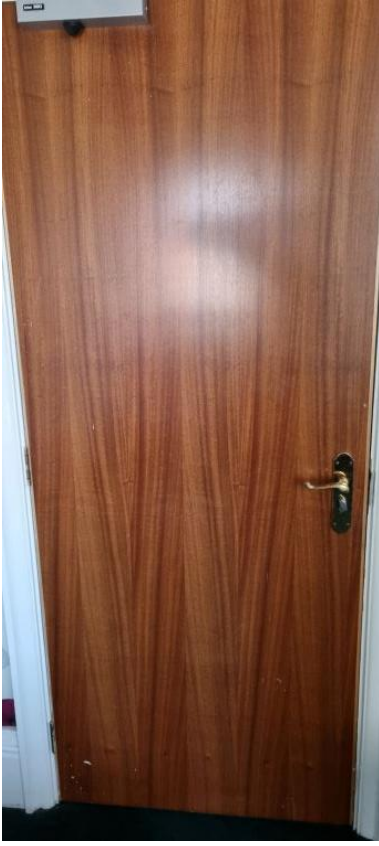
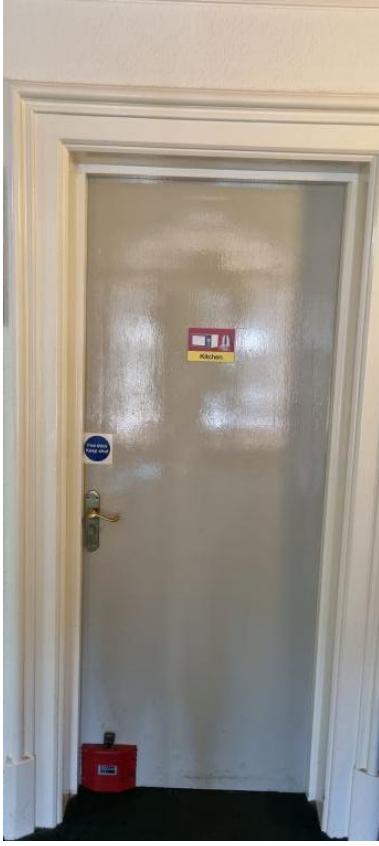
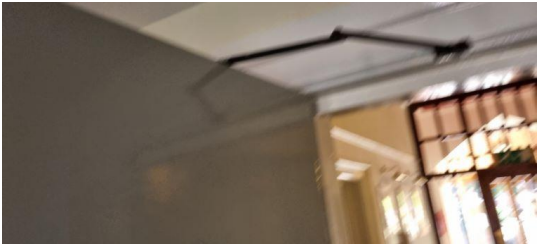
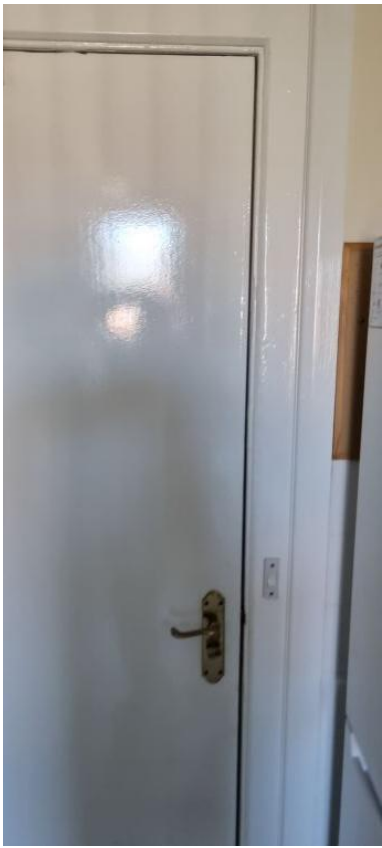
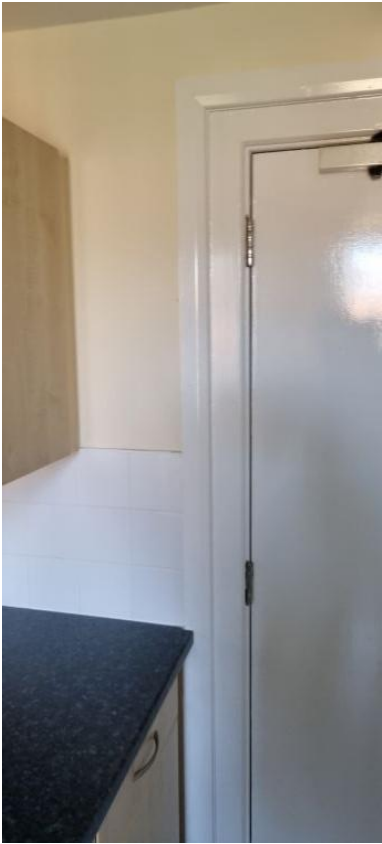
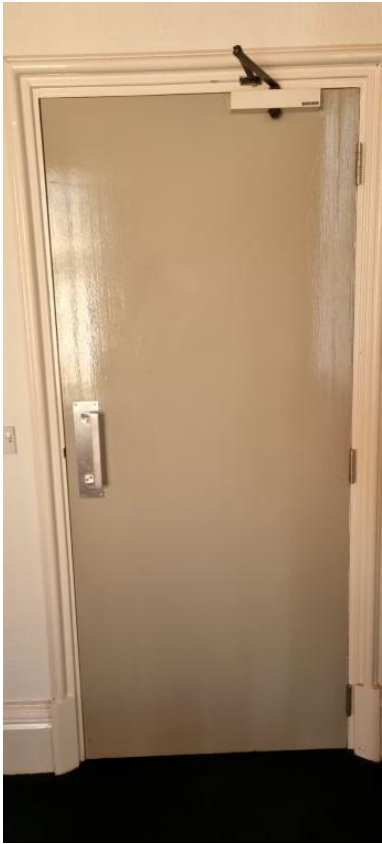
Fire doors are fitted to each sitting room, corridor and kitchen. Intumescent strips and self-closure devices are fitted. Doors the the left and right sitting rooms have excessive gaps.

Management should inspect fire doors to sitting rooms and repair in order that gaps around doors do not exceed 4mm tolerance or replace with certified self closing fire door sets to FD30 specification. Any installation / repair should only be completed by a certified third-party contractor.

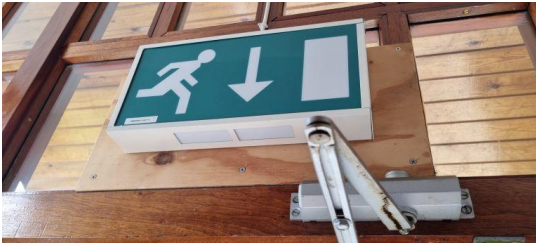
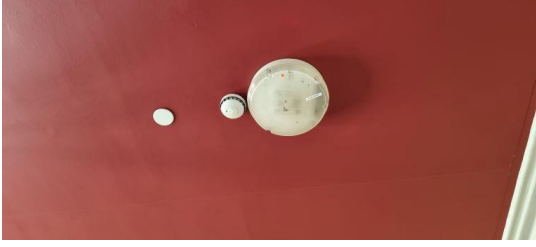
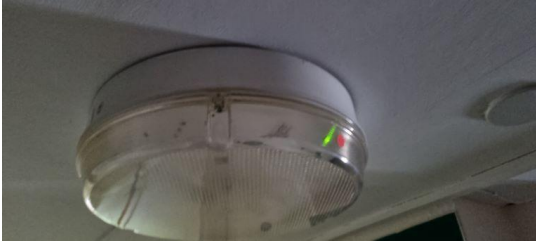
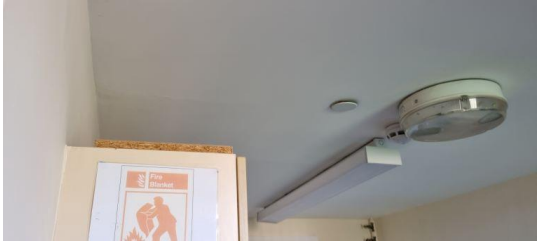
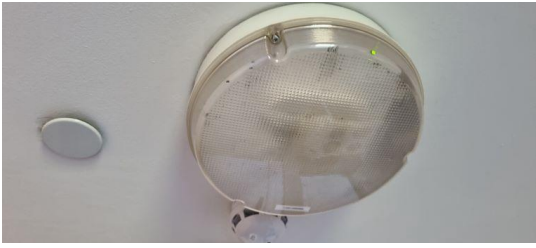
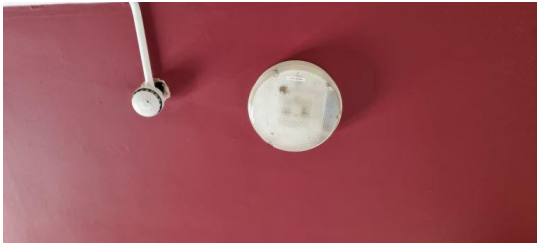
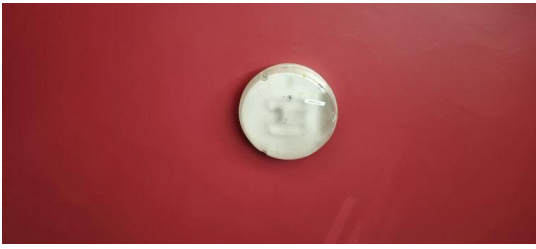
Emergency lighting is fitted throughout. Coverage appeared adequate however some defects were identified to the right-hand sitting room.

Management should inspect emergency lighting throughout and ensure any defective units are repaired as required.

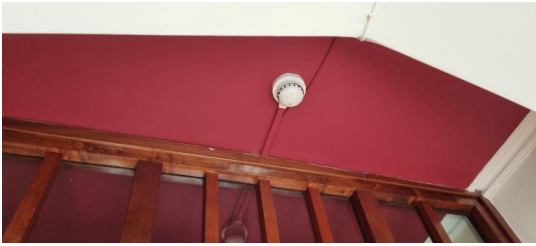
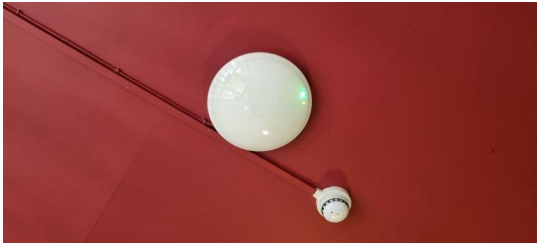
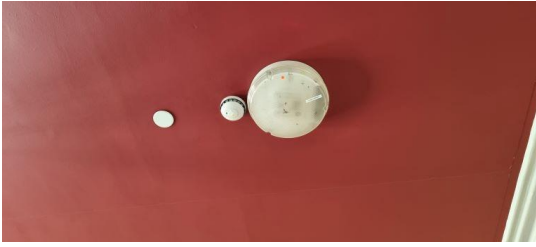
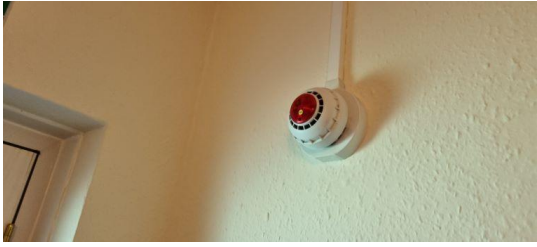
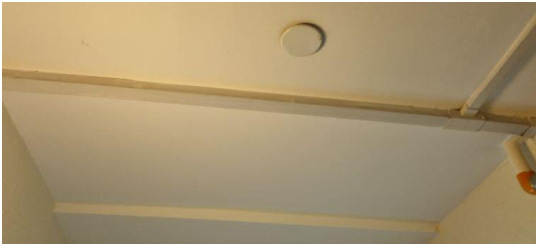
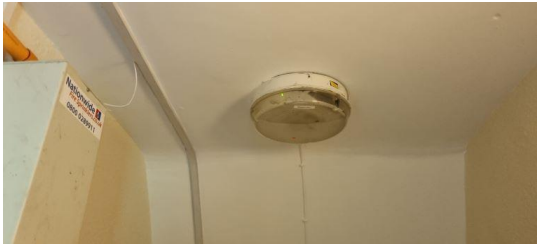
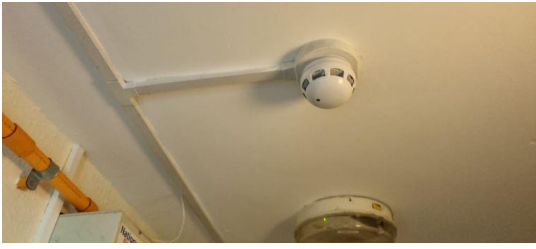
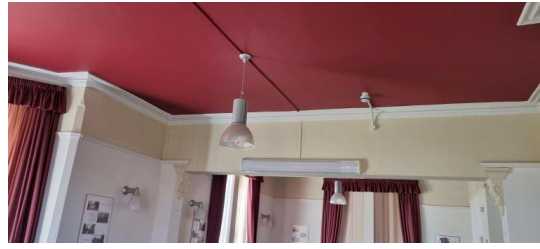
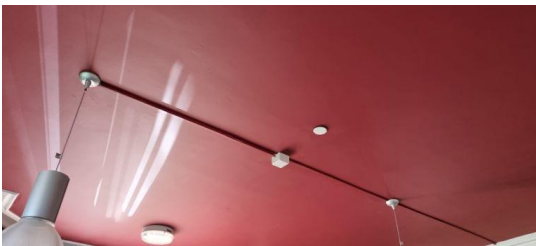
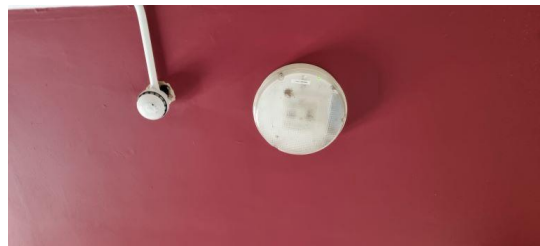
Walls are plastered with emulsion paint / wallpaper coverings. Ceilings are emulsion painted plaster. A small penetration was identified to the AFD / Sounder within the right-hand sitting room. In addition, it was not possible to establish the level of compartmentation between the community centre and dwellings above.

Management should ensure that the small hole to the sounder / AFD within the right hand sitting room is filled with fire rated building materials.

Management should ensure that compartmentation between the community centre and dwellings above (controlled by FHG) is adequate.

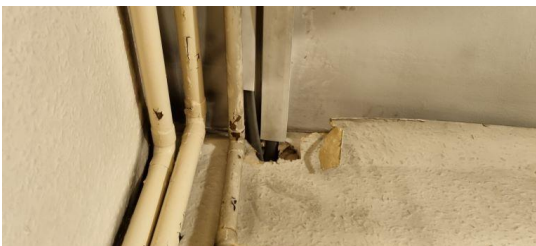
Photo 77

A penetration was identified around wiring within the cellar entrance.

Management should ensure that the penetration is fire stopped with fire rated building materials.

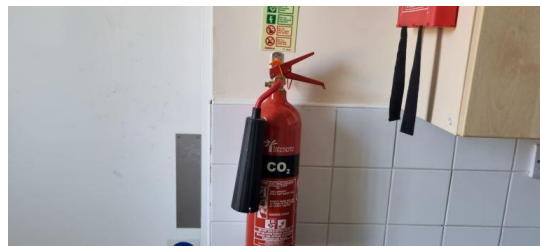
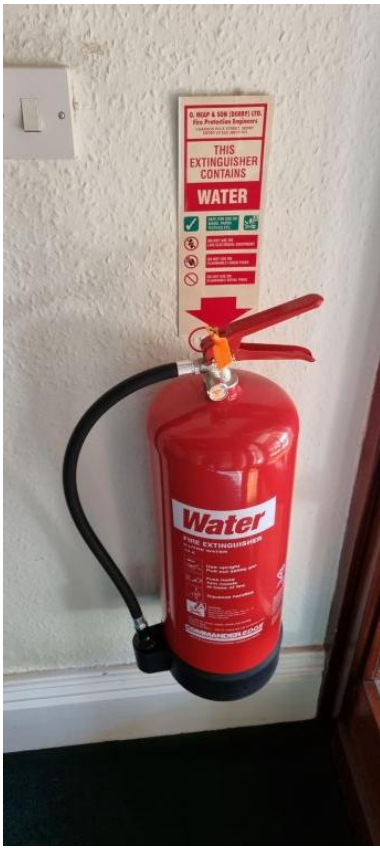
There are two 9Litre 27A Water and a 2KG CO2 units installed. Extinguishers are maintained under service contract with Harmony. The last service was completed 06/23. There are no signs displayed to state 'extinguishers should only be used by trained persons'.

Management should ensure that signs are displayed at extinguisher points to state 'only to be used by trained persons'.

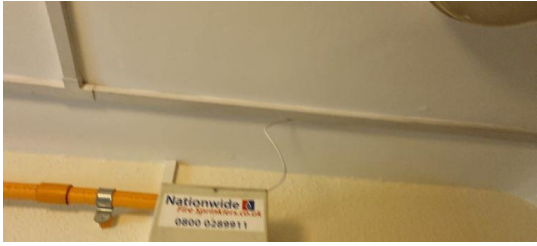
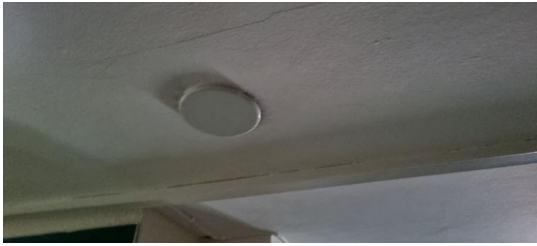
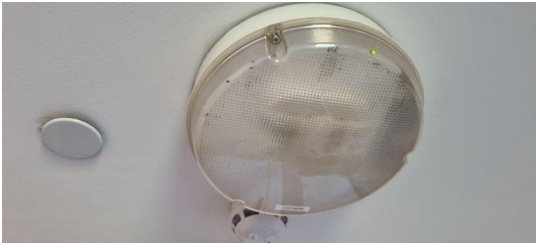
There is a sprinkler system installed however sprinkler heads were not visible as covers are fitted. It was not possible to establish if the system is adequately tested and maintained.

Management should ensure that the sprinkler system is adequately tested and maintained and that adequate records are retained.
