## Futures Fire Risk Assessment

Futures Homescape, 14-16 Wheatcroft Lane: DE74 2BH, - UPRN: N/A / 173562 / QA Approved / Andy Cloke

Futures Homescape, 14-16  
Wheatcroft Lane: DE74 2BH, -  
UPRN: N/A, Fire Risk  
Assessments, Futures  
Homescape

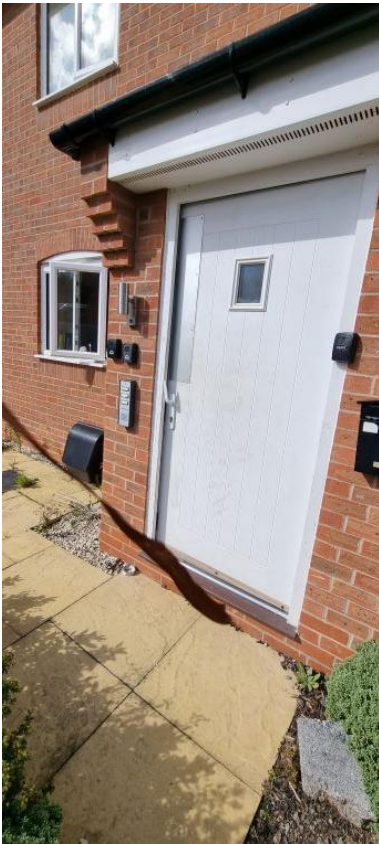
Photo 3

**Are premises secure against arson by outsiders? (Please state how)**

Access to the premise is via standard security lock and intercom. The door was accessible at the time of assessment.

Management should liaise with residents and ensure that the entrance is locked when not in use in order to maintain adequate measures of security.

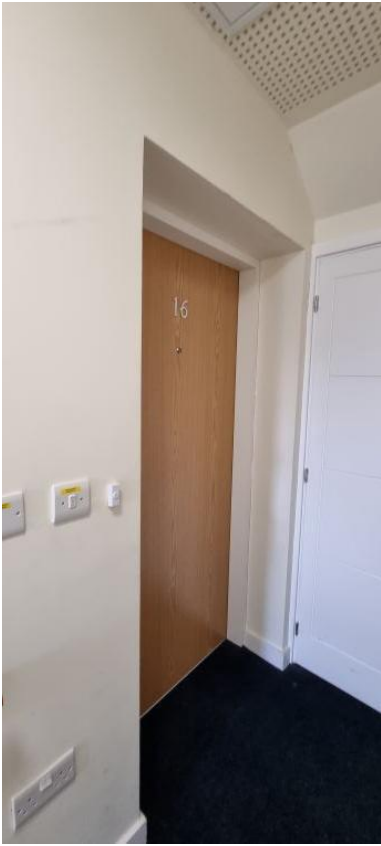
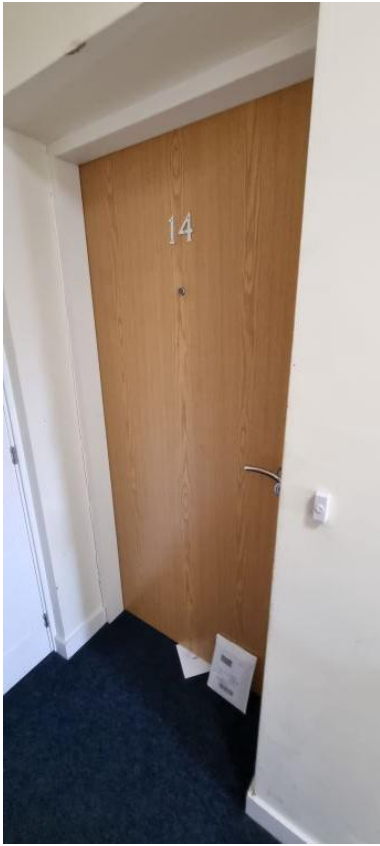
Photo 9

**Are the sample inspection flat entrance door or doors in good condition and appropriately fire rated?**

It was not possible to establish fire rating or condition of flats doors as not flats were accessible at the time of assessment.

Management should inspect dwelling doors to flats 4 and 6 to establish fire rating and condition. Where doors do not conform to FD30 specification, they should be replaced with a certified self closing fire door set to a minimum of FD30 specification. Any installation or repairs should only be conducted by a certified third-party contractor. Doors that egress directly to open air and have no passing fire risk are not required to be fire rated.

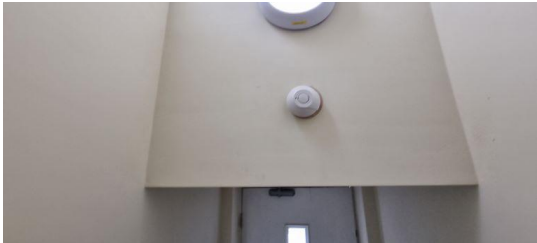
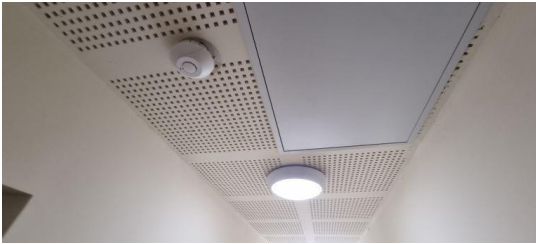
Photo 14

**Is a reasonable fire detection and fire alarm system provided in the common areas, where necessary?**

There is no manual fire alarm system however hard wired AFD is installed to common area. "Section 20.4 of the guidance used highlights how in 'general needs' blocks designed to support a 'stay put' policy, it is unnecessary and undesirable for a fire alarm system to be provided. A communal fire detection and alarm system will inevitably lead to a proliferation of false alarms. This will impose a burden on fire and rescue services and lead to residents ignoring warnings of genuine fires. This is dependent on compartmentation within the block.

Responsible person to confirm that the installed alarm system is warranted, appropriate and effective. Depending on the outcome modify system accordingly.

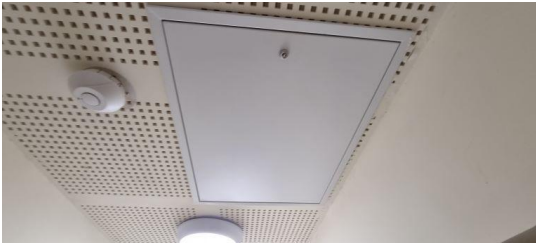
Photo 27

**Is compartmentation maintained in the roof space?**

It was not possible to establish the level of compartmentation within the roof space as the hatch has a lock fitted.

Management should inspect the roof space to ensure that is an adequate fire break for the size of compartment in accordance with building regulations. Any penetrations identified should be fire stopped using fire rated building materials. Any work required should only be conducted by an approved third-party contractor.
