## Futures Fire Risk Assessment

Futures Homescape, 7-12 The Sandholes: NG6 8UL, - UPRN: FB278 / 173549 / QA Approved / Andy Cloke

**INSPECTION DATE:** 11 Jul 2023

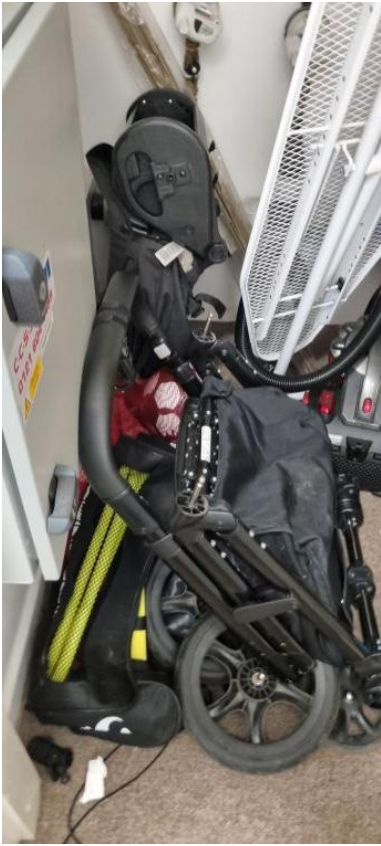
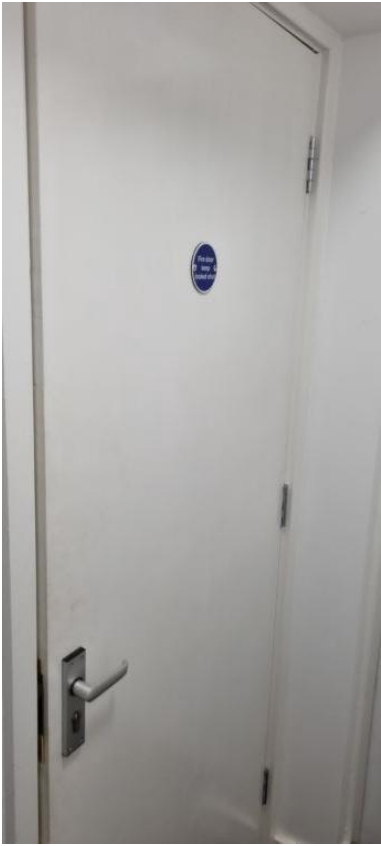
The electrical intake cupboard was accessible at the time of assessment with resident's personal items stored within.

Management should liaise with residents to ensure that items are removed from the electrical intake cupboard. Management should ensure that the cupboard is locked and only accessible to authorised persons.

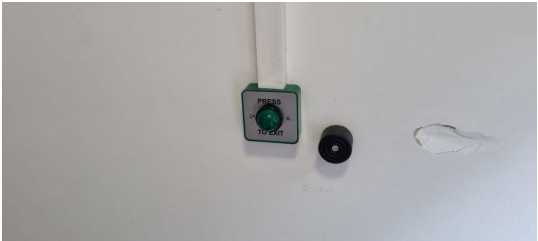
Photo 7

A green door release button is fitted to the exit door. It was not possible to establish if the door release button fails to safety in the event of mains power failure.

Management should confirm if the door release button fails to safety in the event of mains power failure. A green 'Break Glass' emergency door release device should be installed where the door release button does not fail to safety.

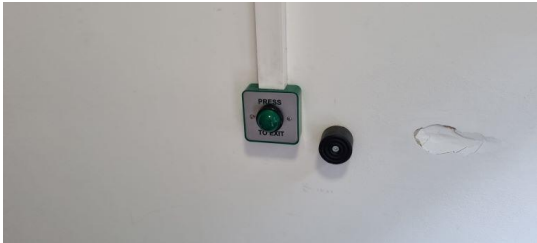
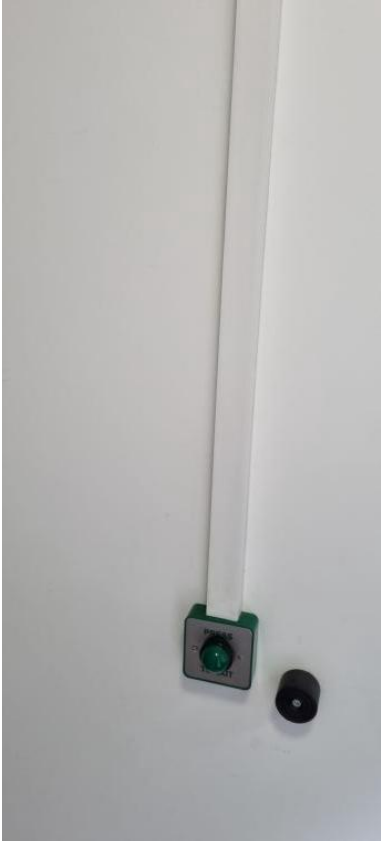
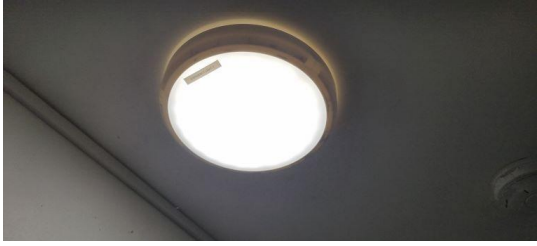
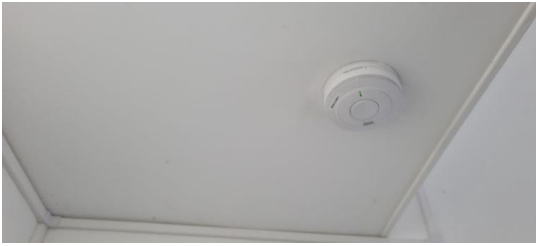
Conduit and cables were noted throughout the common are and it was not possible to confirm that the requirements of Regulation 521.10.202 of the BS 7671 - 18th Edition of The IET Wiring Regulations, which requires all cables to be adequately supported using non-combustible fixings to prevent premature collapse in the event of a fire. The new regulation is not applied retrospectively so any wiring systems fitted before 2019 do not need to be immediately updated. Any new installation or additions and alterations to existing systems, including temporary wiring, have to comply with the regulations.

Management is to consider the requirements of the Regulation 521.10.202 of the BS 7671 - 18th Edition. The IET Wiring Regulations which requires all cables to be adequately supported using non-combustible fixings to prevent premature collapse in the event of a fire albeit not retrospective and seek the advice of a suitably qualified competent person or organisation and undertake any remediation identified by the aforementioned competent person or organisation.

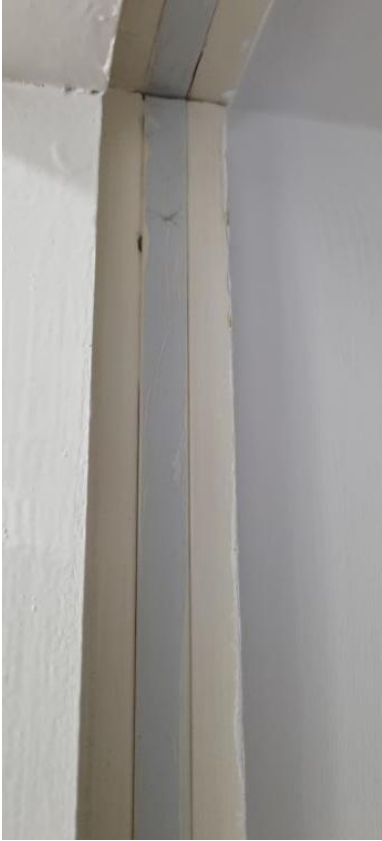
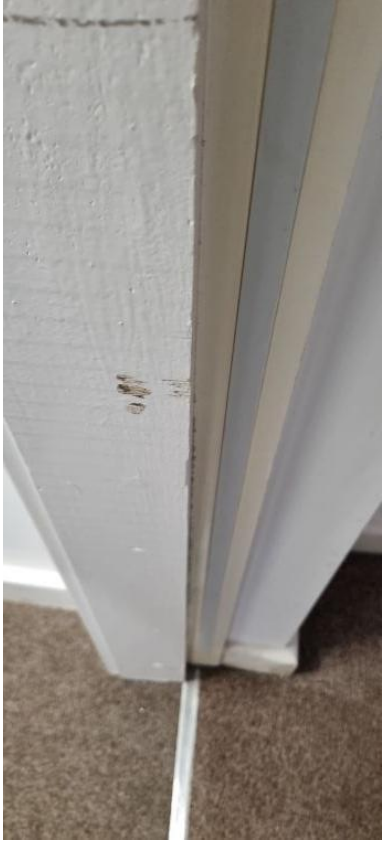
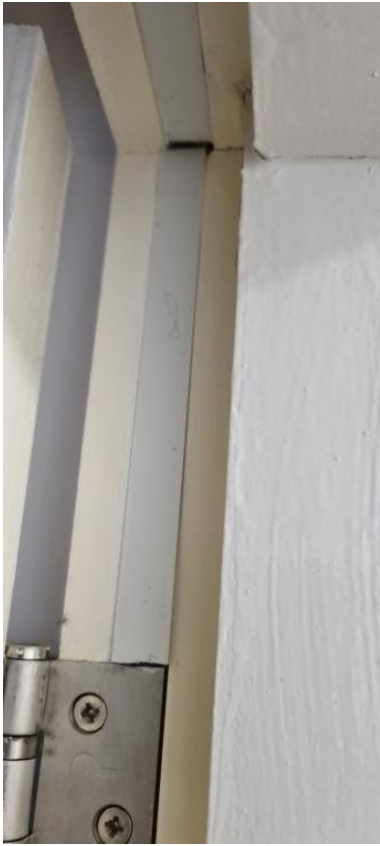
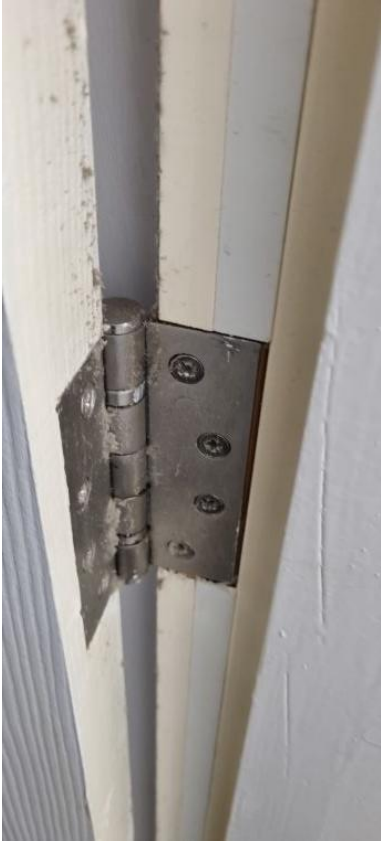
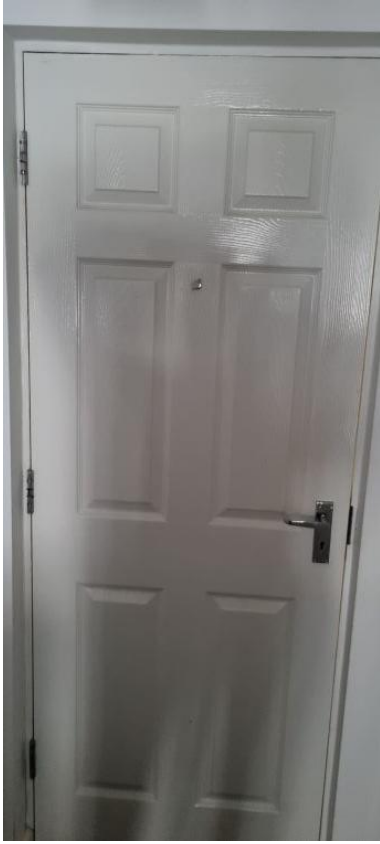
Flat 8 was sampled. Intumescent strips are fitted however, the door was not labelled and it was not possible to establish fire rating. The intumescent strips has some small gaps and is loose in one area. No self closure device is fitted. In addition, it was not possible to establish fire rating or condition of other dwelling doors as no other flats were sampled.

Management should confirm fire rating of all dwelling doors. Doors that do not comply to a minimum of FD30S specification should be replaced with a certified self closing fire door set to FD30 specification. The door to dwelling 8 should be repair and a self closure device fitted. Any

work required should only be completed by a certified third-party contractor.

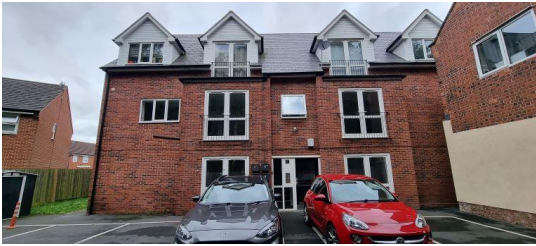
Photo 29

No external emergency lighting was detected. It was not possible to establish if borrowed lighting is sufficient as the assessment was completed during daylight hours.

Management should confirm if the external light has integrated emergency lighting with a view to fit an emergency light above the exit where it is not provided.

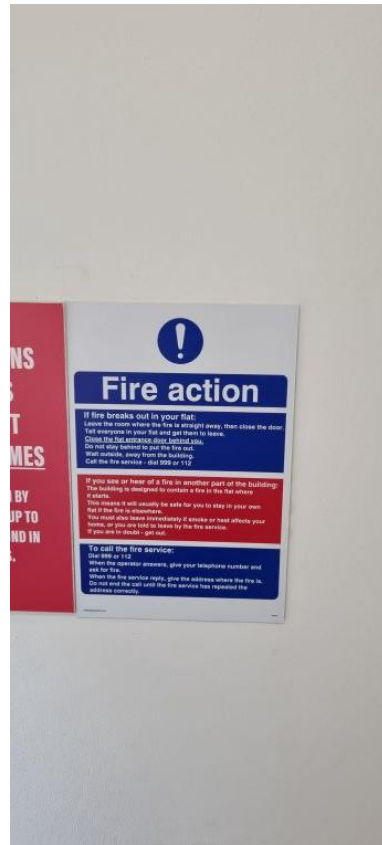
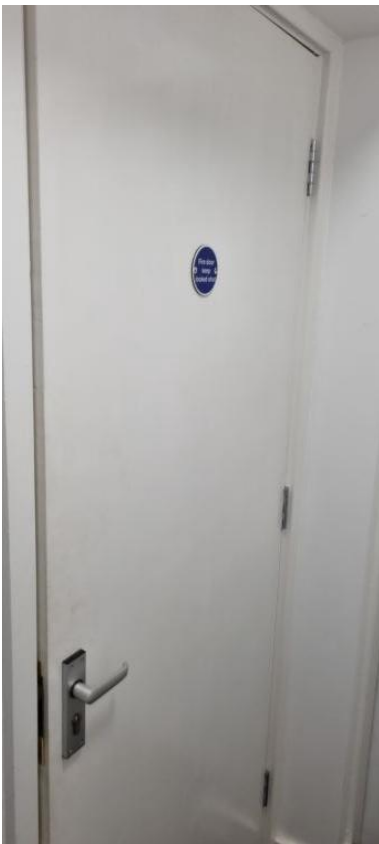
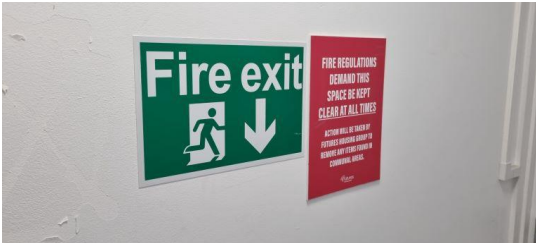
A Fire Action Notice is displayed which advises of a 'Stay Put' policy however, AFD is installed to common areas. In addition, fire door signage is attached to the electrical intake cupboard and directional signs are displayed within the common area.

Depending on the outcome of P1, management may need to amend the FAN to a simultaneous evacuation.

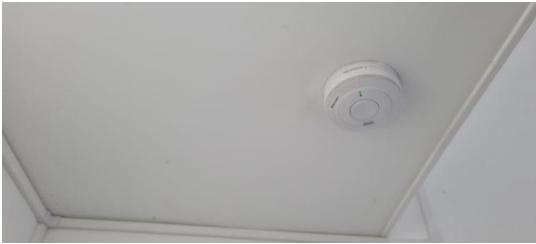
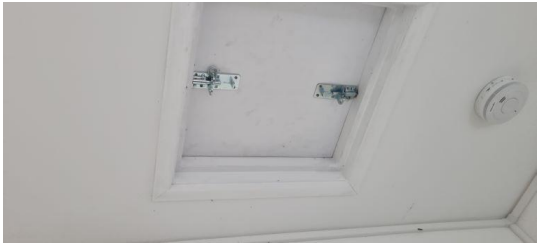
There is no manual alarm system however AFD is installed to common areas. "Section 20.4 of the guidance used highlights how in 'general needs' blocks designed to support a 'stay put' policy, it is unnecessary and undesirable for a fire alarm system to be provided. A communal fire detection and alarm system will inevitably lead to a proliferation of false alarms. This will impose a burden on fire and rescue services and lead to residents ignoring warnings of genuine fires.

Responsible person to confirm that the installed alarm system is warranted, appropriate and effective. Depending on the outcome modify system accordingly.

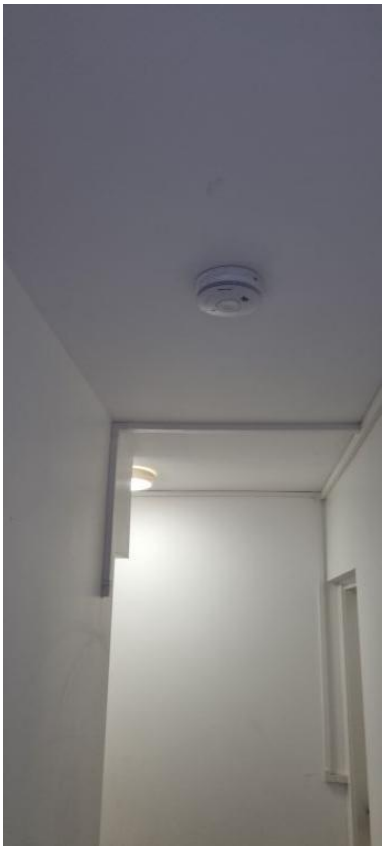
Photo 38

The escape route has emulsion painted plastered ceilings. Walls are solid plastered and studded plasterboard with emulsion painted finish. Stairways and flooring are of wooden construction. Construction on the escape route was found to be in sound condition with no compartmentation breaches identified however, there is some plastic conduit fitted and it was not possible to establish if there are any penetrations identified behind conduit.
