Futures Fire Risk Assessment

Futures Homescape, Flat 1-5 Butchers
House: DE75 7WQ, - UPRN: 14780 /
173573 / QA Approved / Piotr Iwan

INSPECTION DATE: 3 Jan 2024

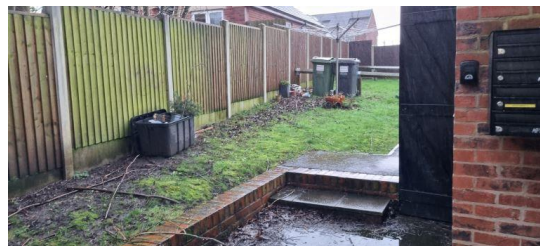
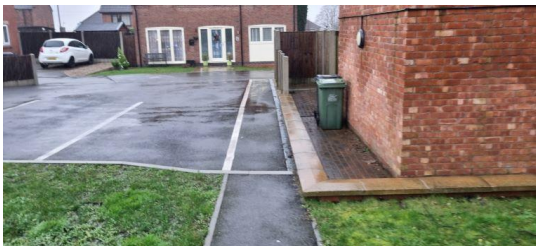
Wheelie bins are located to the rear of the property. There was one wheelie bin stored against the property wall.

Management should ensure that waste bins are located in a safe area away from the building.

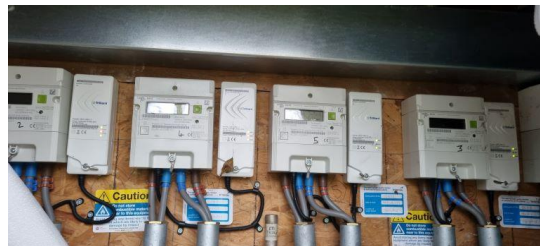
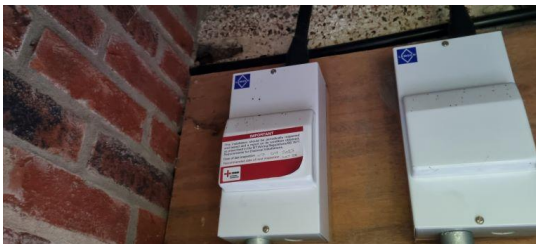
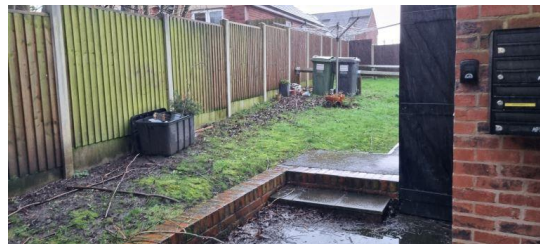
There is an external electrical intake cupboard. Combustible materials are stored within. There is also a cupboard to the first floor landing which was not accessible to the assessor; it was not possible to establish if there are ignition risks or combustable materials within.

Management should liaise with residents to ensure that combustable materials are removed from the external electrical intake cupboard as soon as possible. It is advisable that the door is locked to prevent unauthorised access. Management should also inspect the cupboard to the first landing to ensure that combustable are not stored in proximity of ignition risks within.

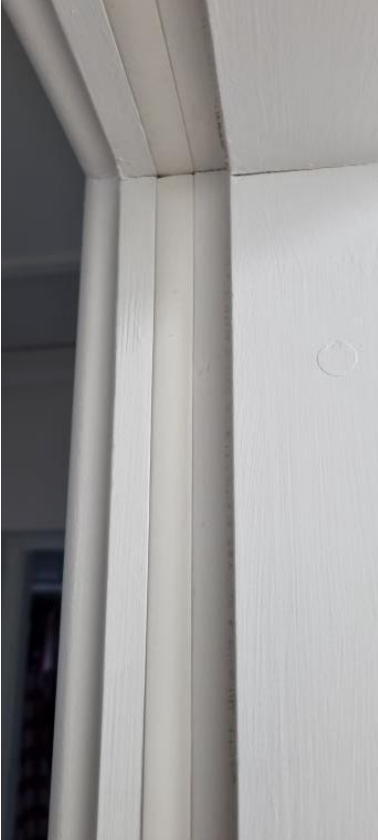
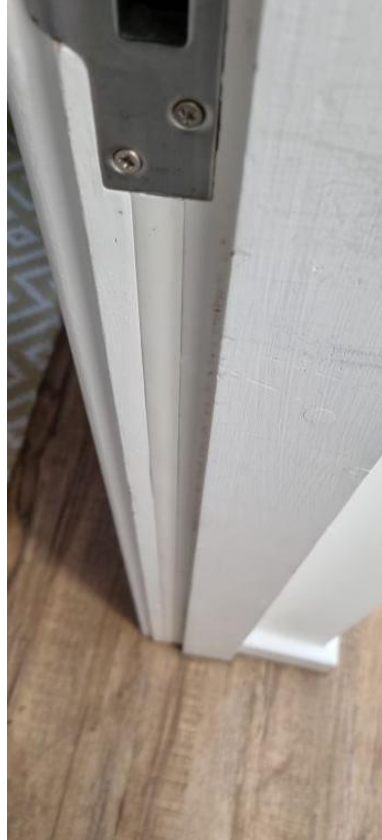
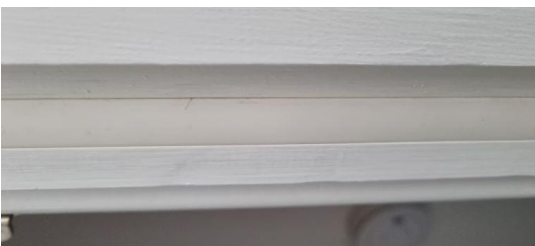
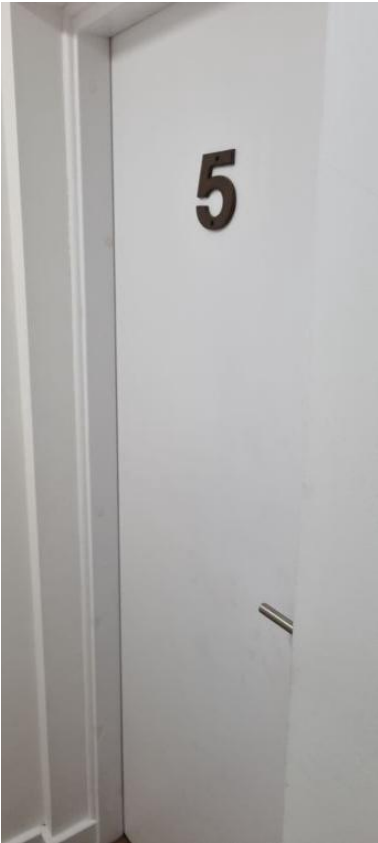
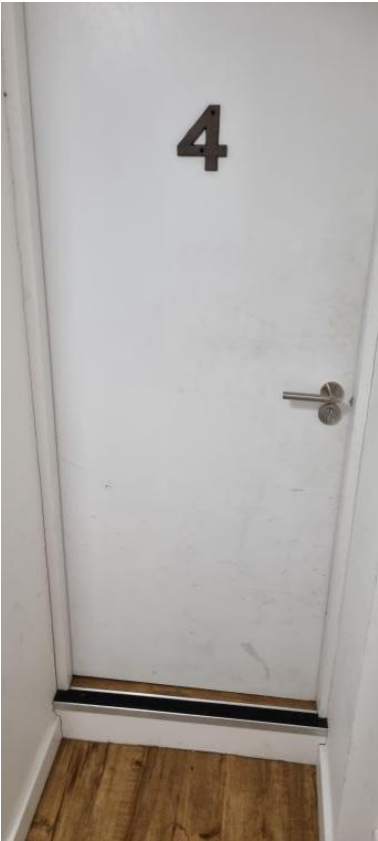
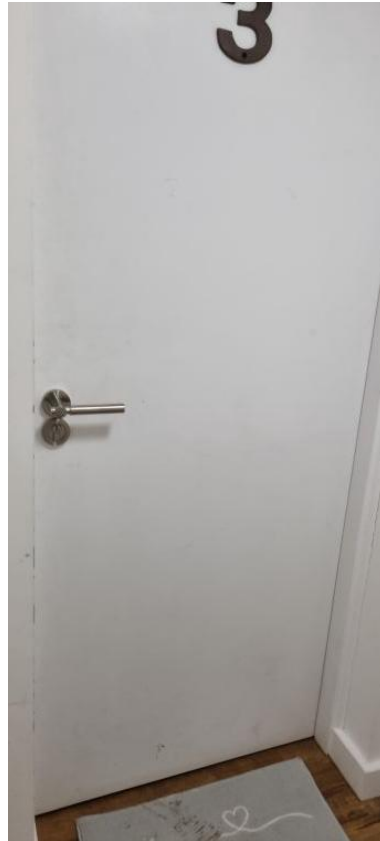
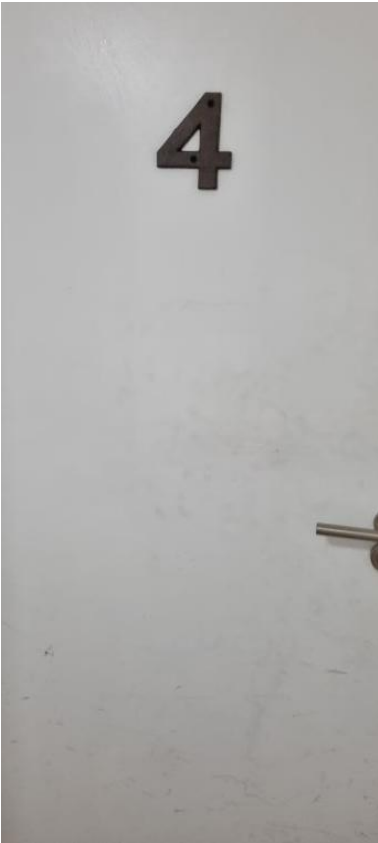
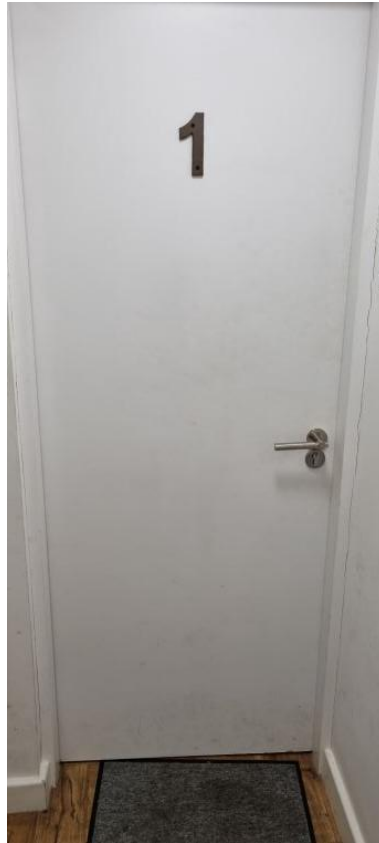
The door to flat 5 was sampled. The door is labelled to confirm that it is a certified FD30 fire door. Smoke seals and a self-closure device are fitted. It was not possible to establish fire rating or condition of other dwelling doors as no other flats were sampled.

Management should inspect all other dwelling doors to establish fire rating and condition. Where doors do not conform to a minimum of FD30S specification, they should be replaced with certified self-closing fire door sets to a minimum of FD30S specification. Any repairs or installation should

only be completed by a certified third-party contractor.

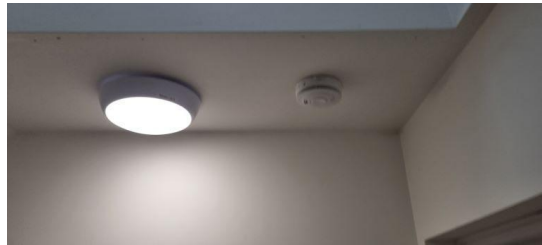
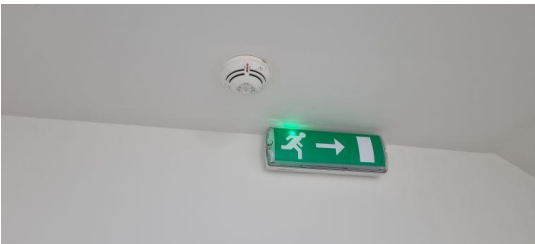
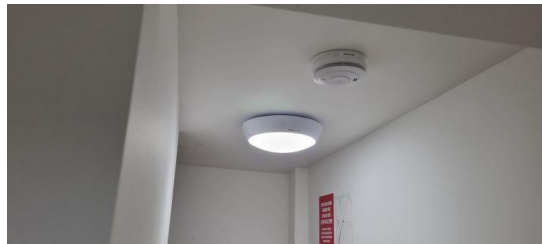
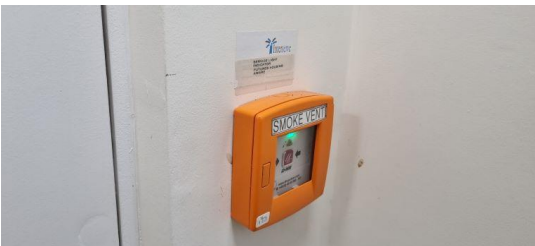
There is no manual alarm system installed however hard-wired smoke alarms are fitted to the common area. In 'general needs' blocks designed to support a 'stay put' policy, it is unnecessary and undesirable for a common area fire alarm system to be provided. This is due to the potential for false alarms, unnecessary fire service attendance and residents ignoring genuine alarms. There is also a smoke detector fitted for the AOV system.

Responsible person to confirm that the installed alarm system is warranted, appropriate and effective. Depending on the outcome modify system accordingly to ensure that it supports the evacuation strategy for the building.

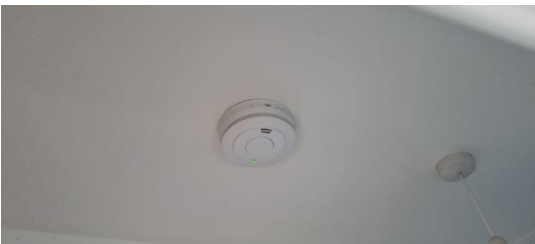
Photo 41

A hard-wired smoke detector is installed to the hallway of the dwelling sampled. It was not possible to

establish if detection is installed to other rooms within the dwelling (Type 1 Survey). In addition, it was not possible to establish the level of detection to other flats within the block as no other dwellings were accessible.

Management should ensure that hard-wired smoke / heat detection is installed to all flats within the block, in accordance with BS5389-6:2019 (Grade D1, LD2 smoke alarms). If found not to be, install to this standard. All work to be carried out by a third-party accredited fire alarm company.

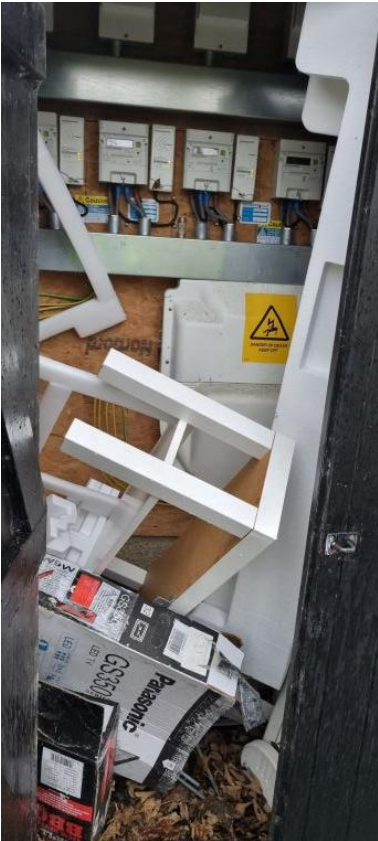
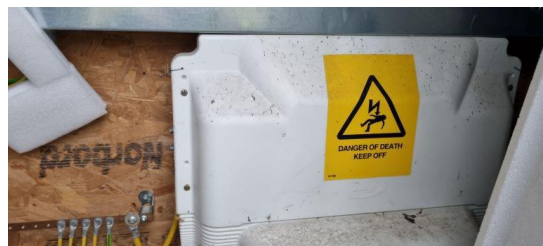
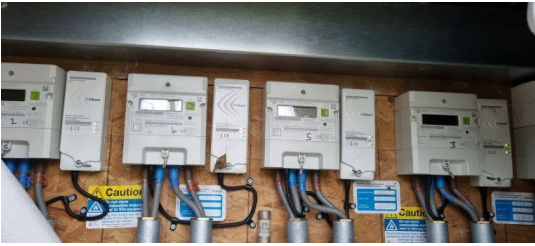
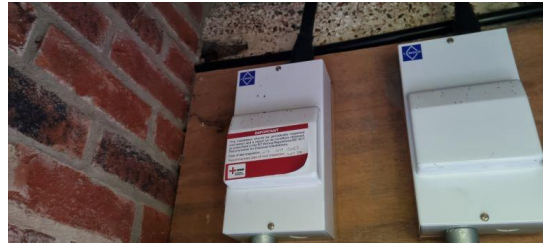
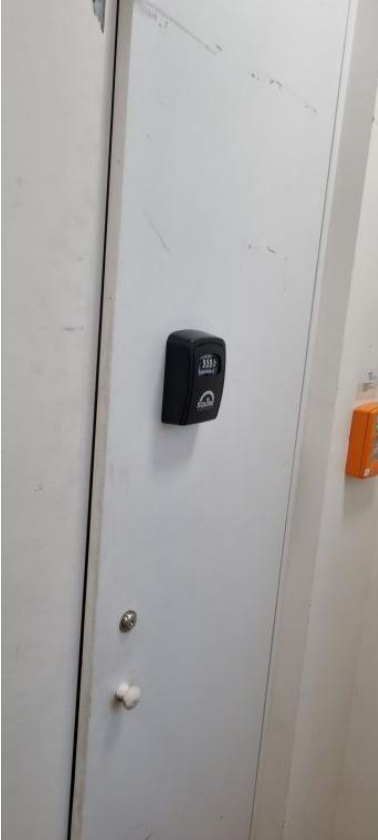
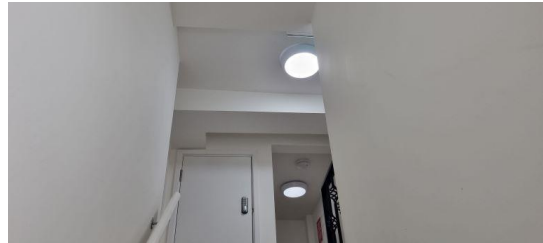
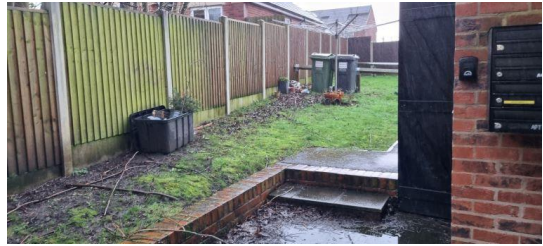
There is an external electrical cupboard that does not have fire rated doors (passing fire risk). The door to the internal electrical intake cupboard appears to be constructed of MDF type material and the assessor was not able to establish if it is fire resistant. There is also a cupboard to the first floor landing that was not accessible and it was not possible to establish if there ignitions sources within or fire rating of the cupboard.

Where ignition risks are present within, management should ensure that cupboards / cupboard doors are fire rated to a minimum of FD30S specification. Any installation should only be completed by a certified third-party contractor.
