Futures Fire Risk Assessment

Futures Homescape, 13 Park Road: NN10
0RW, - UPRN: 14606 / 173598 / QA
Approved / Paul Doodson

1.2 Property Type: Converted Detached House

This is a two storey property being used as a HMO (temporary accommodation for homeless persons) consisting of 9 bedrooms on the ground and first floors served by a single staircase.

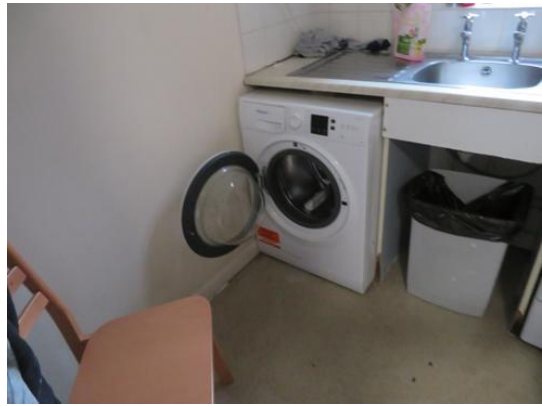
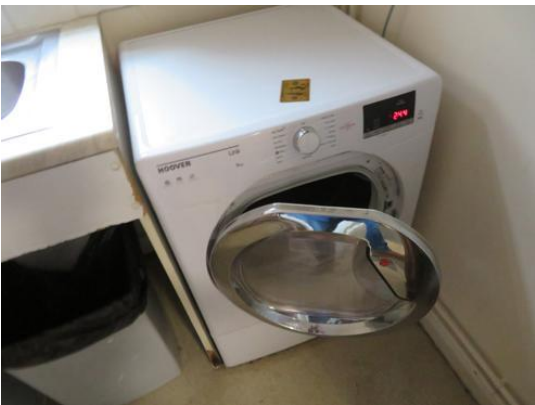
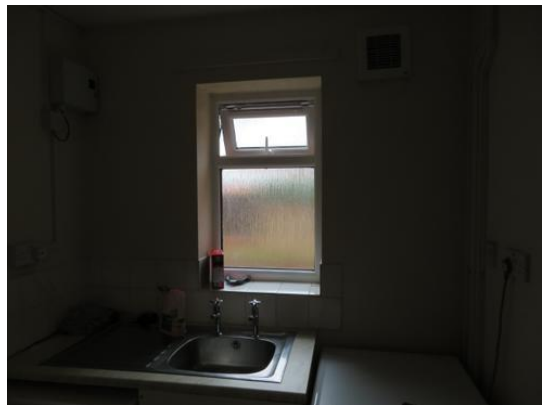
A laundry room is provided on the ground floor. There is no evidence to suggest that filters for the drying machine are regularly checked for the build up of combustible materials.

It is recommended that signage is installed above drying machines instructing residents to clear the filter after each use. Regular checks should be conducted by staff to ensure compliance.

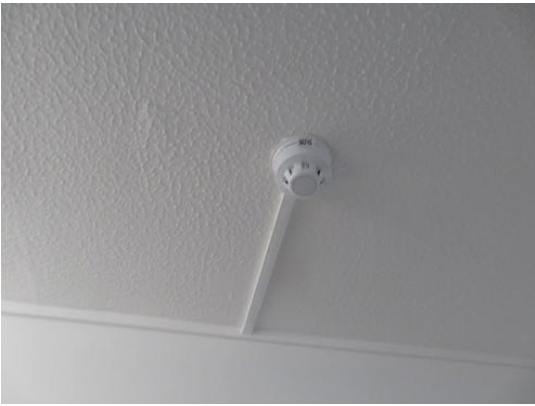
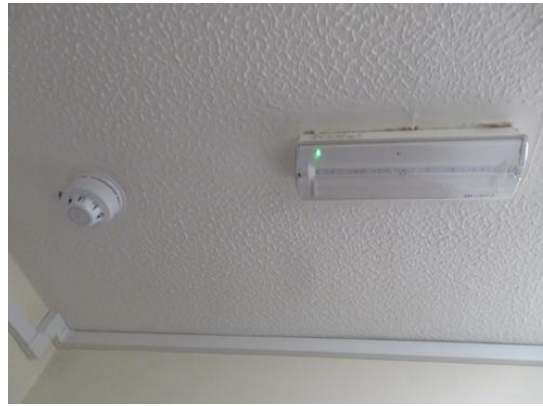
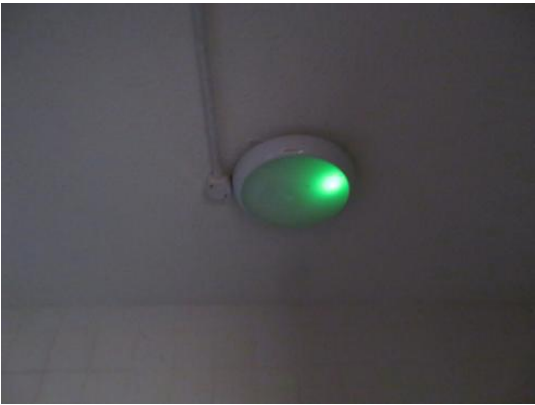
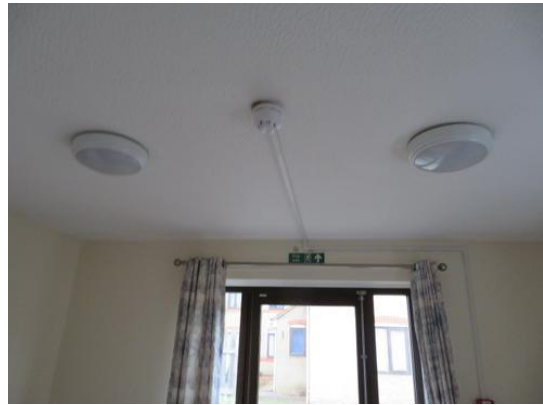
Plastic conduit was noted directly above the front entrance door to the block. It could not be confirmed if wiring within was adequately supported to prevent premature collapse in the event of a fire situation.

The client should ensure that all surface mounted wiring is adequately secured with non-combustible means to prevent premature collapse and cable entanglement scenarios in the event of a fire situation.

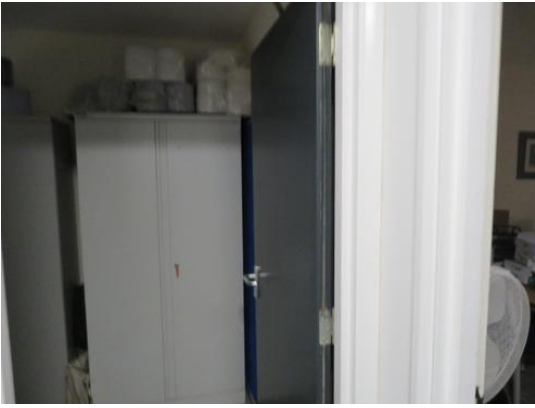
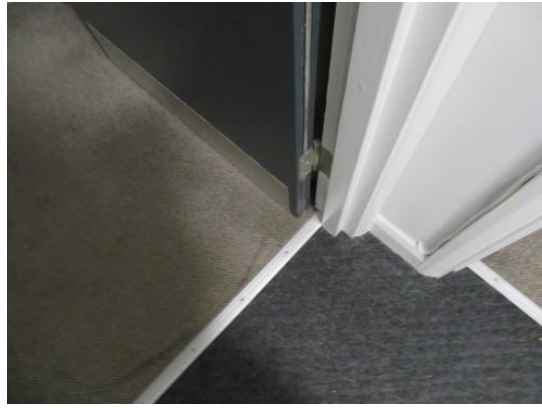
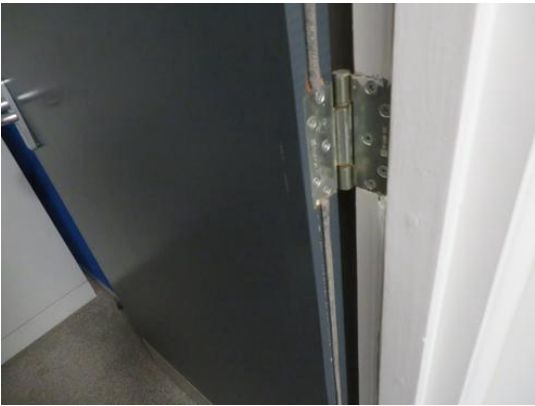
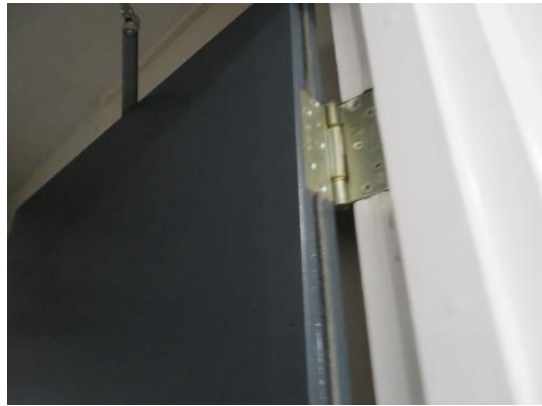
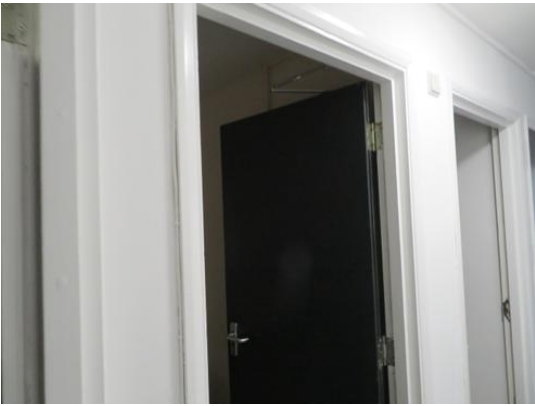
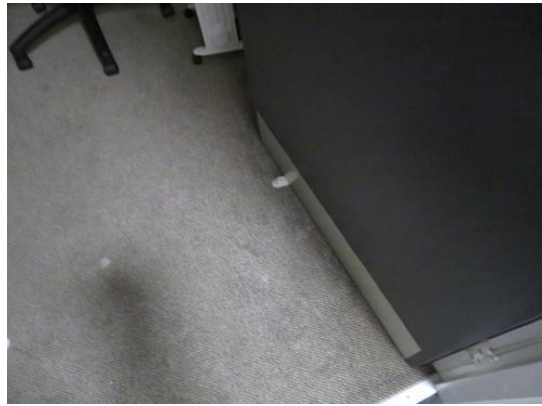
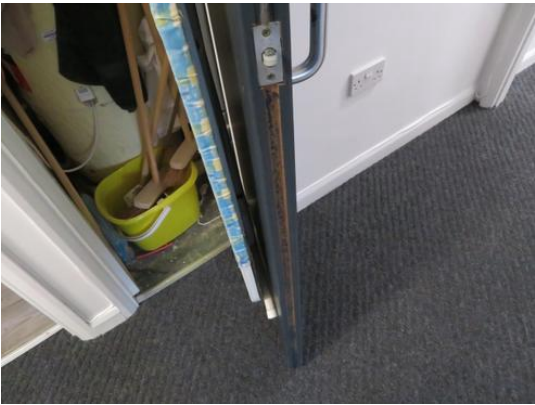
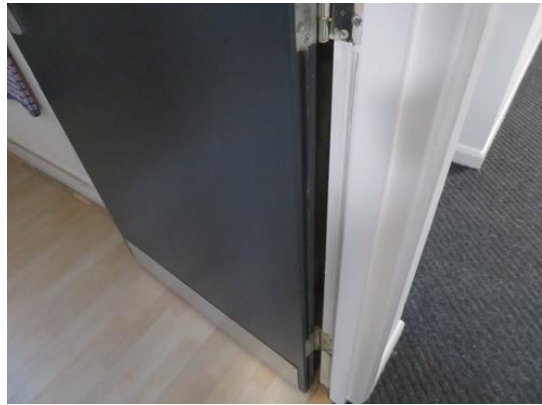
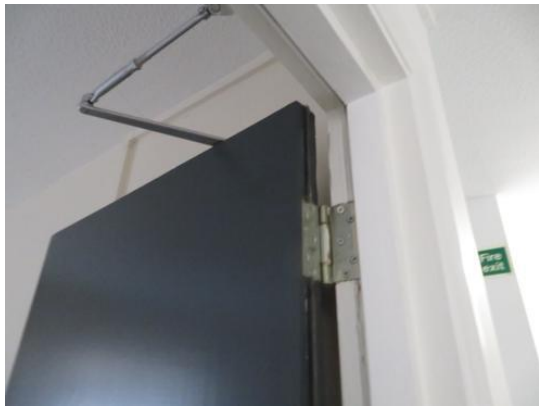
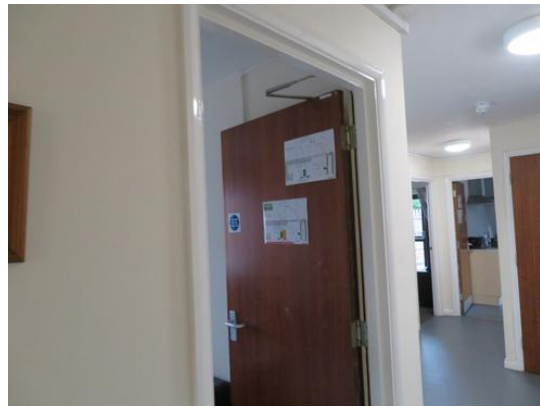
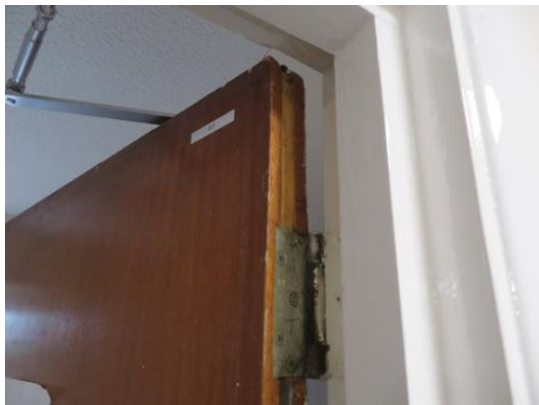
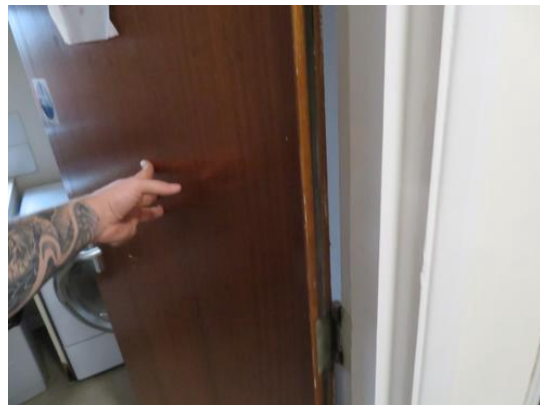
Common area doors/frames are a mix of original 'notional' & FD30s timber fire doors. (N.B. - From limited visual inspection; certification not seen; adequacy of installation not confirmed).

- The door to both offices were noted to be wedged open.
- A section of combined strip/seal was missing from the HWSC door and the laundry room door.

Replace missing sections of combined strip/seal noted. It is recommended that to maintain compatibility, the strip and seal across the entire door is replaced at once. Work should be carried out by a third party accredited fire door company.

Wedges should be removed from fire doors noted. Staff should be made aware that fire doors should not be wedged open. Regular checks should be conducted to ensure compliance.

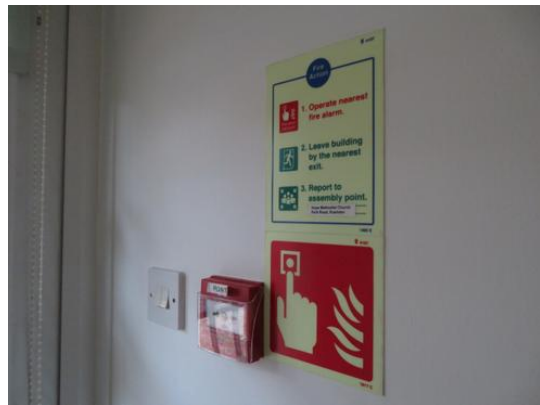
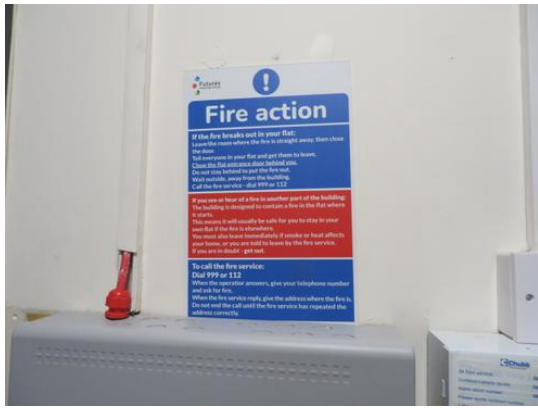
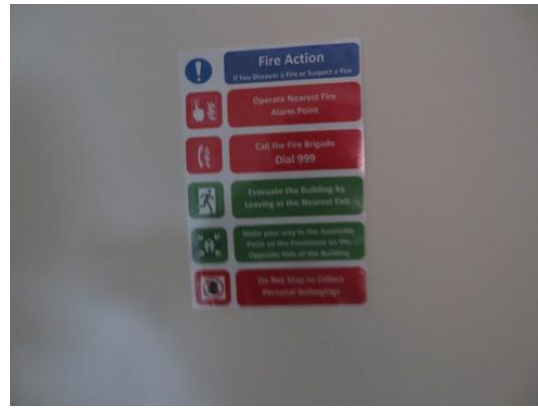
There were noted to be 3 different types of Fire Action Notice installed to the building, one which details a simultaneous evacuation, one of which is generic in nature giving little detail, and one which details a 'Stay Put' strategy (located above the fire alarm panel).

The FAN's installed throughout the building should be uniform in design and specific to the building. The client should removed both the generic Fire Action Notices and the 'Stay Put' FAN's as soon as is reasonably practicable and replace them with the 'Simultaneous' evac FAN's installed elsewhere.

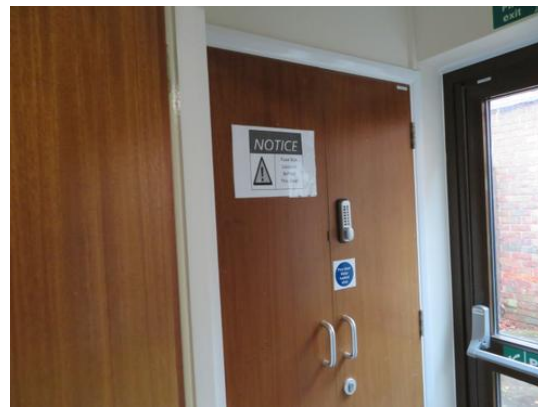
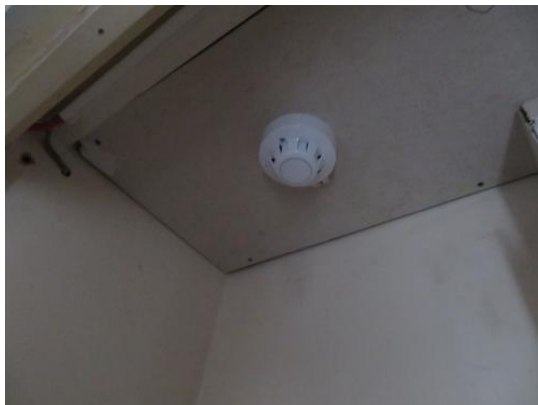
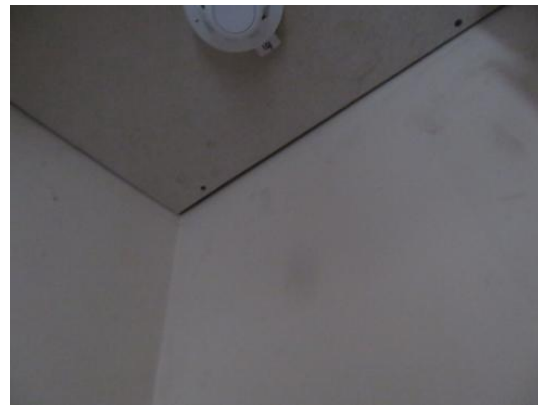
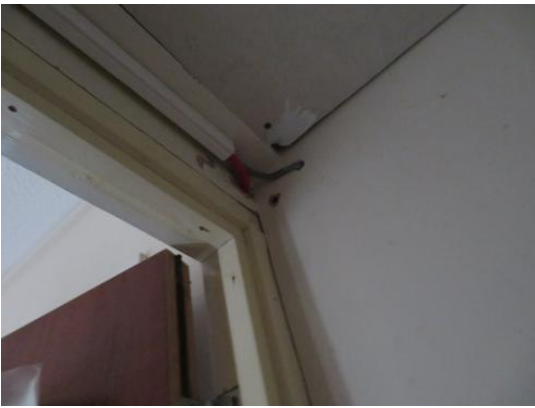
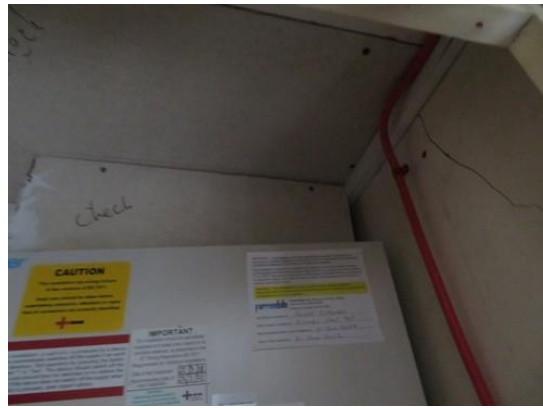
The electrical intake cupboard located at the base of the stairs was not found to be adequately fire resisting. Penetrating services were not adequately fire stopped and compartment boundaries had linear gaps in between fire resisting construction that were not suitably sealed to prevent the passage of smoke and other products of combustion.

In mitigation, the cupboard and immediate communal area outside is installed with smoke detection.

The electrical intake cupboard should be upgraded to provide 30 minutes fire resistance. This should include fire stopping all linear gaps and penetrating services.

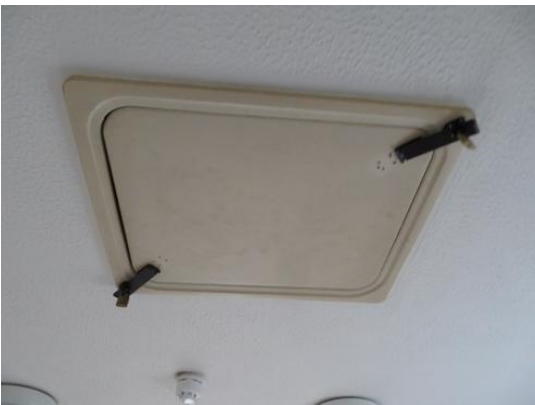
Photo 49

Roof space not inspected due to non-standard locks being installed.

The client should arrange for an inspection of the roof space to ensure adequate compartmentation is present.

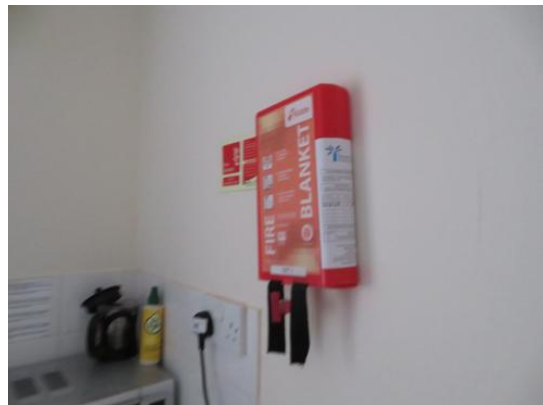
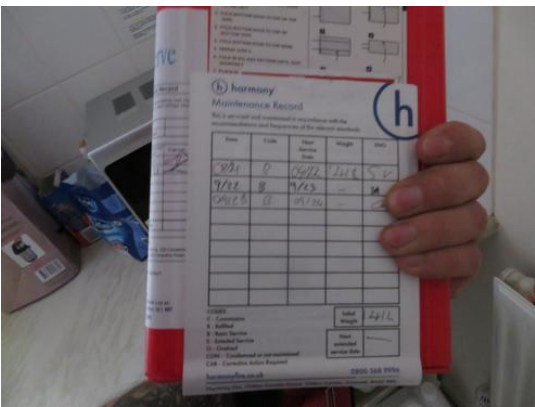
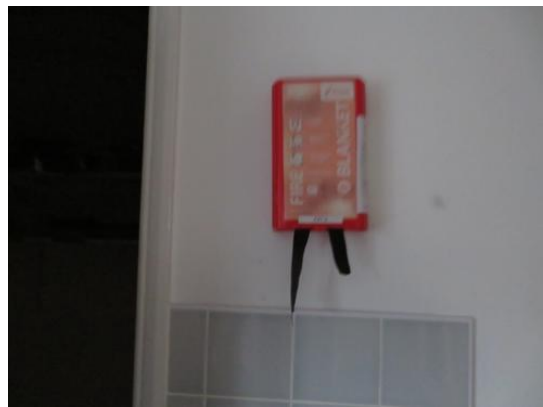
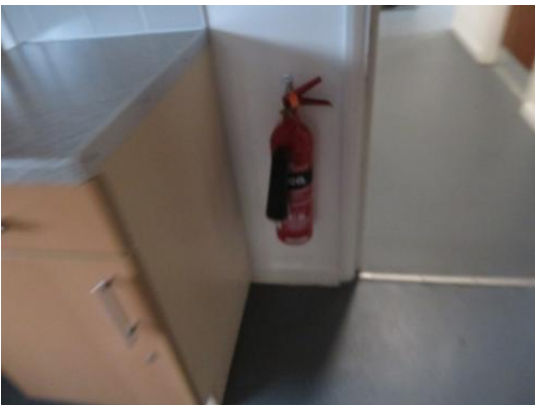
A CO2 extinguisher and fire blankets are noted in the kitchens on the ground floor. Staff or residents are not trained in the use of these appliances, and documentation on site states that the building has no extinguishers installed.

The extinguishing appliances installed to the kitchens should be removed as there are no trained users present in the building.
