Futures Fire Risk Assessment

Futures Homescape, Connaugh Court Office (Ground Floor CBC): DE55 7EJ , -
UPRN: OF|01099|0000 / 173540 / QA Approved / Andy Cloke

INSPECTION DATE: 6 Mar 2024

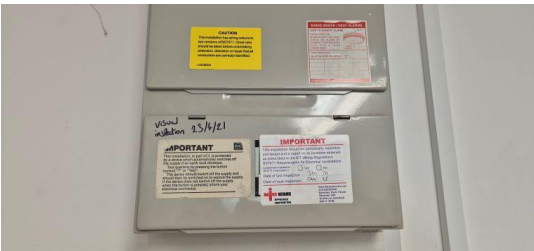
Photo 3

The label on the electrical consumer unit confirms that the fixed electric were last tested in January 2020.

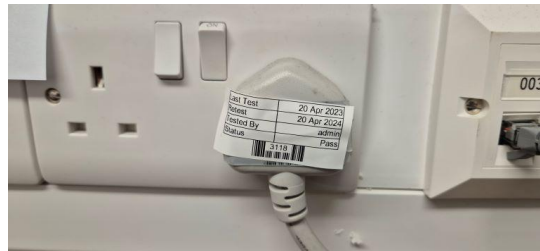
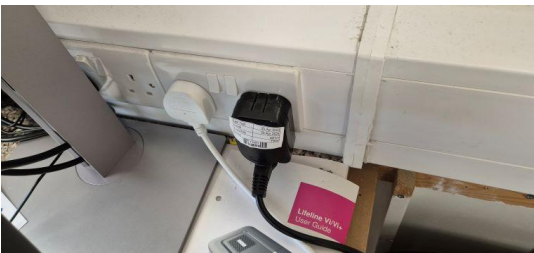
Labels on portable electrical equipment confirm that PAT testing was last carried out in April 2023.

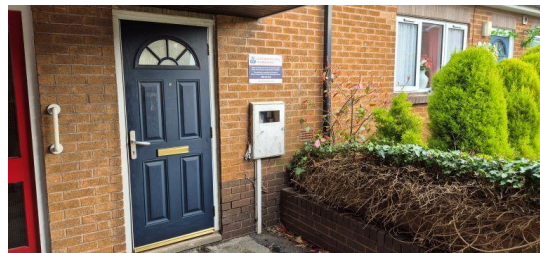
Photo 6

The front door is fitted with a key and only accessible by FHG staff.

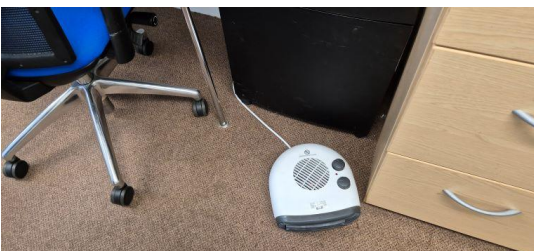
Photo 7

There is central heating fitted however a portable electric fan heater is used to provide additional heat during inclement weather. The fan heater is subject to annual PAT testing.

Management are advised to remove the fan heater and replace it with an electrical oil filled radiator.

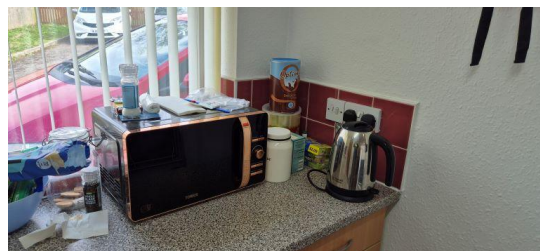
Photo 8

There is a small kitchenette with kettle and microwave only. Kitchen equipment is subject to annual PAT testing. Items were identified on top of the microwave.

Management should ensure that items are removed from on top of the microwave.

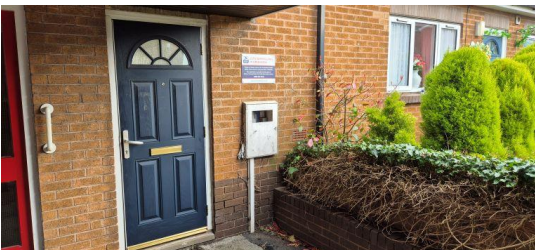
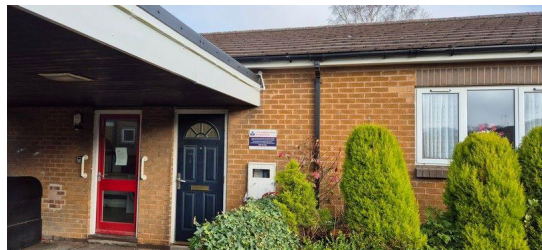
There is no external emergency lighting installed. It was not possible to establish if borrowed lighting is sufficient as the assessment was completed during daylight hours.

Management should consider installing external emergency lighting to exits.

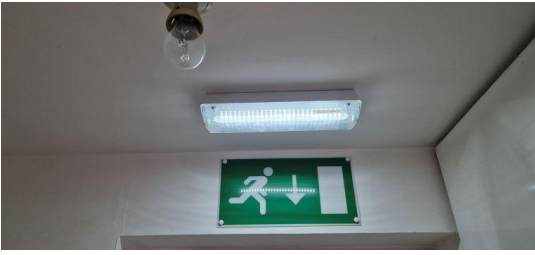
Photo 17

Exit signage is displayed above exit doors. There is no Fire Action Notice displayed.

Management should install a Fire Action notice detailing the appropriate action to take in the event of an emergency and evacuation muster point.
