Futures Fire Risk Assessment

Futures Homescape, Leabrooks Depo
 Crays Hill: DE55 1LN, - UPRN: DEPOHILL /
 282506 / QA Approved / Paul Doodson

Futures Homescape, Leabrooks
 Depo Crays Hill: DE55 1LN, -
 UPRN: DEPOHILL, Fire Risk
 Assessments, Futures Homescape

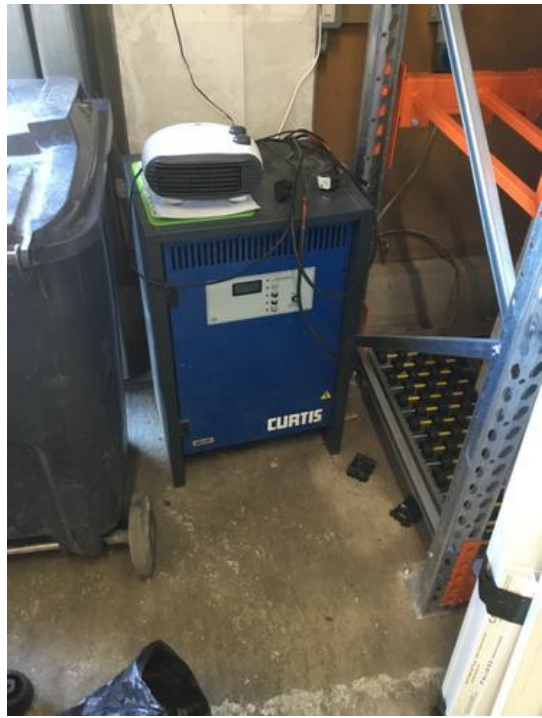
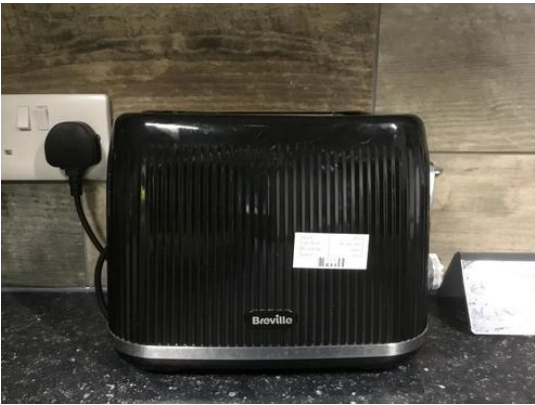
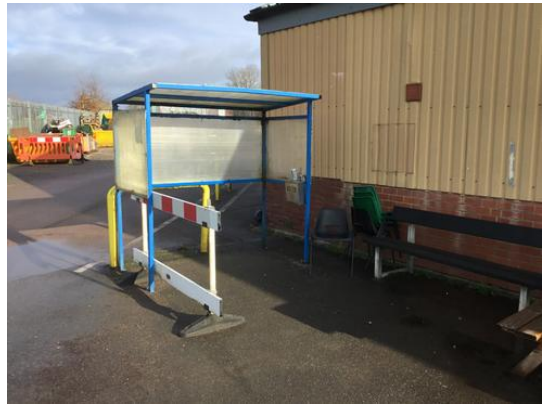
Portable Appliance Testing is carried out in-house, last test date 27 January 2023. The portable electrical equipment in the refurbished office, staff welfare area and meeting rooms are less than 12 months old and therefore, have not been PAT tested.

Ensure all items of Portable Electrical Equipment is PAT tested.

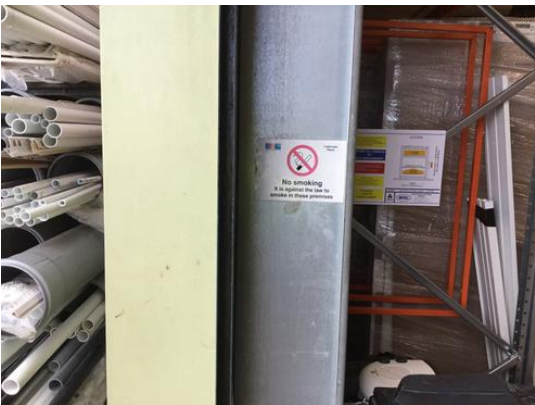
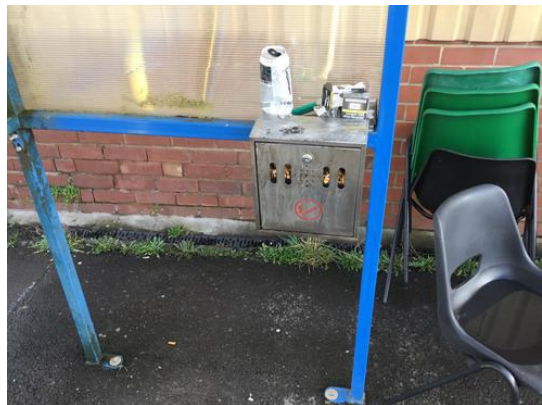
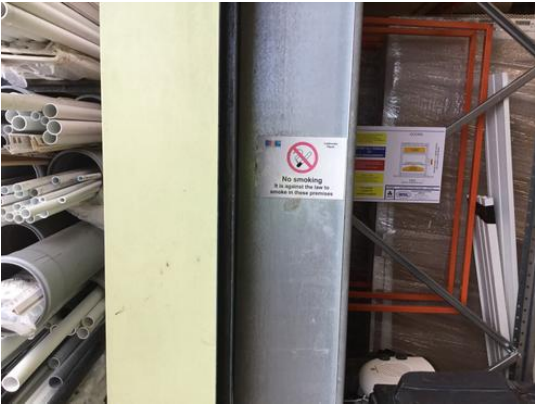
Smoking is not allowed on site apart from the designated smoking area at the side of the grounds maintenance workshop. It was noted the cigarette bin was full at the time of the assessment.

Management should ensure that the cigarette bin provided in the smoking area is emptied on a regular basis.

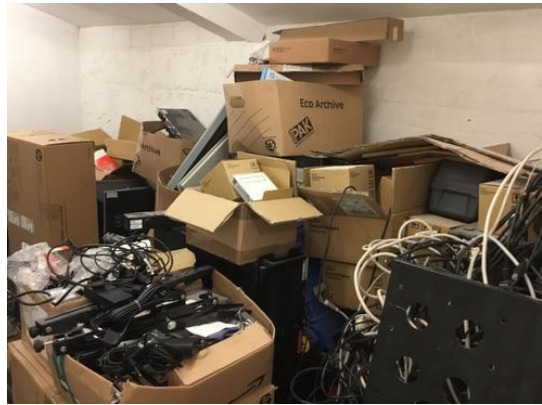
Photo 25

Combustible materials were noted as being stored in areas containing sources of ignition.

Management should ensure that the combustible materials being stored in the server room in the meetings block are removed.

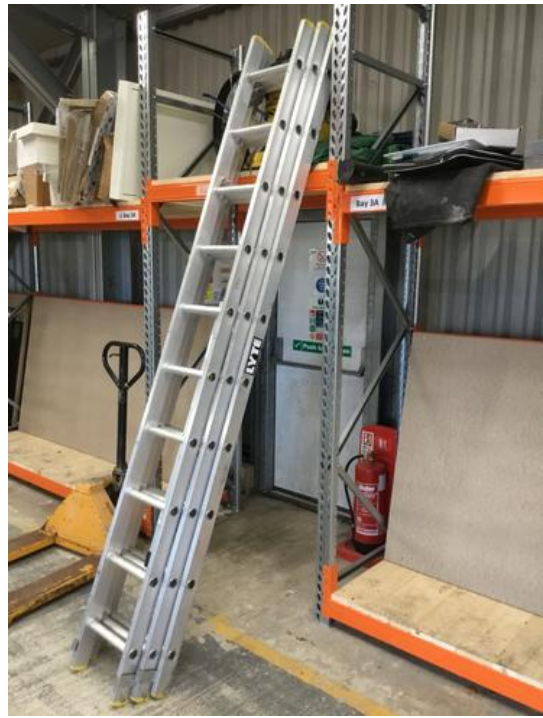
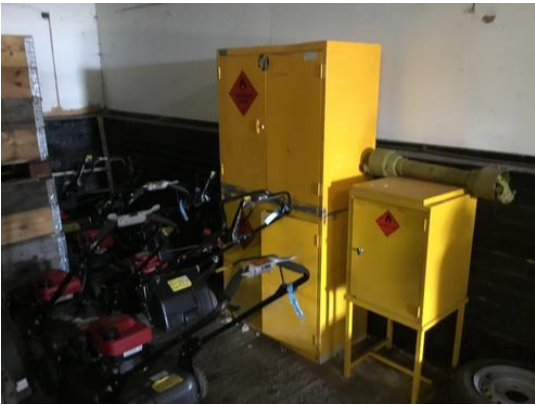
At the time of the assessment the external fire escape route behind the warehouse was becoming blocked. Also, a ladder was blocking the final exit door in the warehouse.

Management should ensure that fire escape routes are available at all times.

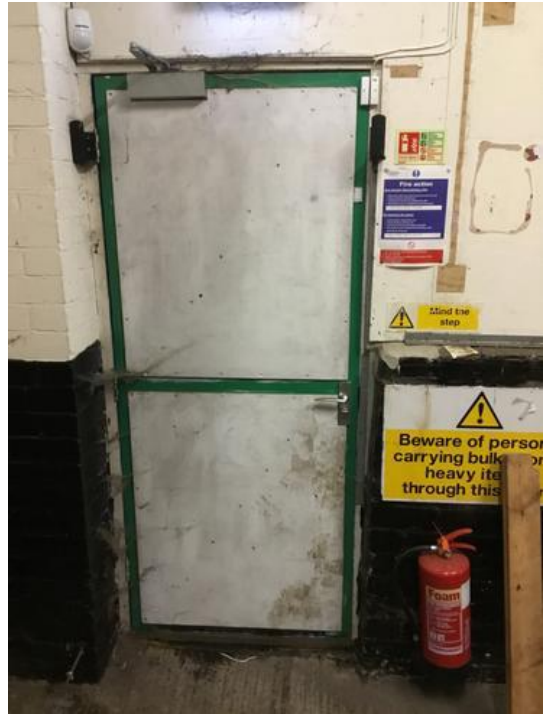
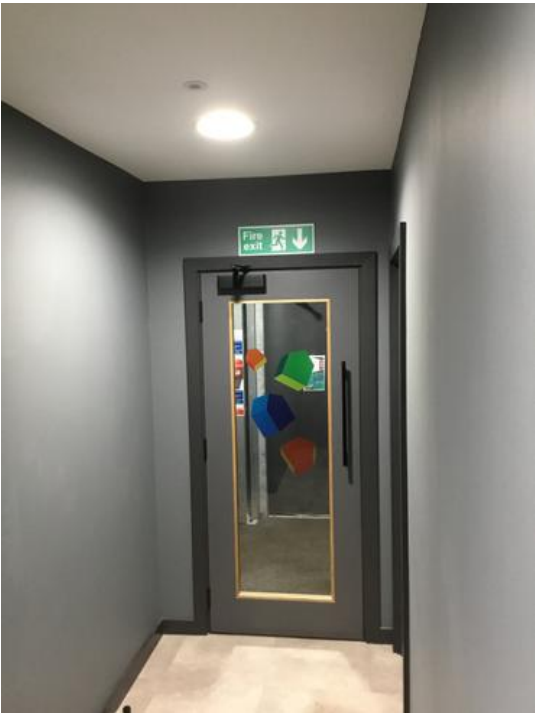
The majority of doors on escape routes open easily. However, in the grounds maintenance workshop two final exit doors were unusable due to them being locked.

Management should ensure that all doors on escape routes are available to use at all time.

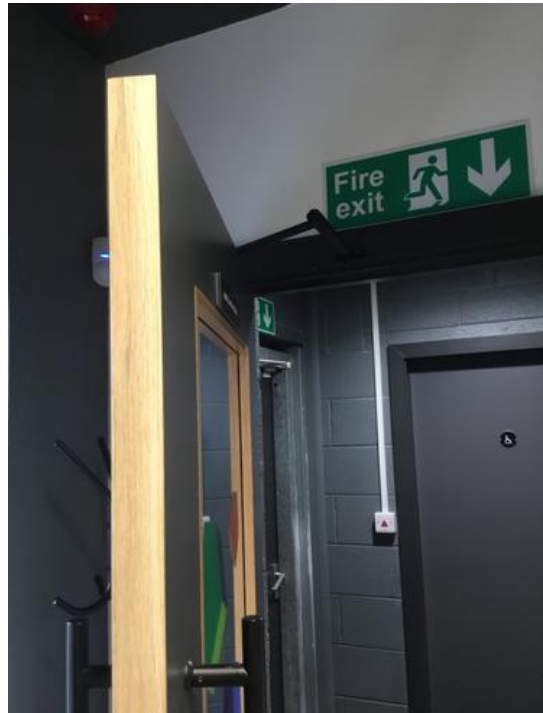
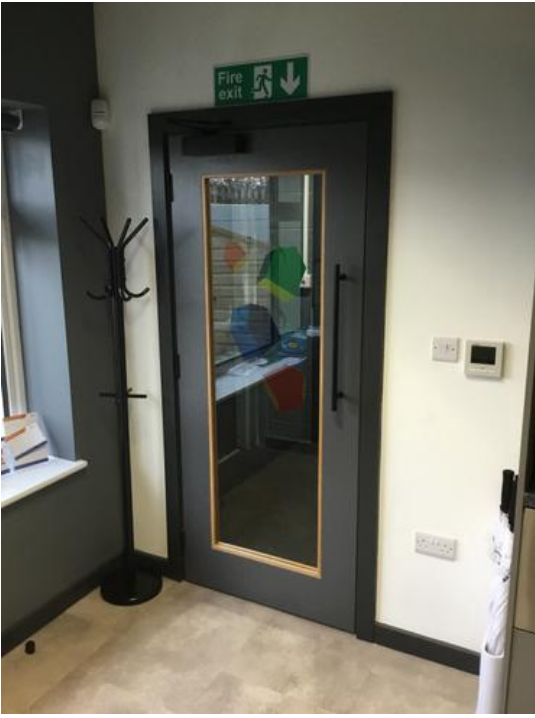
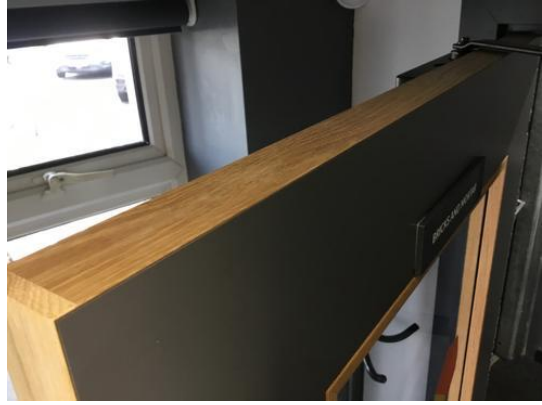
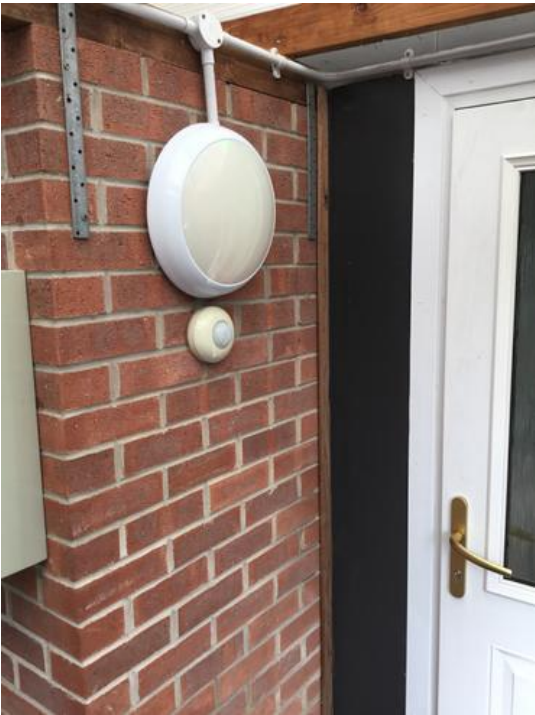
The common area doors appear to be 30 minute fire rated doors including three fire rated hinges, and a self closer. However, none of the new fire doors fitted in the staff welfare facilities and training room have intumescent seals and no labels or identification plugs were observed.

Management should clarify with the fire door installer that the fire resisting doors recently installed in the staff welfare area meet the requirements of BS 8214: 2016. If the doors are found not to conform they should be replaced with certified door sets meeting the standard noted.

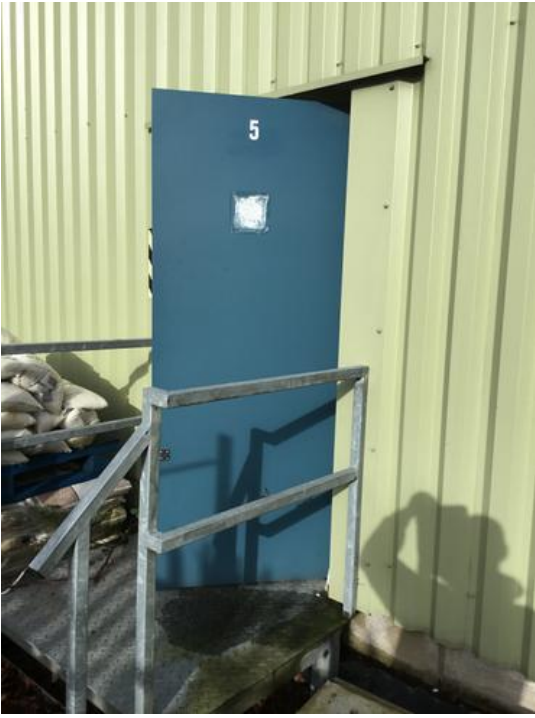
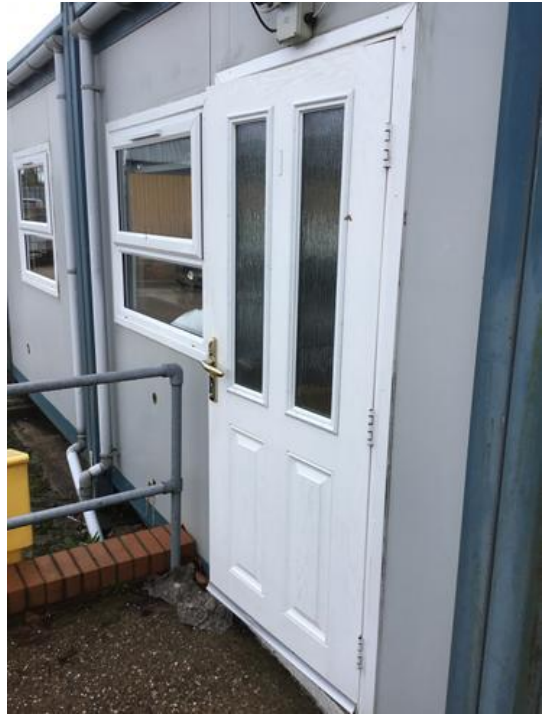
There is no external emergency lighting.

Management should ensure emergency lighting is fitted externally above final exits and on the external escape routes so persons can escape safely if the power fails.

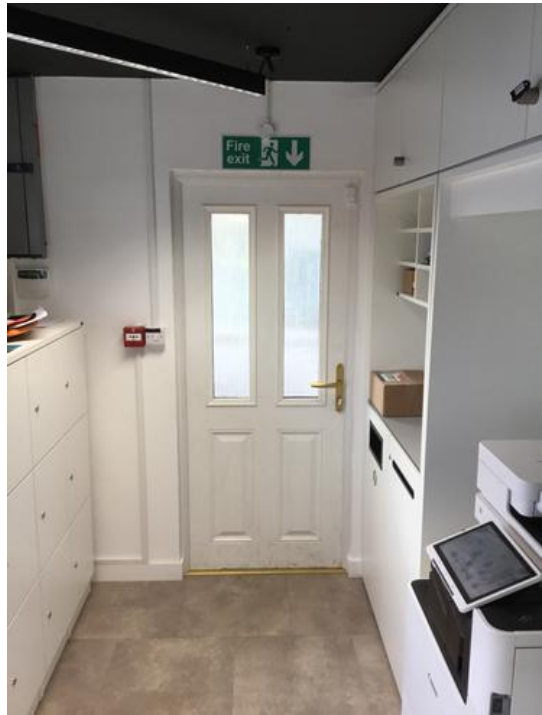
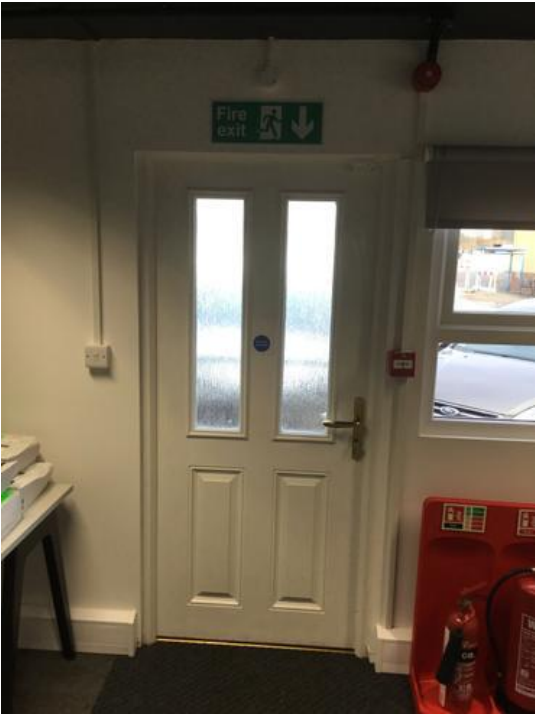
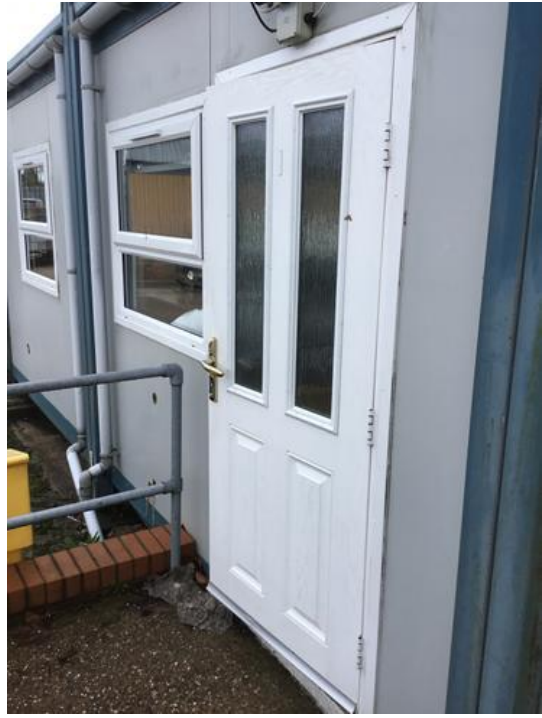
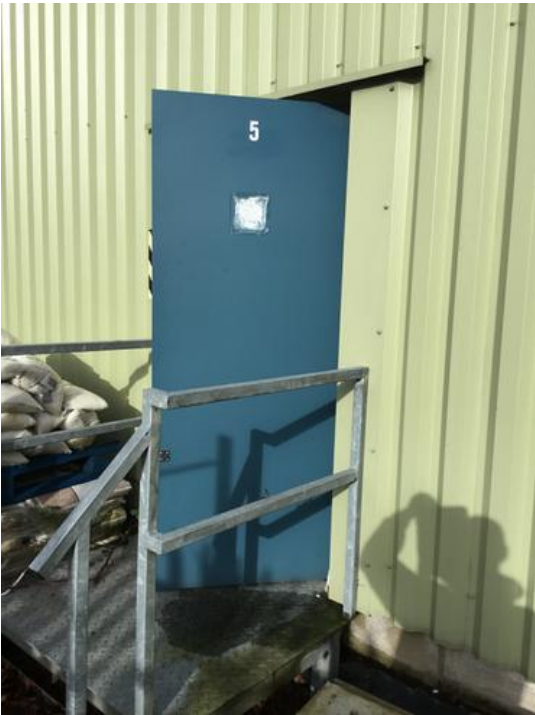
Throughout the site there are various visible fire safety signs. However, certain visible fire safety signs are missing.
