Futures Fire Risk Assessment

Futures Homescape, Rutland mill, 5
Market St: DE7 5PQ, UPRN: 14718 /
316081 / QA Approved / Paul Doodson

Futures Homescape, Rutland mill,
5 Market St: DE7 5PQ, UPRN:
14718, Fire Risk Assessments,
Futures Homescape

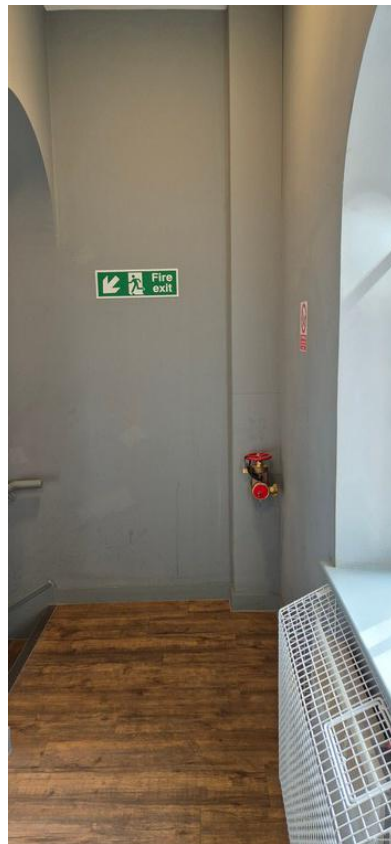
Photo 21

Wall mounted heaters are provided within common areas with metal grill covers fitted. There is no signage displayed to state 'do not cover'. Refer to Policy Principle for dwelling fixed heating maintenance.

Management should ensure that signage is displayed at all electric heaters within the common area 'do not cover'.

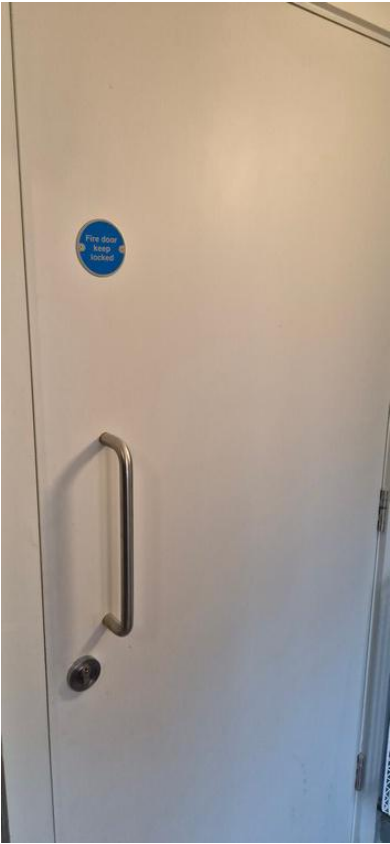
Photo 24

There are service risers, presumed plant / electrical intake rooms within the common area and a plant room to the rear of the premises that were not accessible to the Assessor. It was not possible to establish if combustible materials or ignition sources are present within.

Management should inspect all cupboards, plant rooms and service risers to ensure that combustible materials are not stored in proximity of ignition sources within. Any combustible storage found should be removed.

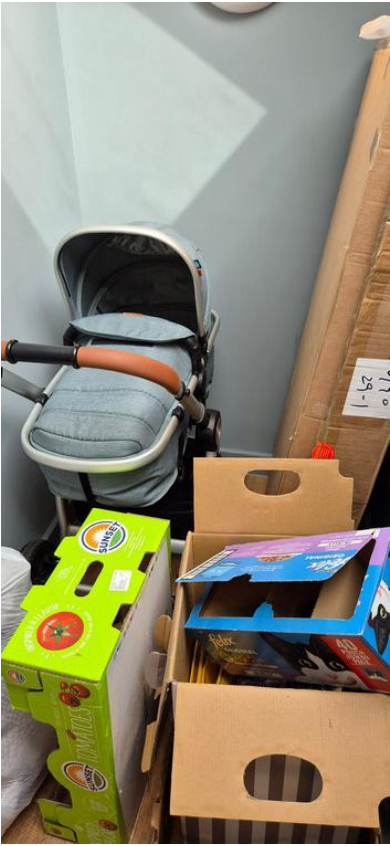
Photo 30

Generally escape routes and common areas were clear however, some personal items and recyclables were stored to third floor flats.

Management should liaise with residents to ensure that items are removed and that common areas and escape routes are kept clear at all times.

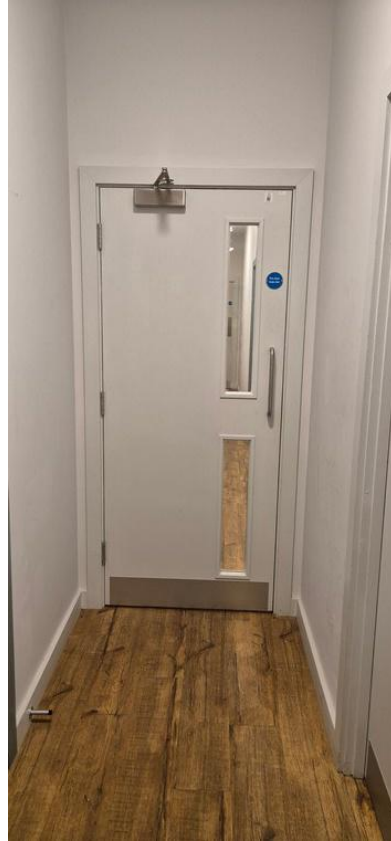
Photo 57

All sub-dividing doors are labelled to confirm that they are certified FD30 doors. Intumescent strips, self-closing devices and Georgian reinforced glass is fitted. The sub-divider adjacent to flat 12 has an excessive gap to the bottom of the door.

Management should repair the sub-divider adjacent to dwelling 12. Any work necessary should be carried out by a third party accredited fire door company.

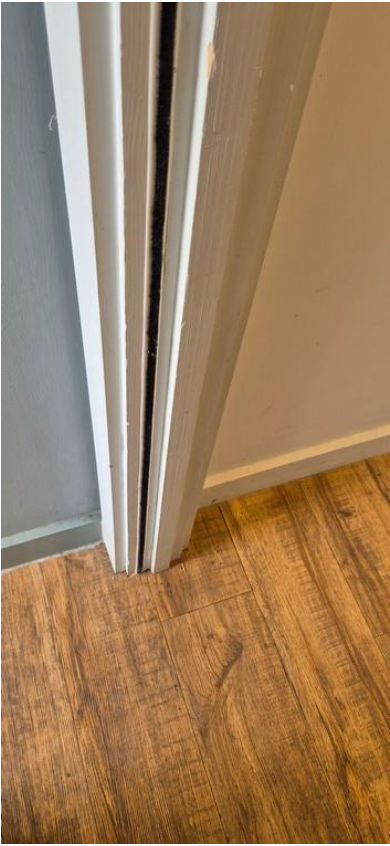
Photo 74

Flats 4, 12 and 21 were sampled. Doors are labelled to confirm that they are certified FD30 fire doors. Intumescent strips and self closure devices are fitted. The gap to the top of the door to flat 4 was excessive. In addition, it was not possible to establish fire rating or condition of other dwelling doors as no other flats were accessible.

Management should inspect all other dwelling doors to establish fire rating and condition. Where doors have a passing fire risk and they do not conform to a minimum of FD30S specification, they should be replaced with certified self-closing fire door sets to a minimum of FD30S specification. Any repairs or installation should only be completed by a certified third-party contractor.

Management should repair the door to flat 4 to ensure that gaps do not exceed 4mm tolerance. Work should be carried out by a third party accredited fire door company.
