Futures Fire Risk Assessment

Futures Homescape, 38-66 Magdalene Drive: DE3 9DH, - UPRN: 15222 / 173522 / QA Approved / Andy Cloke

Futures Homescape, 38-66
Magdalene Drive: DE3 9DH, -
UPRN: 15222, Fire Risk
Assessments, Futures
Homescape

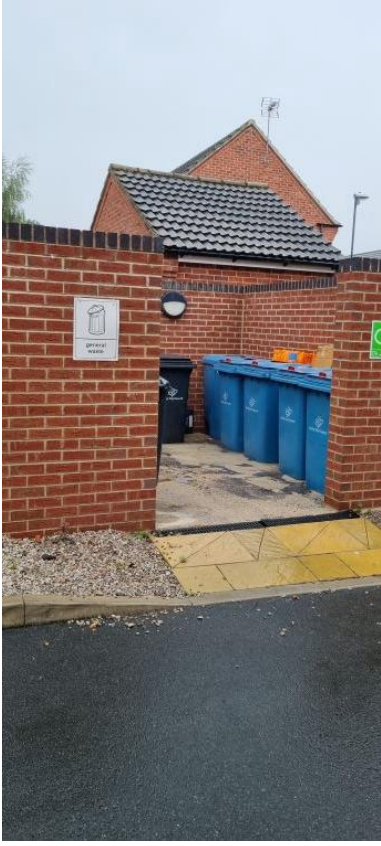
There is a designated area for waste / recycling located away from the building with communal waste skips and wheelie bins. Some wheelie bins had been left against the premise wall.

Management should liaise with waste collectors and residents to ensure that waste receptacles are stored within the designated area and away from buildings.

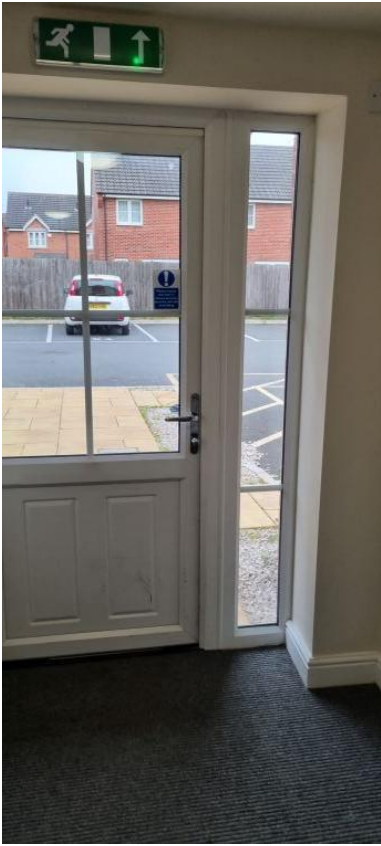
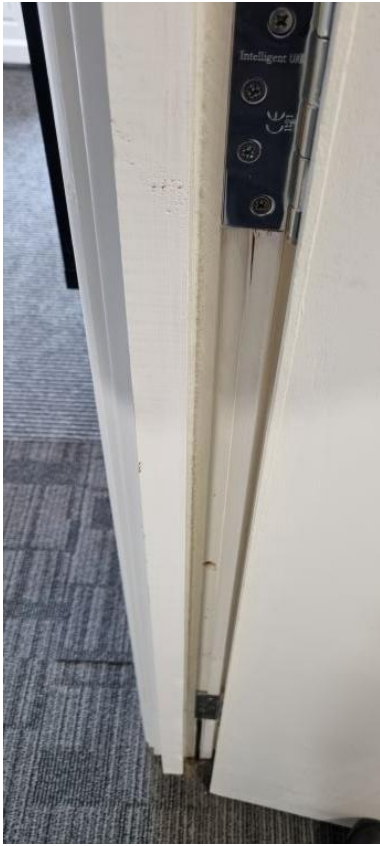
A thumb turn lock is fitted to the right hand exit door. The door to the left wing exit appear to have the ability to be locked with a key.

Exit doors that have a lock with the potential to be locked with a key should be replaced with a thumb turn lock.

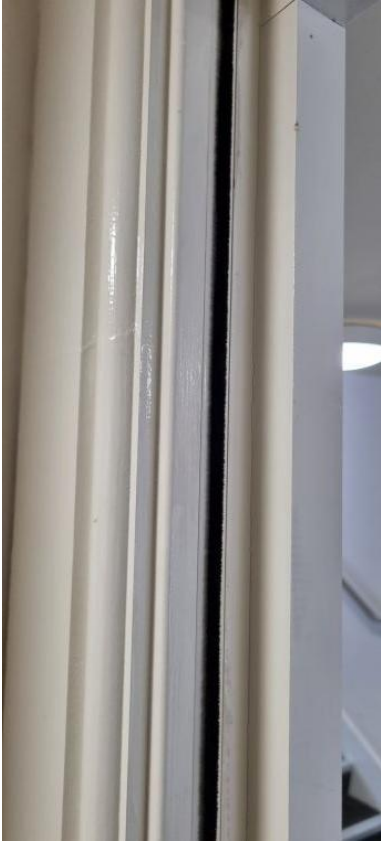
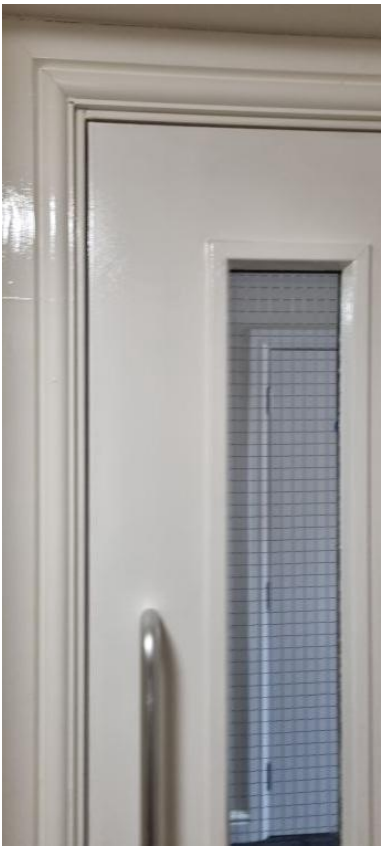
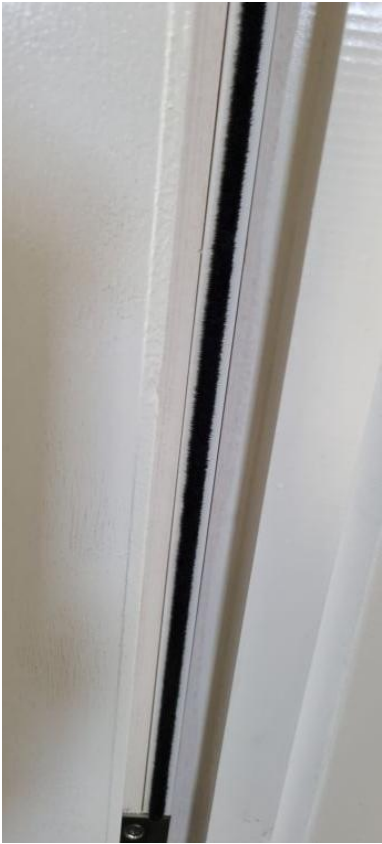
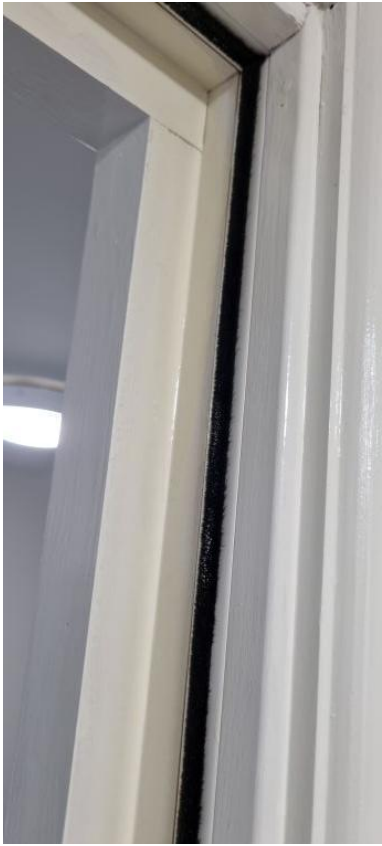
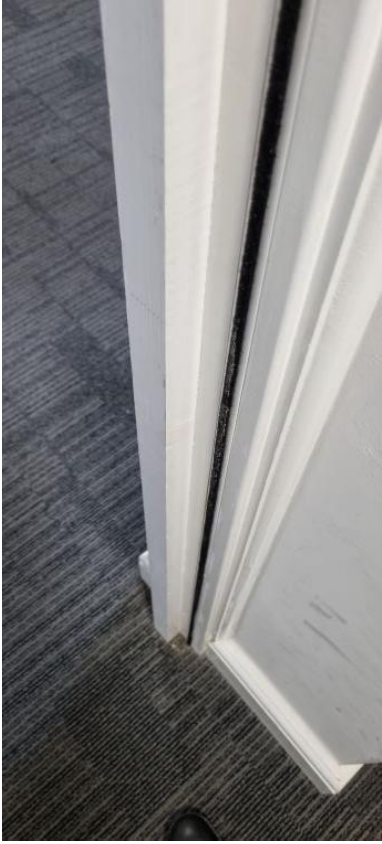
Separating fire door sets are fitted to the entrance lobby and each landing. Separating fire door sets are also fitted to each side of the landing which separates flats (2 each side) from the landings. Doors are fitted with self closure devices, intumescent strips and self closure devices. Doors are labelled to confirm that they are PWL FD30. The ground floor separating door has part of the smoke seal missing from the frame. The second floor landing door does not close properly to the

frame and has an excessive gap below the door.

Management should inspect all separating fire doors and carry out repairs to ensure that all smoke seals are in place / in-tact and that doors close fully to the frame.

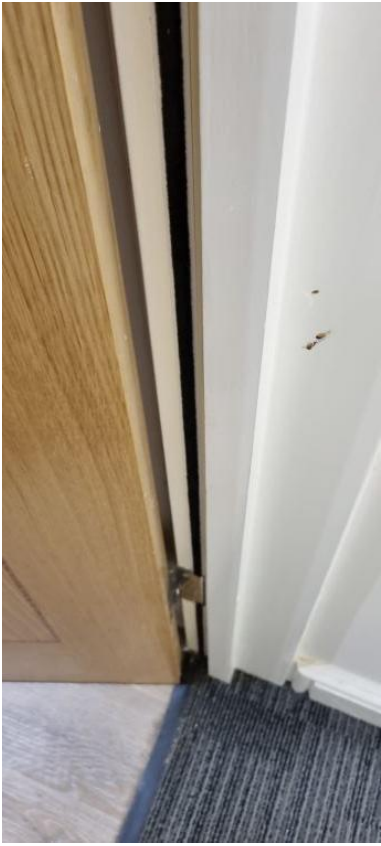
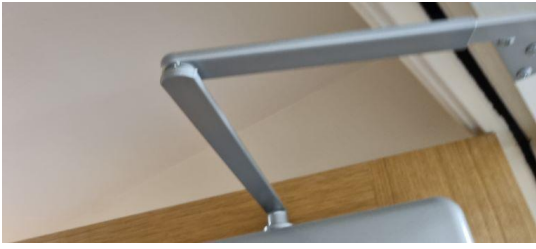
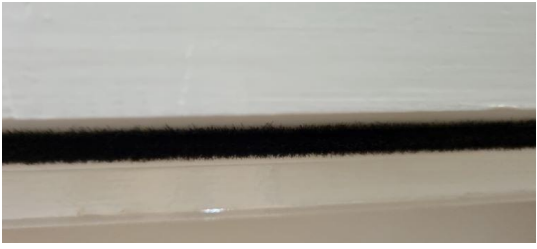
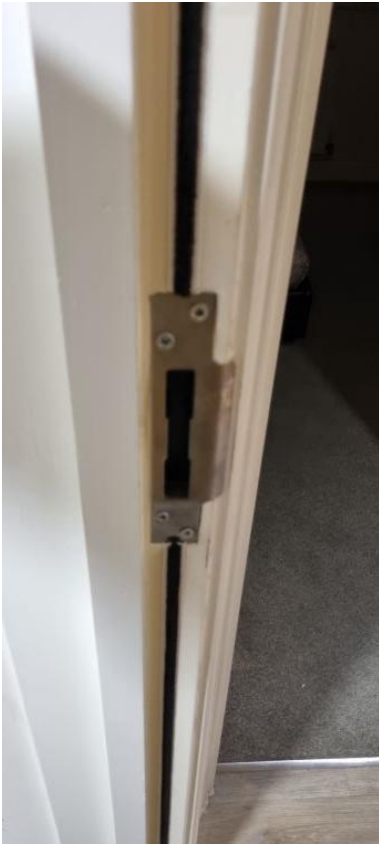
Flats 42 and 58 were sampled. Doors are labelled to confirm that they are certified PWL FD30 fire doors. Intumescent strips and self closure devices are fitted. It was not possible to establish fire rating or condition of other dwelling doors as no other flats were sampled.

Management should inspect all other dwelling doors to establish fire rating and condition. Where doors do not conform, they should be replaced with certified FD30S self closing fire door sets. Any installation should only be completed by a certified third-party installer.

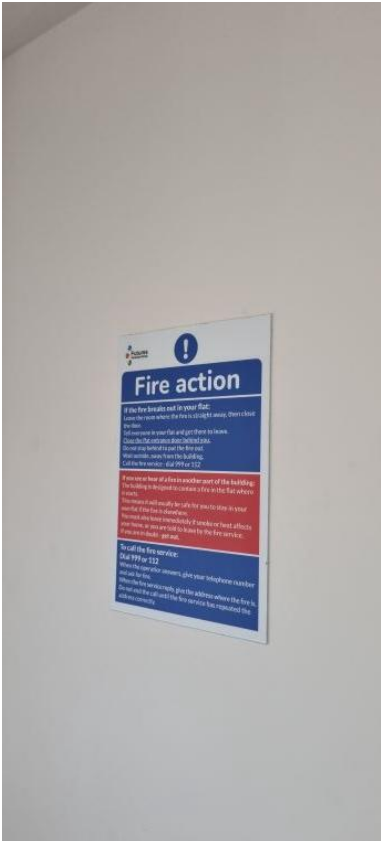
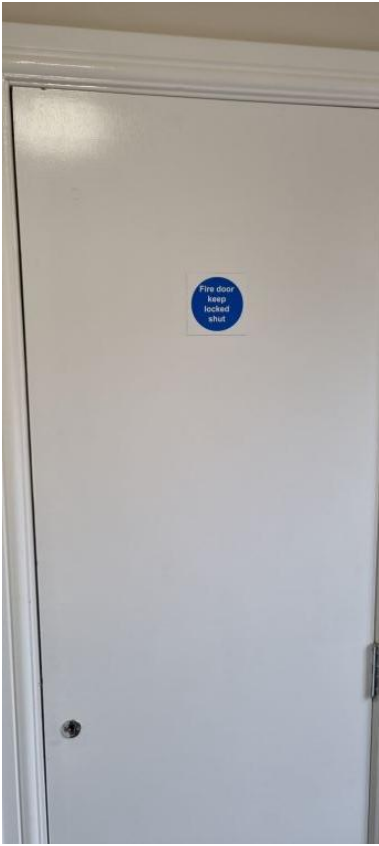
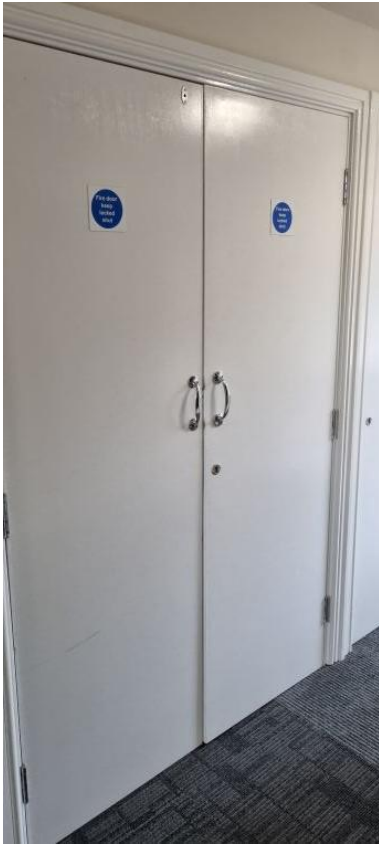
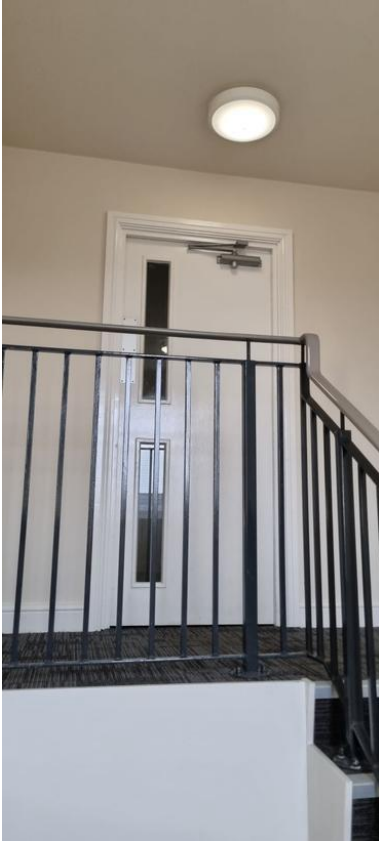
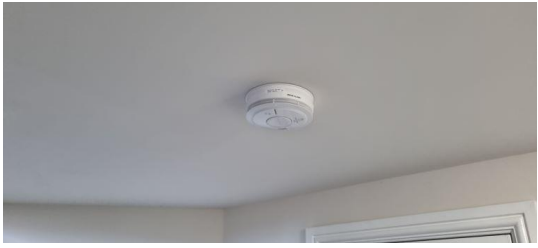
Fire Action Notices are displayed within common areas which advises of a 'Stay Put' policy. Illuminated exit signs are fitted over exits and directional signage is displayed. Service risers have fire door signs attached. Separating doors do not have signs attached.

Managements should ensure that fire door signs are attached to both sides of all common area fire doors.

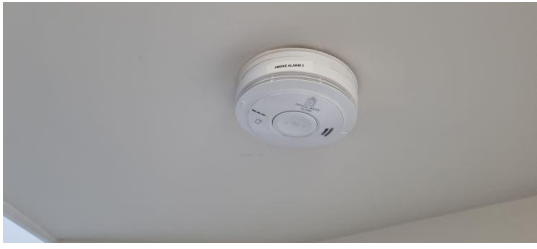
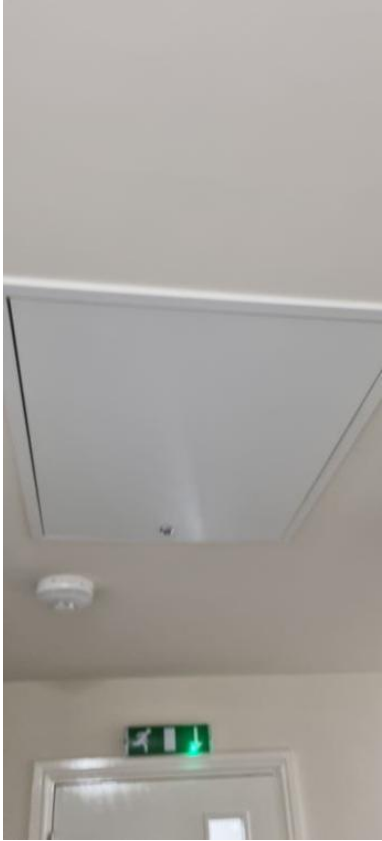
There is no manual alarm system however AFD is installed to common areas. "Section 20.4 of the guidance used highlights how in 'general needs' blocks designed to support a 'stay put' policy, it is unnecessary and undesirable for a fire alarm system to be provided. A communal fire detection and alarm system will inevitably lead to a proliferation of false alarms. This will impose a burden on fire and rescue services and lead to residents ignoring warnings of genuine fires.

Responsible person to confirm that the installed alarm system is warranted, appropriate and effective. Depending on the outcome modify system accordingly.

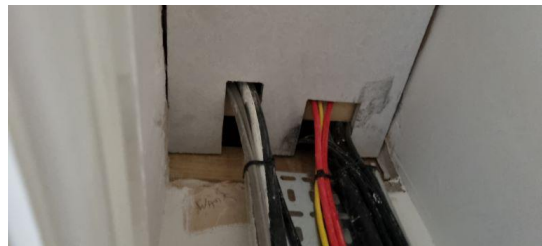
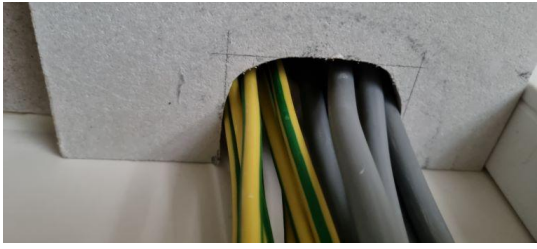
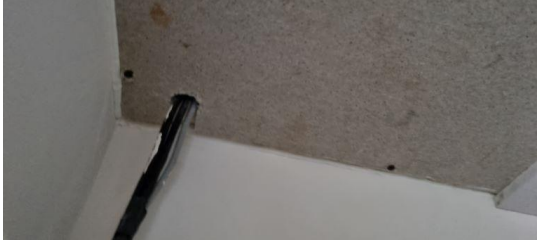
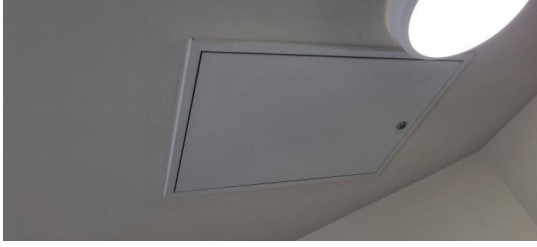
Doors to service risers are / electrical intake cupboards have intumescent strips fitted however they are not labelled and it was not possible to establish fire rating. In addition, doors were left open / accessible. Numerous penetrations were identified although some attempt has been made to fire stop using expandable foam.

Management should inspect all doors to service risers and ensure that they comply to FD30 specification. Where they do not comply they should be replaced with certified FD30 self closing fire door sets. Doors should be kept locked and only accessible to authorised persons.

Management should inspect all service risers. Any penetrations should be fire stopped using fire rated building materials. Any work required should only be completed by a certified third-party contractor.
