Futures Fire Risk Assessment

Futures Homescape, Community Centre
Slack Lane (Field Terrace): DE5 3HF, -
UPRN: 7 / 173572 / QA Approved / Piotr
Iwan

**Futures Homescape,
Community Centre Slack Lane
(Field Terrace): DE5 3HF, - UPRN:
7, Fire Risk Assessments,
Futures Homescape**

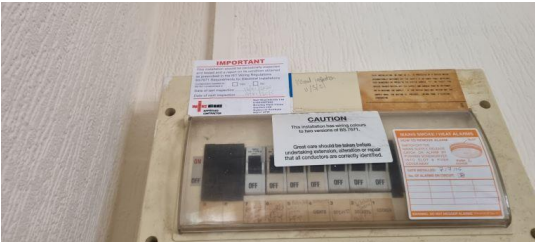
Photo 3

The label on the electrical consumer unit confirms that the fixed wiring was last inspected on 16/01/2020.

Policy Principle: FHG complete Fixed wire testing in line with current regulations every 5 years and complete an annual visual inspection on all properties.

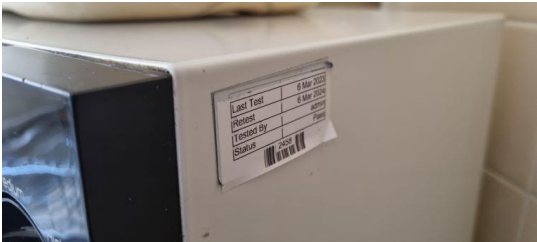
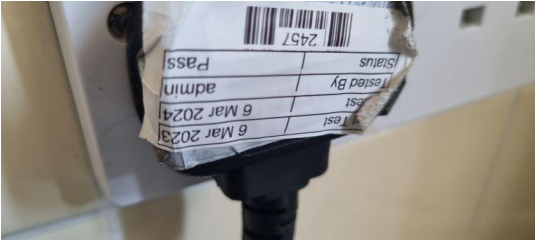
Labels on portable electrical appliances confirmed that PAT testing was last completed on 6/03/2023.

Policy Principle: PAT testing is complete at the time of the visual inspection as mentioned above. All items in the communal areas will be tested.

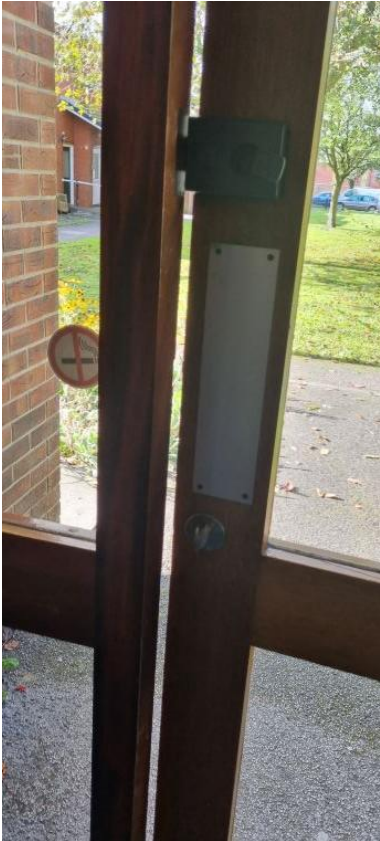
Photo 6

There was no evidence of smoking within the community centre at the time of assessment. There is a no smoking sign displayed on the entrance door however, the sign does not comply with UK Legislation for buildings used by the public.

The 'No Smoking' sign should be replaced with a sign worded 'It is against the law to smoke on these premises'.

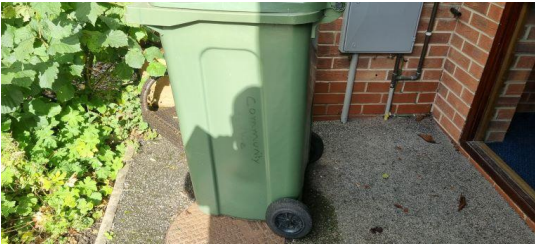
Photo 7

A wheelie bin is located outside the community centre. Waste is removed regularly by FHG cleaners. There were no issues identified at the time of assessment.

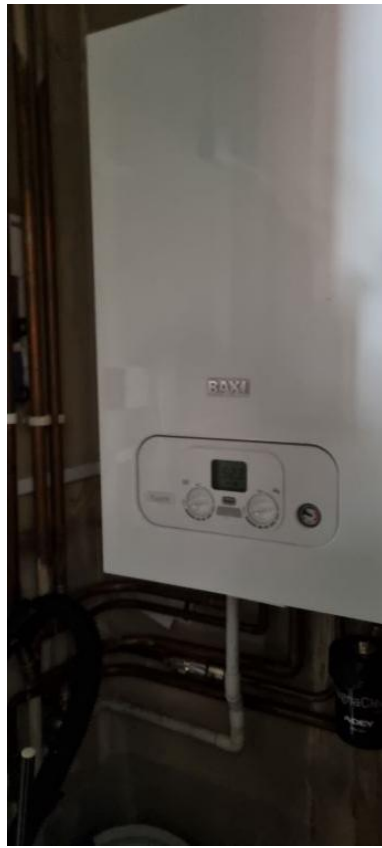
Photo 8

A domestic gas boiler is installed. It was not possible to establish the date of the last gas safety inspection as the information was not available at the time of assessment. Refer to Policy Principle.

Policy Principle: All Safety inspections carried out annually by qualified persons.

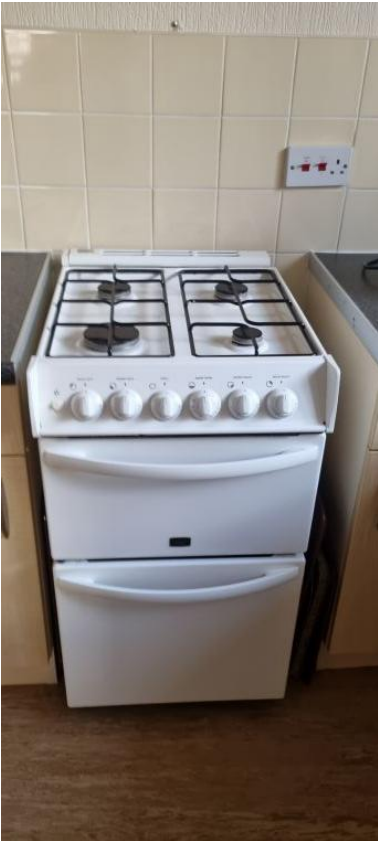
Photo 9

There is a free standing gas cooker within the community centre kitchen that was 'live' at the time of assessment. It was not possible to establish how often the kitchen is used or what rules are in place for cooking etc.

It is recommended that the gas cooker is isolated (as is the case with other FHG community centres). The cooker should be either replaced with an electric cooker or removed in favour of microwave only. Where a cooker is to remain it is advisable that it is only used for low risk activities and that high risk (deep fat frying etc) is prohibited. Rules for the use of the kitchen should be disseminated to users.

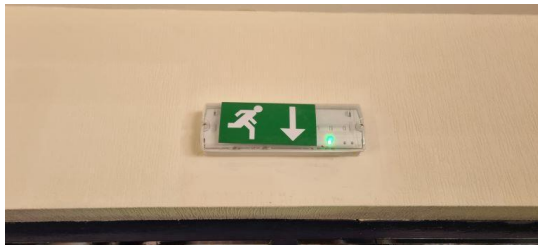
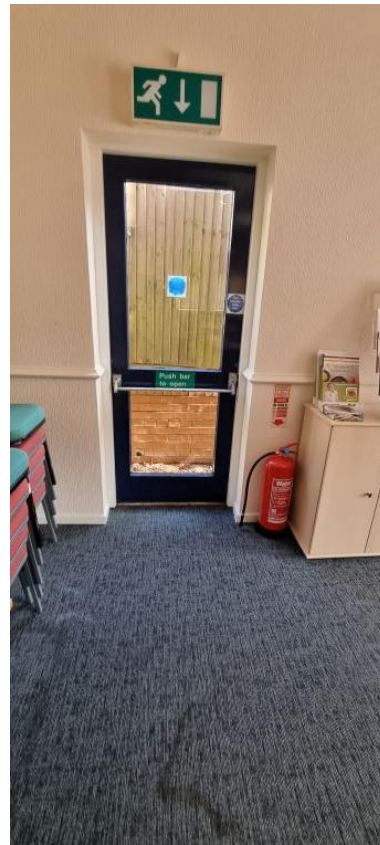
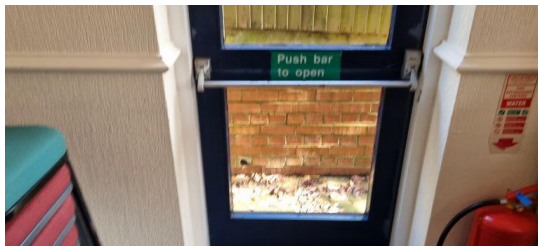
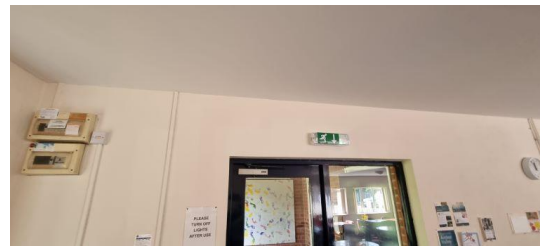
Exits signs are displayed however, there is no Fire Action Notice displayed.

A Fire Action Notice should be displayed which advises of a simultaneous evacuation.

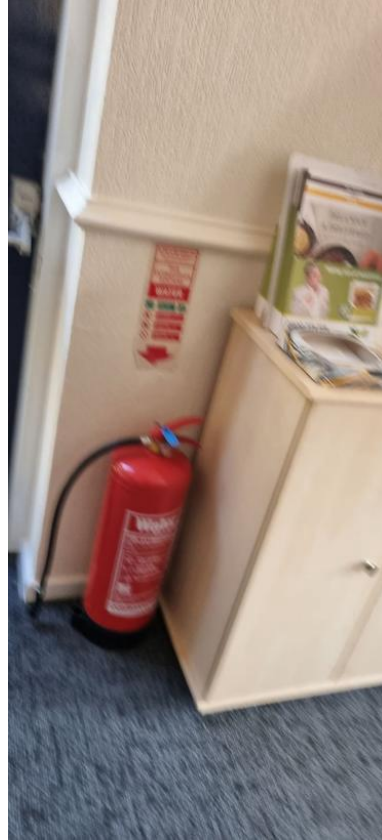
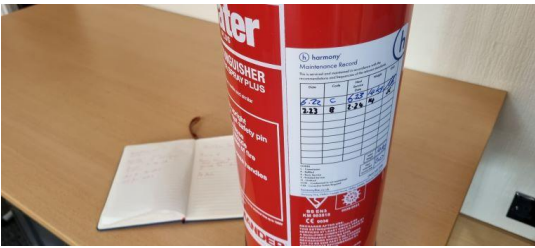
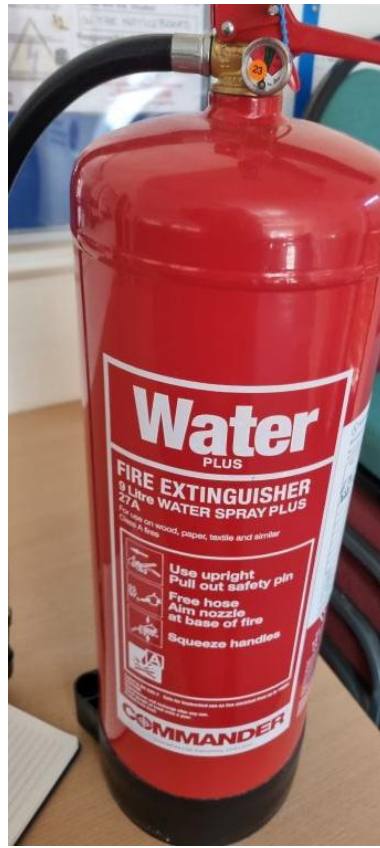
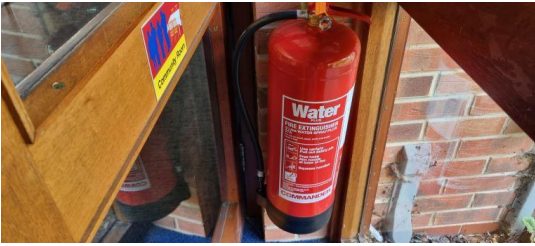
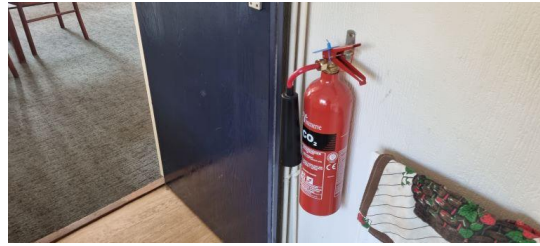
There are 2 x 9Ltr 27A and 1 x 2KG extinguishers installed. The extinguisher to the sitting room is not correctly mounted. In addition, In addition, community centre users are unlikely to be trained on the use of FFE and no signage is displayed to state 'only to be used by trained persons'. Extinguishers are maintained under service contract with Harmony with the last inspection completed 02/23. 9Ltr units are excessive for a small property. BS5306: Part 8 requires that there is only a minimum of 2 x 13A 6Ltr rated units required for compartments of up to 400 sq. metres.

Management should display signage at fire points to state 'extinguishers should only be used by trained persons'. The unit to the sitting room should be correctly mounted on a suitable wall bracket or floor stand. It is advisable that 9 litre units are reduced to 6 litre units at the end of unit life in order to reduce service costs.
