## Futures Fire Risk Assessment

Futures Homescape, Community Centre  
Andrews Drive (Neal Court): NG16 4GG, -  
UPRN: 22 / 173584 / QA Approved / Andy Cloke

INSPECTION DATE: **16 Nov 2023**

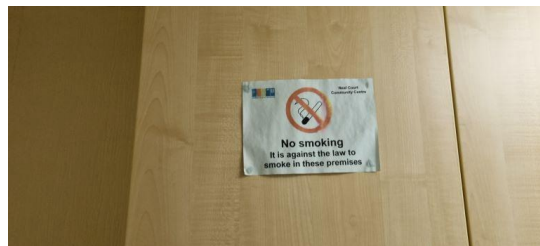
Photo 6

There is a no smoking sign displayed on a cupboard however, there is no sign displayed at point of entry.

Management should ensure that 'It is against the law to smoke on these premises' sign is displayed at point of entry.

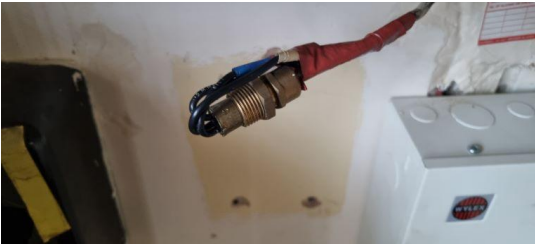
Photo 11

There is an electric cable joint within the electrical intake cupboard that does not appear to be adequately insulated.

Management should inspect the cable and ensure that the electrical joint is properly connected and insulated. Any work required should only be conducted by a competent person.

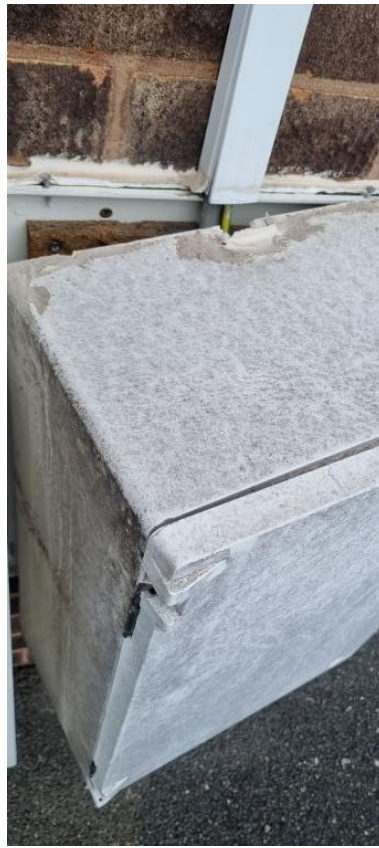
Photo 12

The external meter box to the front of the premise is damaged.

Management should ensure that the meter box is replaced.

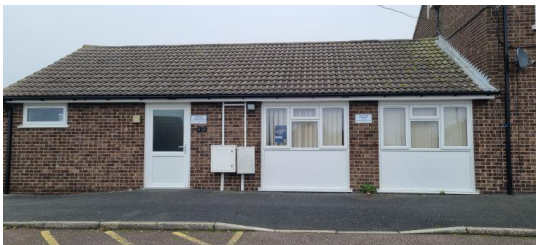
Photo 23

There is no external emergency lighting installed.

Management should ensure that external emergency lighting is installed to exits.

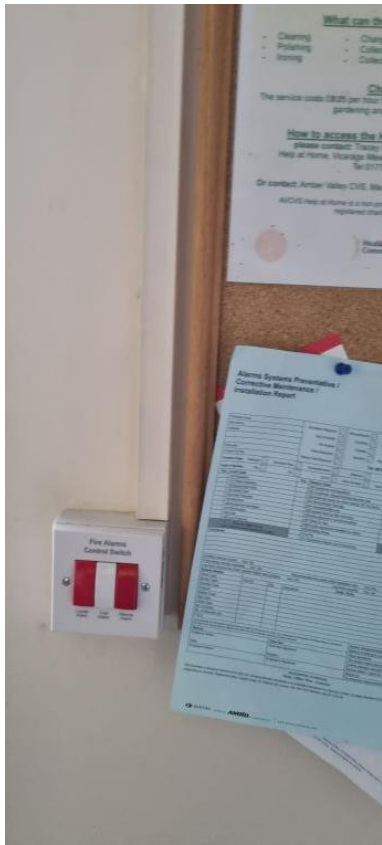
Photo 29

It was not possible to establish the arrangements for silencing and resetting the AFD system.

Management should confirm the arrangements for silencing and resetting the AFD system and ensure that it is communicated to community centre users.

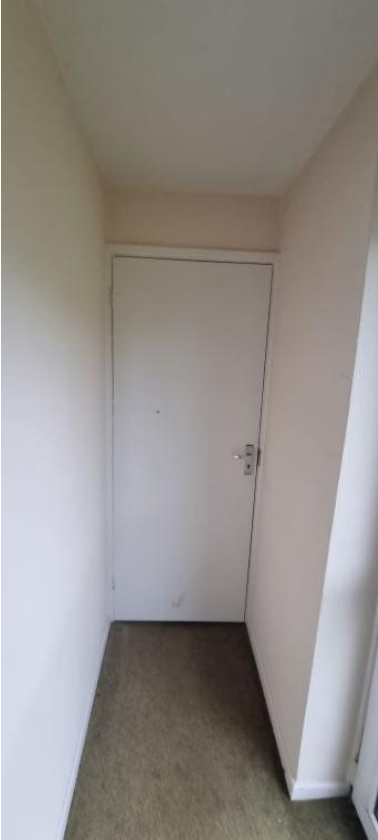
Photo 39

There is a room / cupboard present to the rear of the community centre which was not accessible. It was not possible to establish if there are ignition risks present within or if there are any compartmentation issues.

Where ignition risks are present within the door should be fire rated to a minimum of FD30 specification. Any penetrations identified within should be fire stopped with fire rated building materials. Any work required should be fire stopped with fire rated building materials.

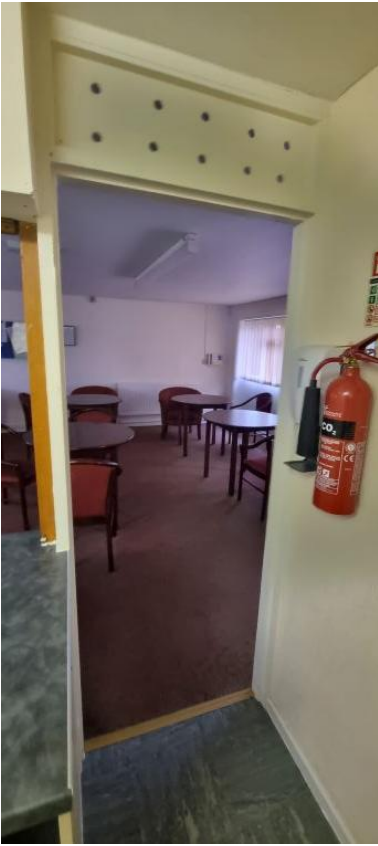
Photo 41

Extinguishers do not meet the requirements of BS5306: Part 8. There is only 1 x 6L 21A Foam unit and 2 x 2KG CO2 units present. BS5306: Part 8 requires that a minimum of 2 x 13A rated units are provided for compartments of up to 400 square metres. In addition, community centre users are unlikely to be trained on the use of FFE and no signage is displayed to state 'only to be used by trained persons'. Extinguishers are maintained under service contract with Harmony with the last inspection completed 02/23.

Management should display signage at fire points to state 'extinguishers should only be used by trained persons'. An addition 6L 13A Water / Foam unit should be installed in order to comply with BS5306: Part 8.
