Futures Fire Risk Assessment

Futures Homescape, Block 1-53 The
Bailey Wills Building: NN1 4HZ, - UPRN:
BAI602-BLK / 173518 / QA Approved /
Andy Cloke

Futures Homescape, Block 1-53
The Bailey Wills Building: NN1
4HZ, - UPRN: BAI602-BLK, Fire Risk
Assessments, Futures Homescape

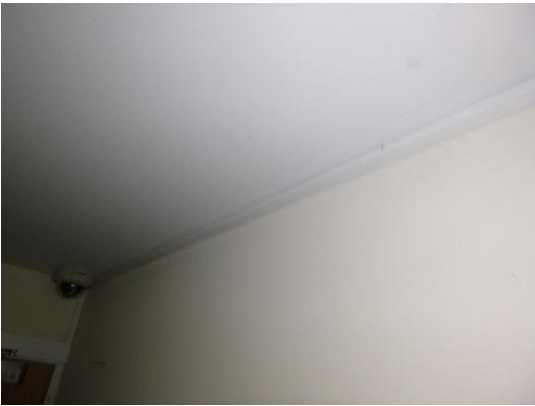
Photo 40

Conduit and cables were noted throughout the premises and it was not possible to confirm that the requirements of Regulation 521.10.202 of the BS 7671 - 18th Edition of The IET Wiring Regulations, which requires all cables to be adequately supported using non-combustible fixings to prevent premature collapse

in the event of a fire. The new regulation is not applied retrospectively so any wiring systems fitted before 2019 do not need to be immediately updated. Any new installation or additions and alterations to existing systems, including temporary wiring, have to comply with the regulations.

Management is to consider the requirements of the Regulation 521.10.202 of the BS 7671 - 18th Edition The IET Wiring Regulations which requires all cables to be adequately supported using non-combustible fixings to prevent premature collapse in the event of a fire albeit not retrospective and seek the advice of a suitably qualified competent person or organisation and undertake any remediation identified by the aforementioned competent person or organisation.

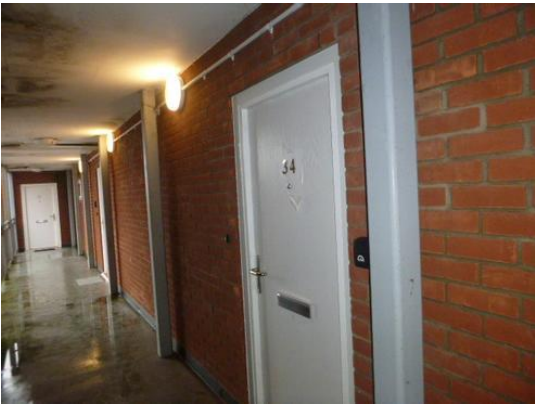
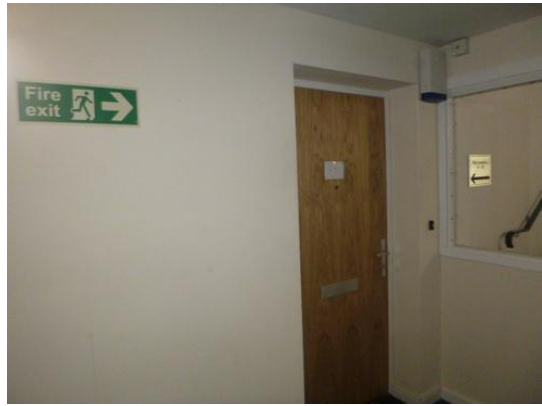
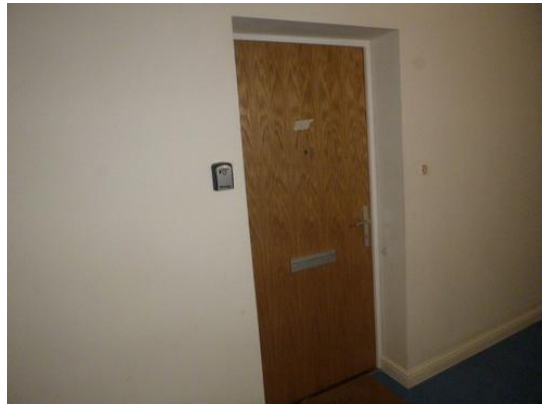
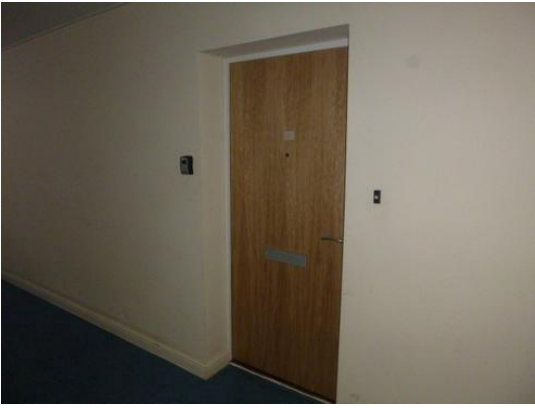
Sampled flat entrance door is situated at the end of one of the open decks with no passing risk. It was unable to be confirmed if flat entrance doors offer 30 minutes fire resistance. Ineffective flat entrance doors in a fire condition may allow smoke heat and fire to spread; this may impede escape and may cause physical harm to the occupants of the building

Management to confirm that adequate FD30S certification is present for the flat entrance doors. If certification is unavailable, then a comprehensive fire door survey should be undertaken to the flat entrance doors by a competent 3rd party accredited company. Any recommendations from such a survey should be implemented as soon as practicable.

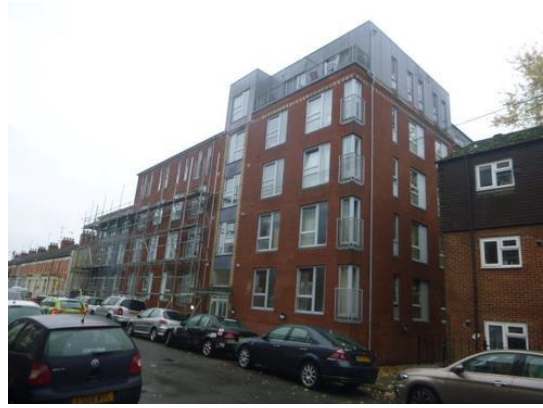
Photo 80

Predominantly brick faced external fascia, however cladding was noted to the top floor level.

Management to confirm the cladding to the top floor as noted conforms to current guidelines with reference to external spread of flame.
