## Futures Fire Risk Assessment

Futures Homescape, Flats 1-6 Booth Street: DE5 3DP, - UPRN: FB254 / 173525 / QA Approved / Andy Cloke

Futures Homescape, Flats 1-6  
Booth Street: DE5 3DP, - UPRN:  
FB254, Fire Risk Assessments,  
Futures Homescape

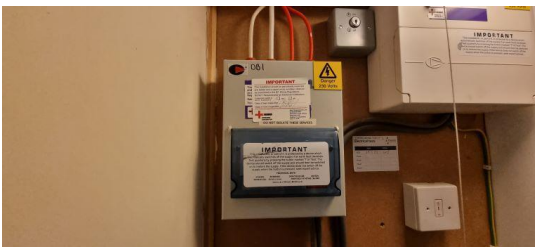
Photo 3

The date label on the distribution board has been crossed out. It was not possible to establish the date of the last fixed wiring test. Refer to Policy Principle.

Management should ensure that the fixed wiring has been tested in line with Policy Principle.

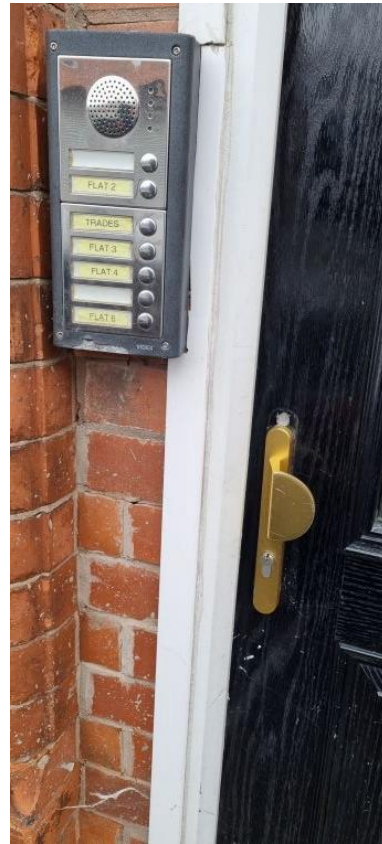
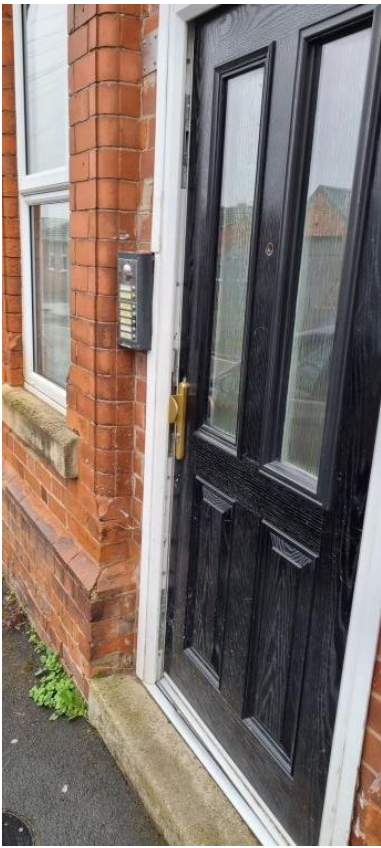
A standard security lock and intercom is fitted. The door was left wedged open and accessible at the time of assessment.

Management should liaise with residents to ensure that the entrance door is locked when not in use in order to maintain adequate measures of security.

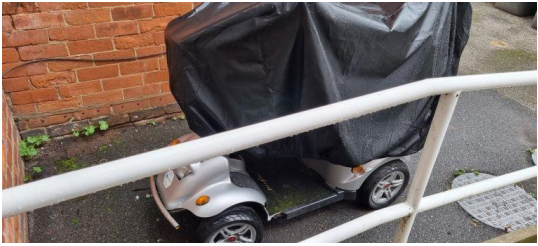
Photo 7

There was a mobility scooter located outside the rear entrance. It was not possible to establish the charging arrangements or if a risk assessment has been completed as the information was not available at the time of assessment.

Management should establish the arrangements for charging of mobility scooters. Management should ensure that a risk assessment has been completed in line with NFCC Mobility Scooter Guidance in residential buildings. Any risk assessment should account for Lithium Ion battery risks where necessary.

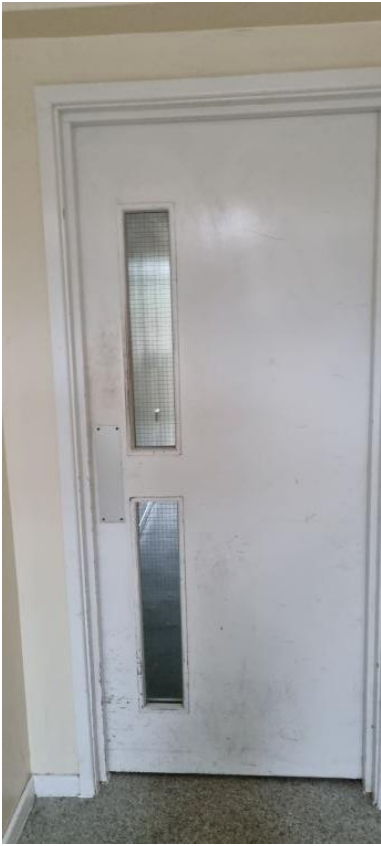
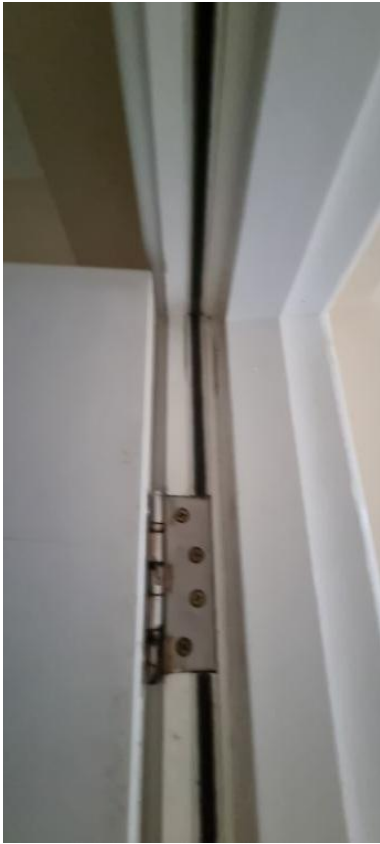
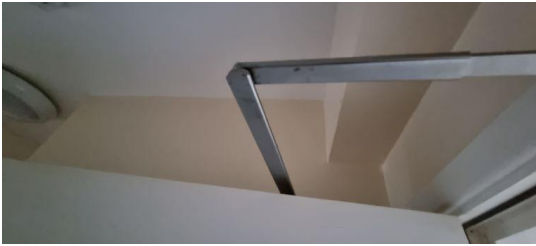
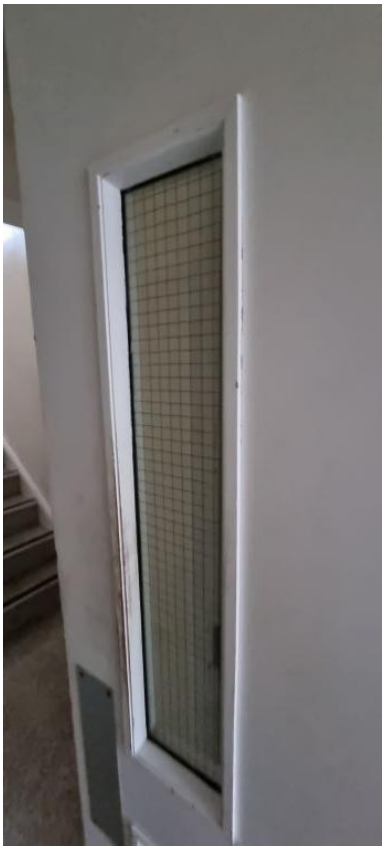
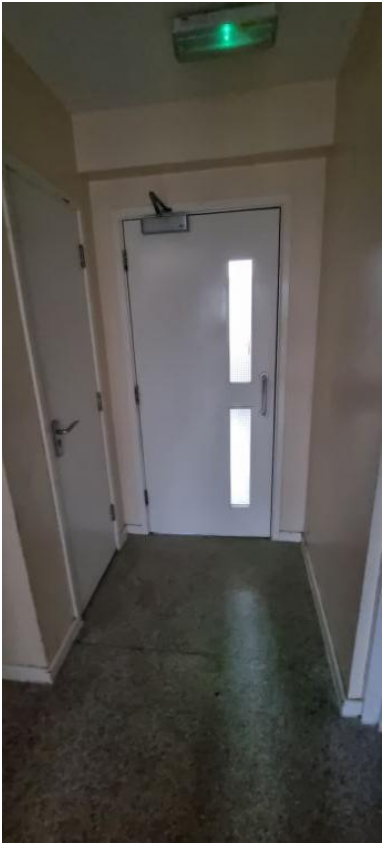
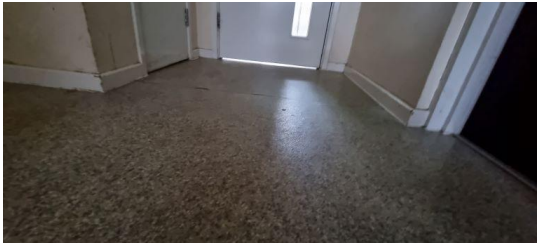
There is a fire door to which separates the small entrance hallway from the small corridor. Intumescent strips are fitted and a self closure device. A Georgian reinforced glass viewing panel is fitted. The door has an excessive gap to the bottom of the door. The door is not labelled and it was not possible to establish fire rating.

Management should confirm fire rating of the separating fire door. Where the door does not conform to FD30 specification it should be replaced with a certified FD30 fire door set. Any installation or repair should only be completed by a certified third party contractor.

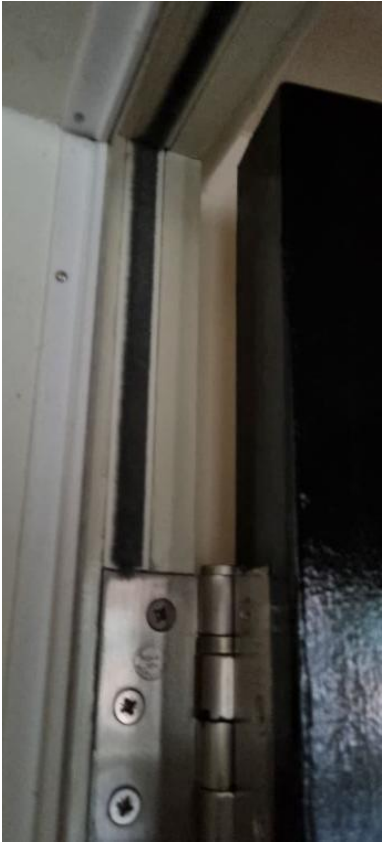
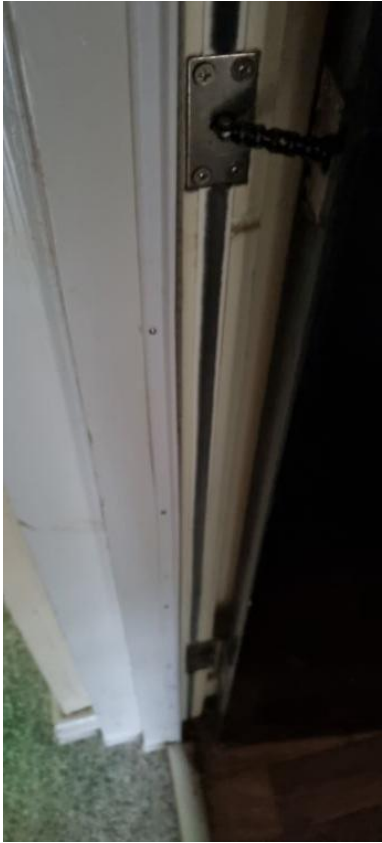
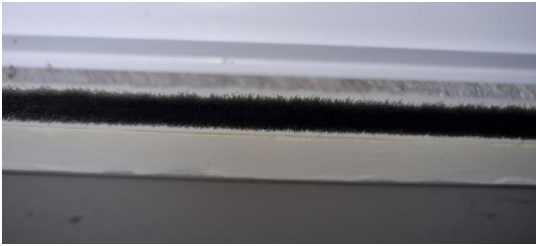
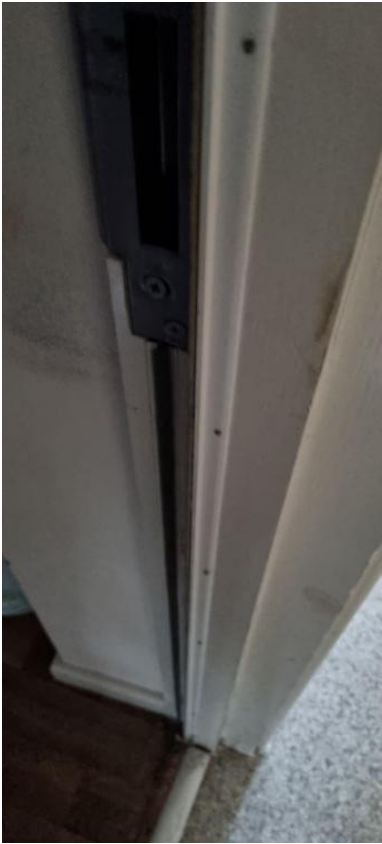
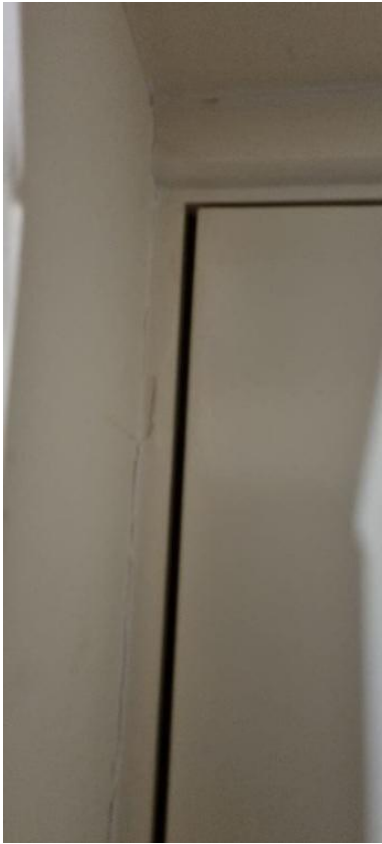
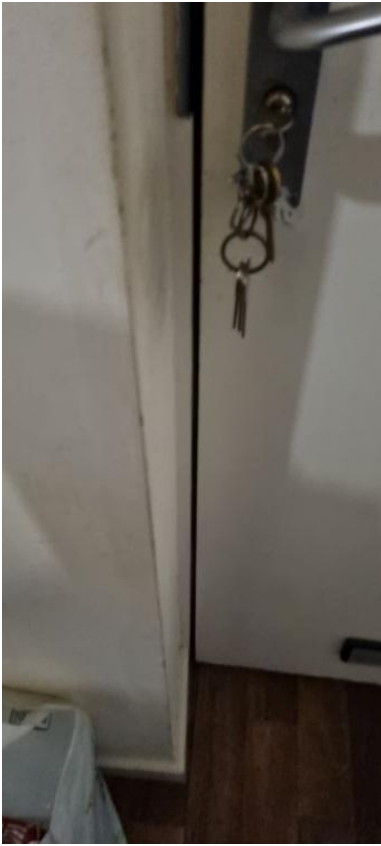
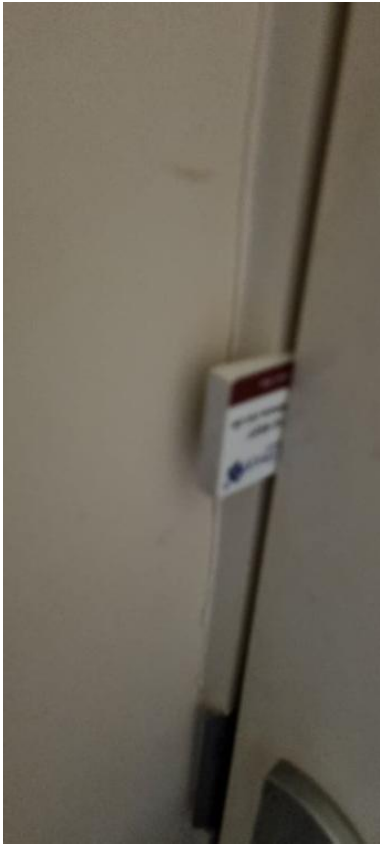
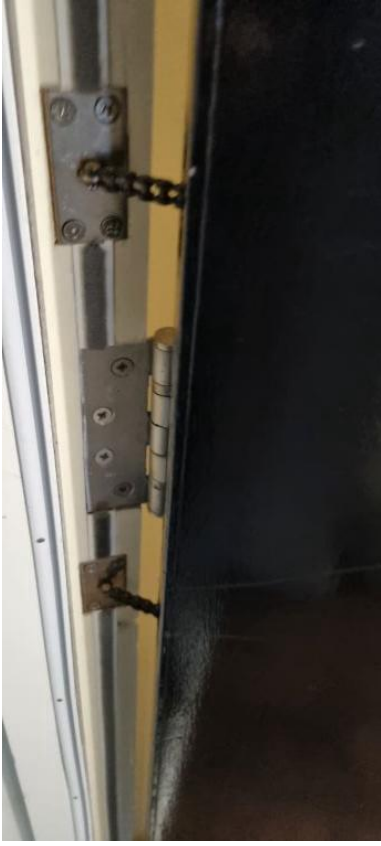
Flat 1 was sampled. Intumescent strips are and concealed self-closure devices are fitted. The door was not labelled and it was not possible to establish fire rating. Gaps to the door were excessive. In addition, it was not possible to establish fire rating or condition of other dwelling doors as no other flats were sampled.

Management should confirm fire rating of the dwelling sampled and repair or replace the door with a certified self closing fire door set to a minimum of FD30 specification. Management should also inspect all other dwelling doors to establish fire rating and condition. Where doors do not conform or if damage is identified, doors should be repaired or replaced with certified FD30 fire doors sets. Any installation or repair should only be conducted by a certified third-party contractor.

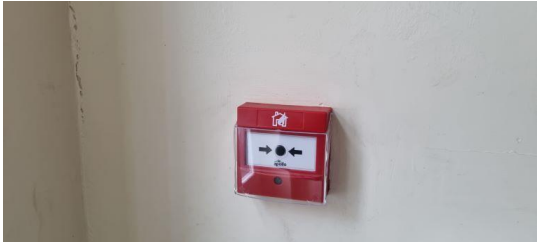
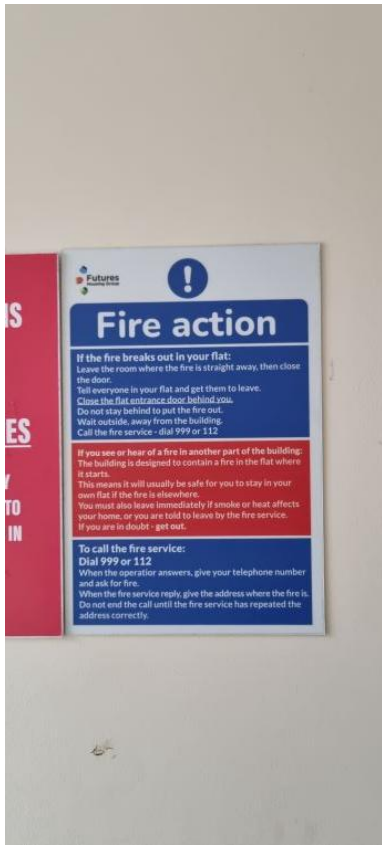
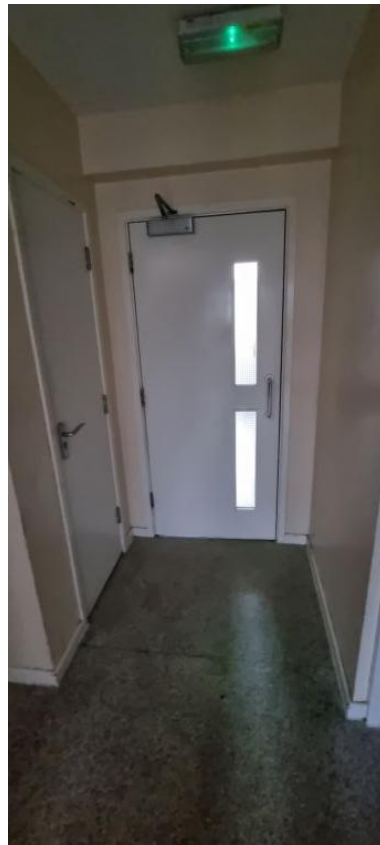
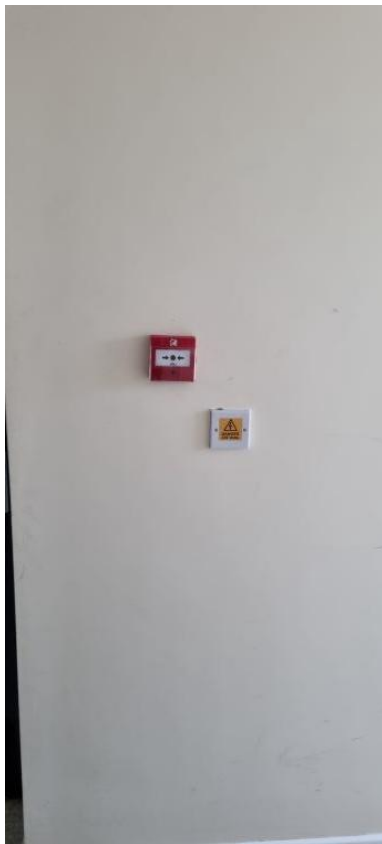
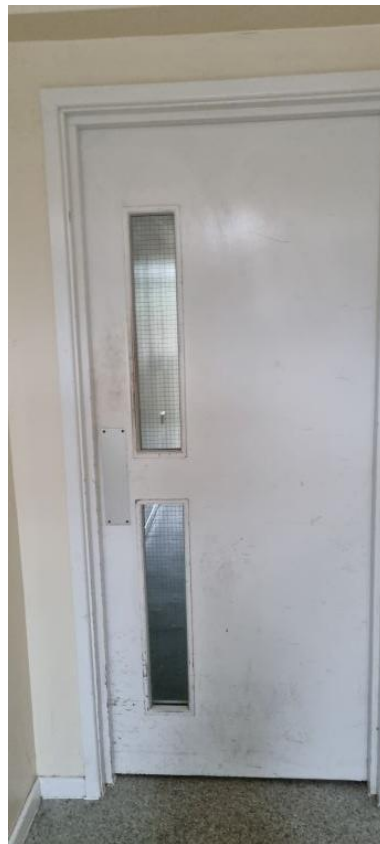
A Fire Action Notice is displayed to the common area. There is no signage attached to the fire door to the ground floor. In addition, there is no signage attached to fire alarm call points.

Management should display fire door signs to both sides of the fire door. Call point signage should be displayed at MCPs.

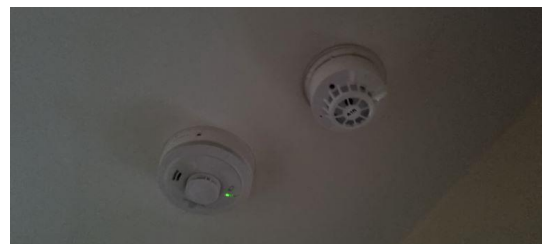
Photo 48

Hard-wired linked detection is installed to the hallway of the dwelling sampled. It was not possible to establish if detection is installed to other rooms within the dwelling. In addition, it was not possible to establish the level of detection to other dwellings as no other flats were sampled.

Management should ensure that hard-wired smoke / heat detection is installed to all flats within the block, in accordance with BS5389-6:2019 (Grade D, LD3 smoke alarms interlinked) in-line with LACORS Guidance. If found not to be, install to this standard. All work to be carried out by a third-party accredited fire alarm company.
