Futures Fire Risk Assessment

Futures Homescape, Community Centre Castle
 Drive: DE55 4LN, - UPRN: 19 / 173534 / QA
 Approved / Andy Cloke

Futures Homescape,
 Community Centre Castle
 Drive: DE55 4LN, - UPRN: 19,
 Fire Risk Assessments, Futures
 Homescape

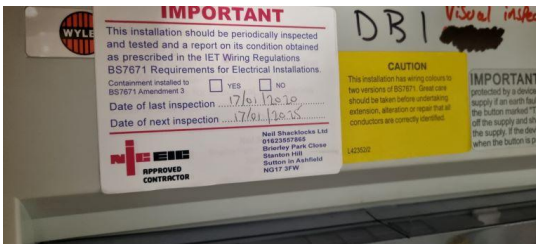
Photo 3

The label on the consumer unit confirms that the fixed wiring was last tested on 17/01/2020.

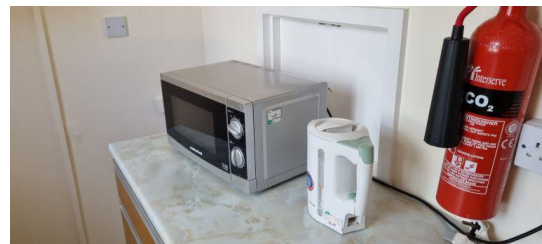
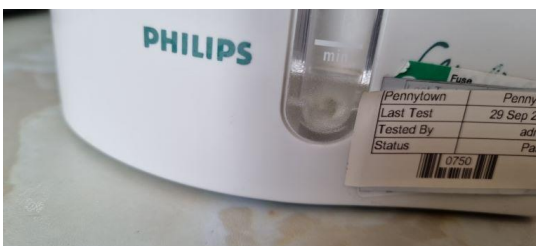
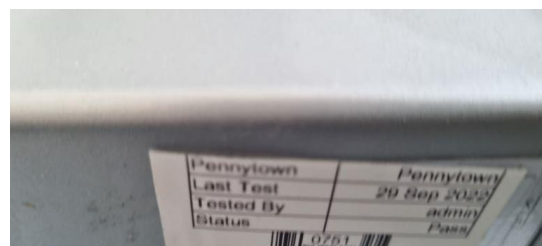
Photo 4

Labelling on portable electrical appliances confirmed that PAT testing was completed in September 2022.

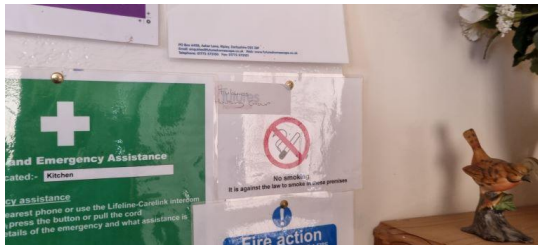
Photo 7

There is a no smoking sign within the sitting room displayed on the notice board however, there is no sign displayed at point of entry.

Management should ensure that a no smoking sign is displayed at the point of entry with the wording 'it is against the law to smoke on these premises'

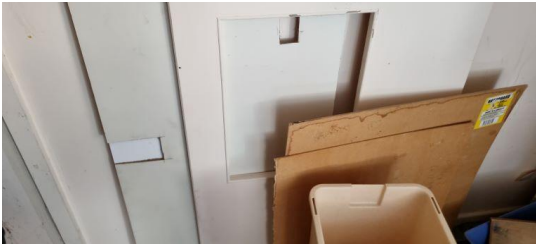
Photo 11

There is some wooden / boarding stored within the electrical intake cupboard.

Managements should ensure that combustibile materials are removed from the electrical intake cupboard.

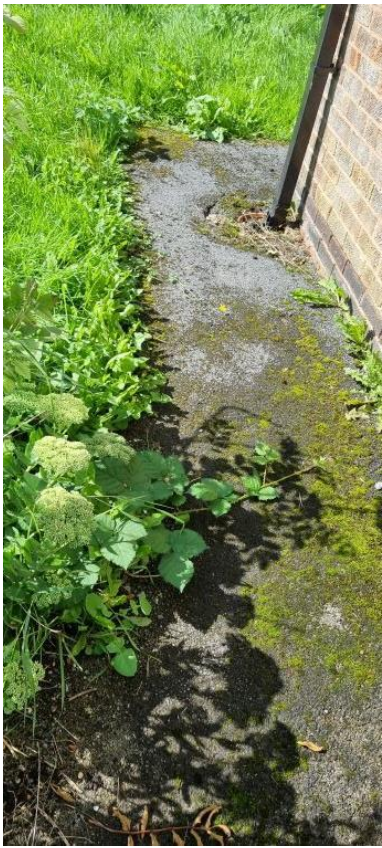
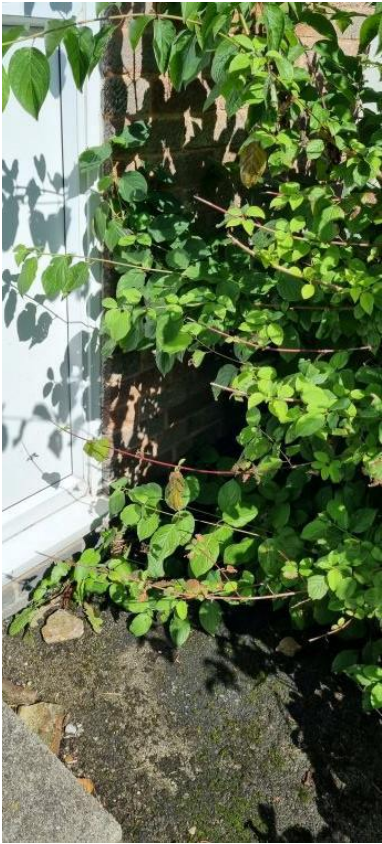
Photo 12

There is weed and plant growth to the rear exit door and pathway which may impede safe egress to the rear as it grows.

Management should ensure that plant and weed growth is cut back and that the pathway is kept clear of moss etc.

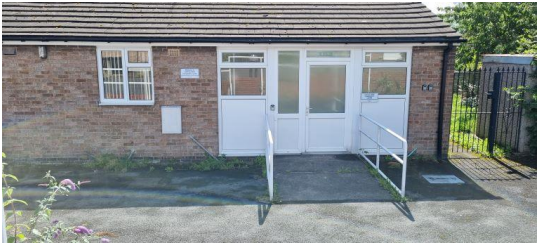
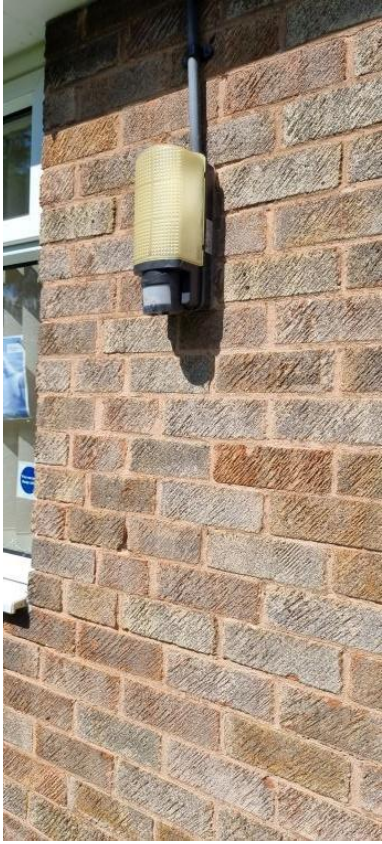
Photo 21

There is no external emergency lighting installed. It was not possible to establish if borrowed lighting is adequate as the assessment was conducted during daylight hours.

External emergency lighting should be installed to front and rear exits.

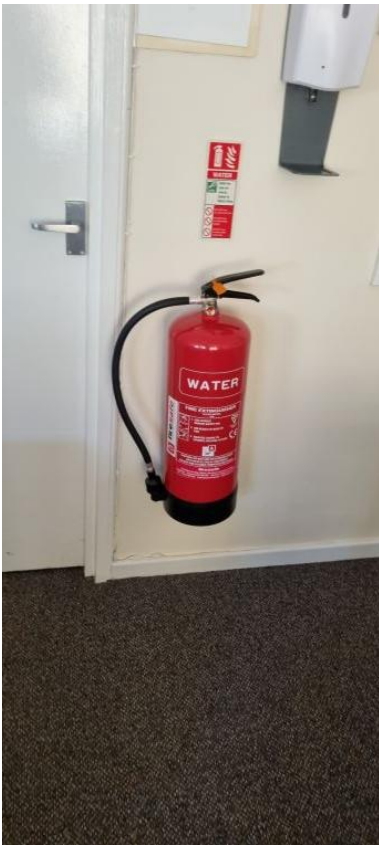
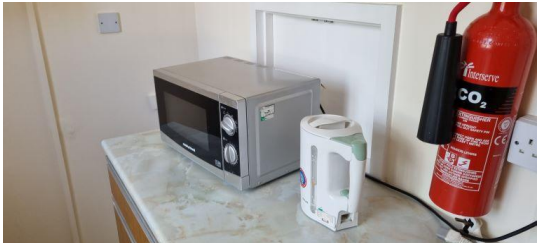
Photo 33

There is 1 x 9L 13A rated Water and 1 x 2KG CO2. BS5306: Part 8 requires that a minimum of 2 x 13A rated units are provided for compartments of up to 400 square metres. In addition, community centre users are unlikely to be trained on the use of FFE and no signage is displayed to state 'only to be used by trained persons'. Extinguishers are serviced annually by Harmony. The last service was completed 02/23.

Management should display signage at fire points to state 'extinguishers should only be used by trained persons'. An addition 6L 13A Water / Foam unit should be installed in order to comply with BS5306: Part 8. The 9L Water unit should be replaced with a 6L 13A Water at unit end of life.
