Futures Fire Risk Assessment

Futures Homescape, 7 - 12 Shipley View: DE7 6ED,
 - UPRN: FB212 / 173524 / QA Approved / Piotr
 Iwan

Futures Homescape, 7 - 12
 Shipley View: DE7 6ED, - UPRN:
 FB212, Fire Risk Assessments,
 Futures Homescape

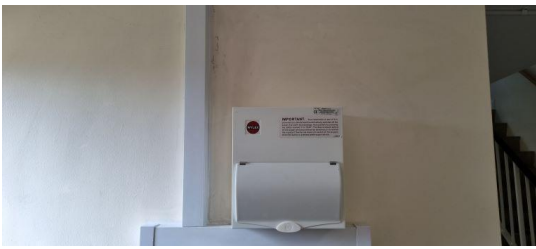
The consumer unit located within the common area is not labelled. It was not possible to confirm the date of the last fixed wiring test. Refer to Policy Principle.

Management should confirm that the fixed wiring has been tested in line with the Policy Principle.

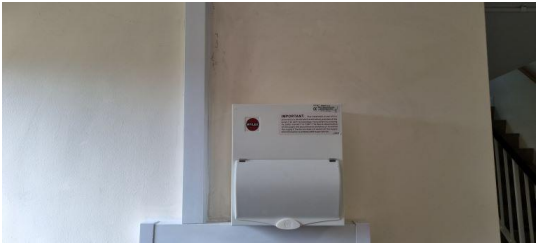
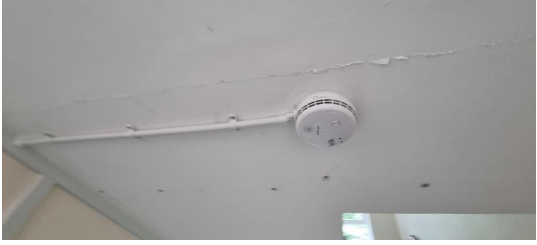
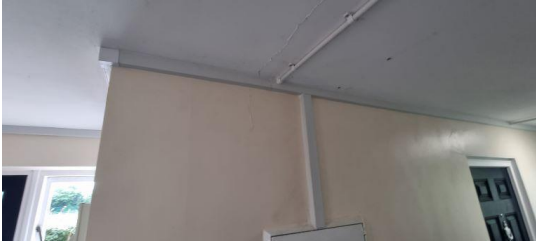
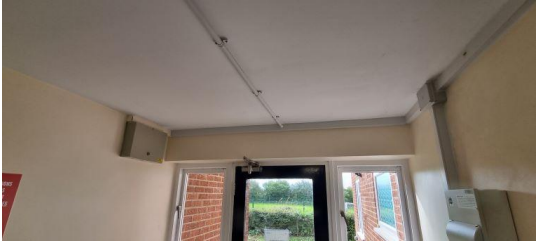
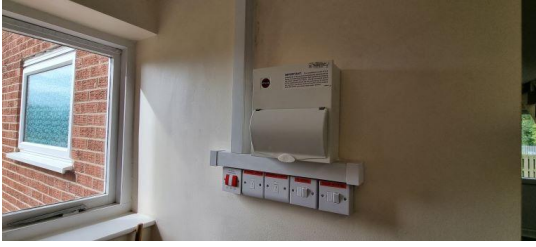
Conduit and cables were noted throughout the common area and it was not possible to confirm that the requirements of Regulation 521.10.202 of the BS 7671 - 18th Edition of The IET Wiring Regulations, which requires all cables to be adequately supported using non-combustible fixings to prevent premature collapse in the event of a fire. The new regulation is not applied retrospectively so any wiring systems fitted before 2019 do not need to be immediately updated. Any new installation or additions and alterations to existing systems, including temporary wiring, have to comply with the regulations.

Management is to consider the requirements of the Regulation 521.10.202 of the BS 7671 - 18th Edition The IET Wiring Regulations which requires all cables to be adequately supported using non-combustible fixings to prevent premature collapse in the event of a fire albeit not retrospective and seek the advice of a suitably qualified competent person or organisation and undertake any remediation identified by the aforementioned competent person or organisation.

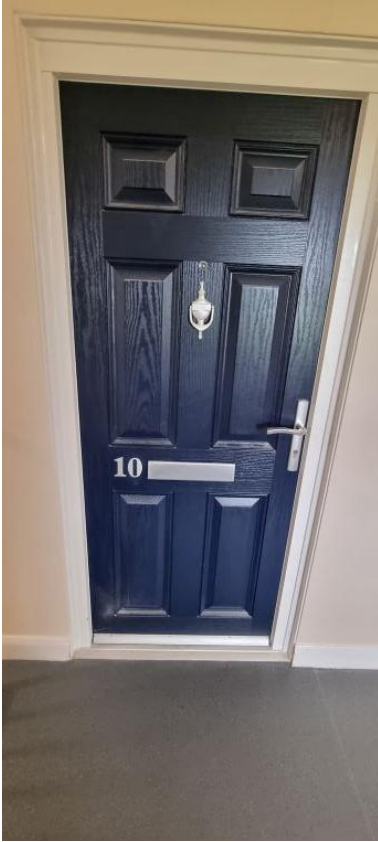
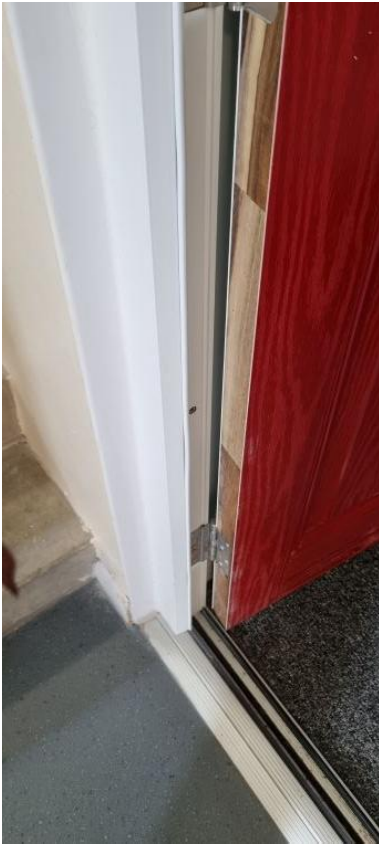
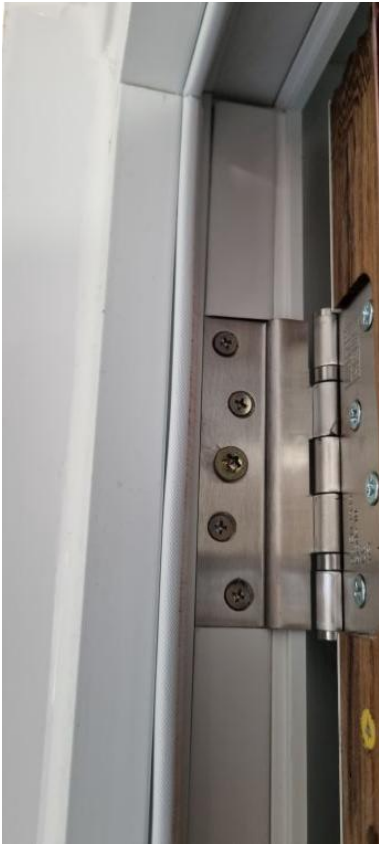
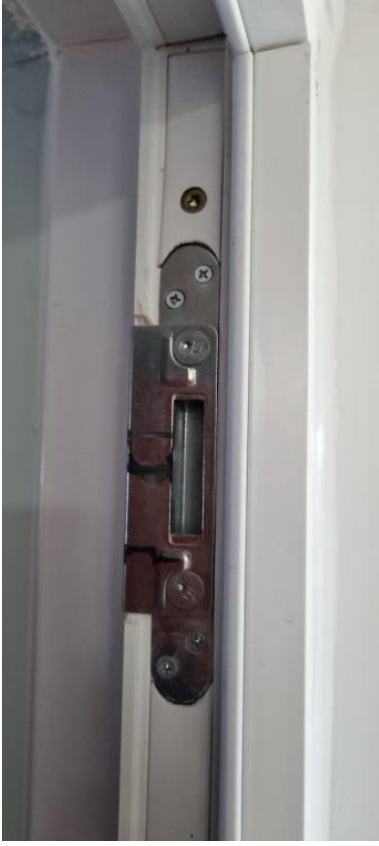
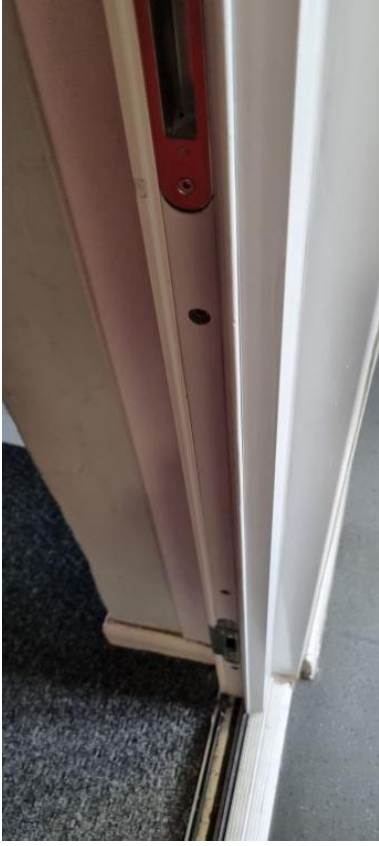
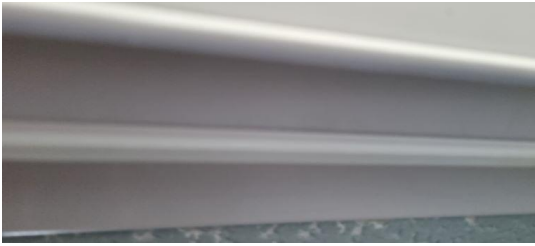
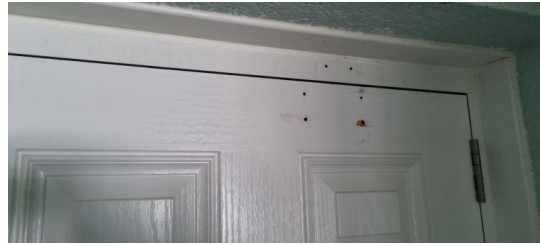
Flat 7 was sampled. The door is labelled to confirm that it is a certified BM Trada fire door to FD60 specification. The door was in good order however the self-closure device has been removed. In addition, it was not possible to establish fire rating or condition of other dwelling doors as no other doors were sampled.

Management should replace the self-closure device to flat 7. Management should also inspect all other dwelling doors to establish fire rating and condition. Where doors do not conform to a minimum of FD30S specification, they should be replaced with certified self-closing fire door sets to a minimum of FD30S specification. Any repairs or installation should only be completed by a certified third-party contractor.

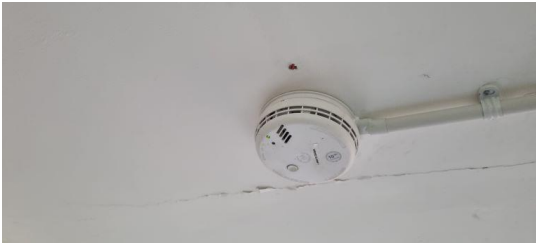
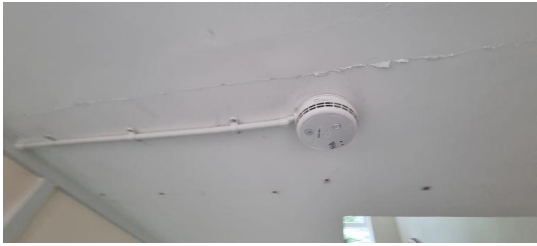
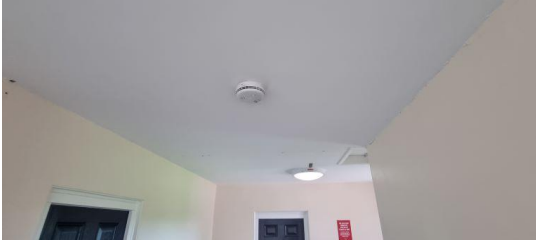
There is no manual fire alarm system however hard wired AFD is installed to common area. "Section 20.4 of the guidance used highlights how in 'general needs' blocks designed to support a 'stay put' policy, it is unnecessary and undesirable for a fire alarm system to be provided. A communal fire detection and alarm system will inevitably lead to a proliferation of false alarms. This will impose a burden on fire and rescue services and lead to residents ignoring warnings of genuine fires. This is dependent on compartmentation within the block.

Responsible person to confirm that the installed alarm system is warranted, appropriate and effective. Depending on the outcome modify system accordingly.

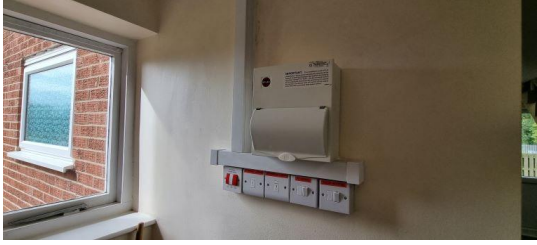
It was not possible to establish the arrangements for silencing and resetting the communal AFD system. The AFD test / silencing switch is located on the first floor landing.

Management should confirm the arrangements for silencing and resetting the communal AFD system and ensure that it is communicated to residents. The AFD switch should be relocated or kept in a lockable enclosure to prevent unauthorised use.

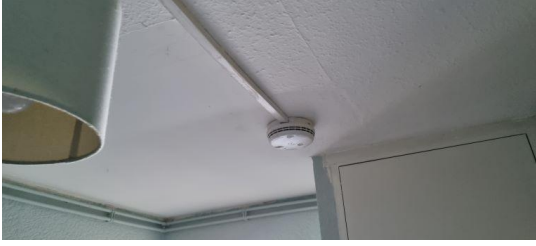
A hard-wired smoke detector is installed to the hallway of the dwelling sampled. It was not possible to establish if detection is installed to other rooms within the dwelling (Type 1 Survey). In addition, it was not possible to establish the level of detection to other flats within the block as no other dwellings were accessible.

Management should ensure that hard-wired smoke / heat detection is installed to all flats within the block, in accordance with BS5389-6:2019 (Grade D1, LD2 smoke alarms). If found not to be, install to this standard. All work to be carried out by a third-party accredited fire alarm company.

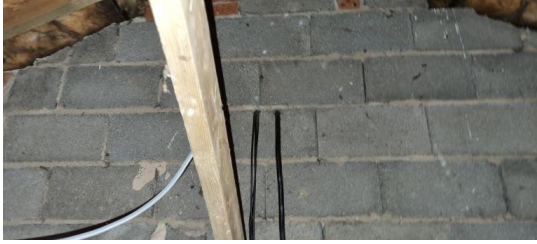
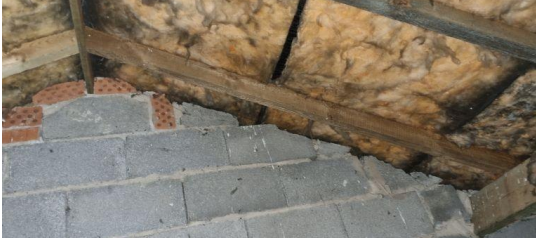
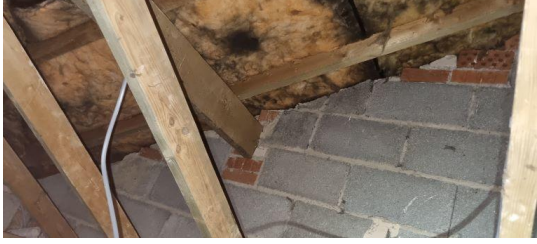
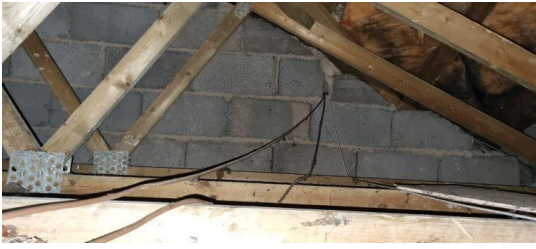
A head and shoulders inspection of the rook space was completed. There are fire break walls fitted however there are gaps between the top of the wall and rafters / insulation material. There are also some gaps to the wall.

Management should ensure that the roof space is adequately fire stopped with fire rated building materials. Any fire stopping work should only be conducted by a certified third-party contractor.

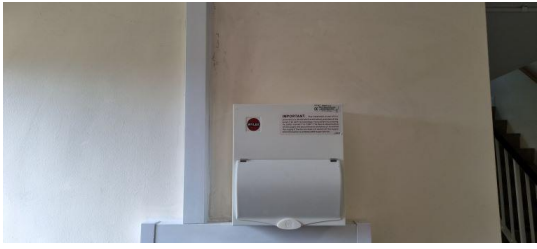
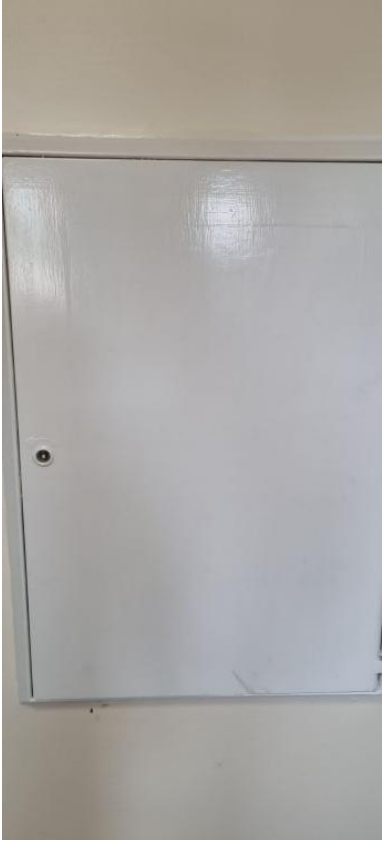
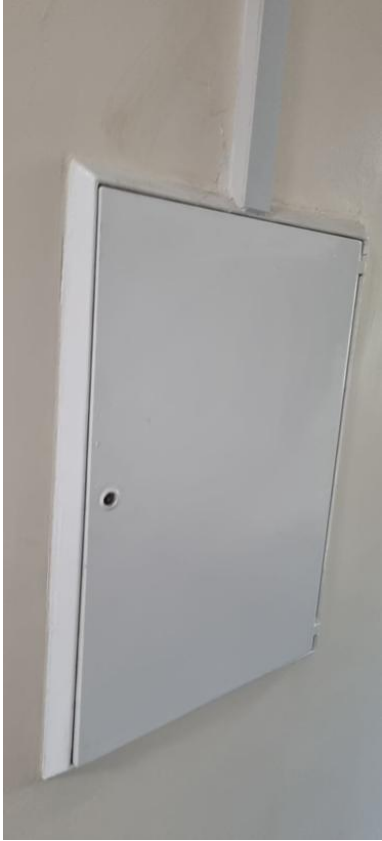
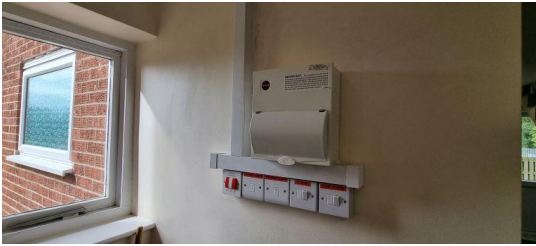
The consumer unit within the common area is not contained within a fire rated cabinet. In addition, there are embedded meter enclosures that were not accessible and it was not possible to establish fire rating or if there any penetrations identified within.

Management should ensure that the consumer unit is enclosed within a fire rated cabinet. Management should confirm fire rating of embedded meter enclosures with a view to replace them with a fire rated type where they are found not to conform. Any penetrations within should be fire stopped with fire rated building materials. Any fire stopping / installations should only be conducted by a certified third-party contractor.
