## Futures Fire Risk Assessment

Futures Homescape, Flats 5-16 The Bank:  
NN1 5JD, - UPRN: PYC002-BLK / 173595 /  
QA Approved / Piotr Iwan

Futures Homescape, Flats 5-16  
The Bank: NN1 5JD, - UPRN:  
PYC002-BLK, Fire Risk  
Assessments, Futures Homescape

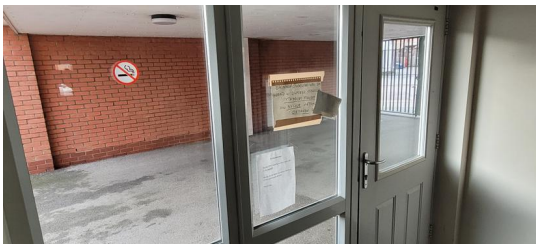
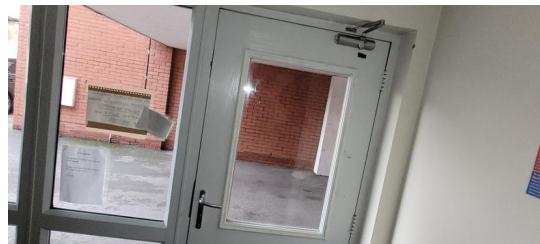
Final exit doors are installed with lever handles to override the magnetic locking mechanisms. It is however noted that the doors are installed with euro cylinder locking mechanisms that require the use of a key to unlock from the inside.

It is recommended that the euro cylinder mechanisms noted are replaced with thumb turn style mechanisms. This is applicable to the front and back doors for the block.

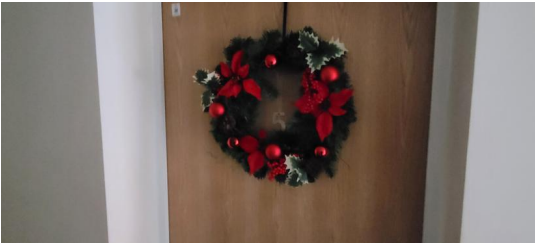
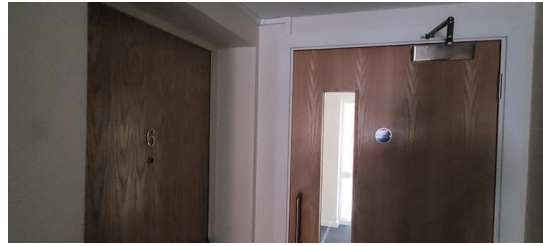
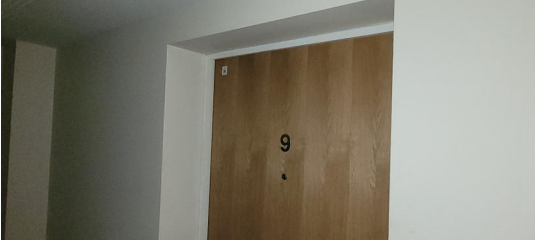
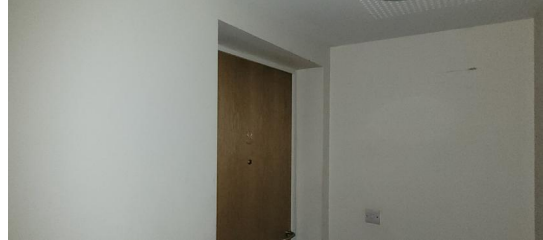
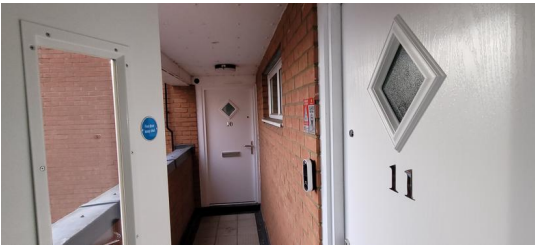
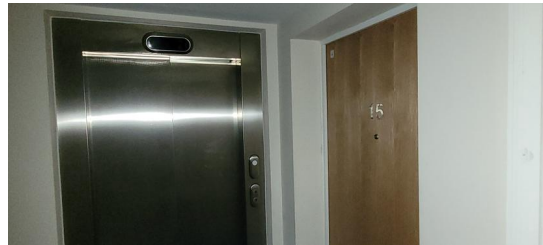
Flat entrance doors appeared to be FD30 fire resisting doors. (NB. - from limited visual inspection, certification not seen; adequacy of installation not confirmed).

No flats available for sample inspection at the time of the assessment.

Management should establish an ongoing programme of rolling checks to flat entrance doors to ensure they are installed with combined intumescent strips/cold smoke seals and positive action self-closing devices.

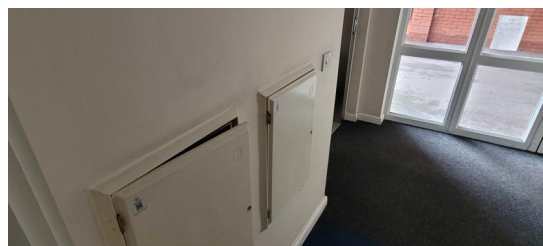
Recessed electricity meters are not enclosed within fire resisting construction. Current enclosures are plastic or fibreglass.

The recessed meter enclosures noted that house the communal distribution board and domestic meters should be upgraded to offer 30 minutes of fire resistance. Alternatively, the enclosures can be installed with 30 minute fire rated overboxes. All penetrating services between compartments should be fire stopped. Remedial works should be completed by a competent third-party accredited contractor.

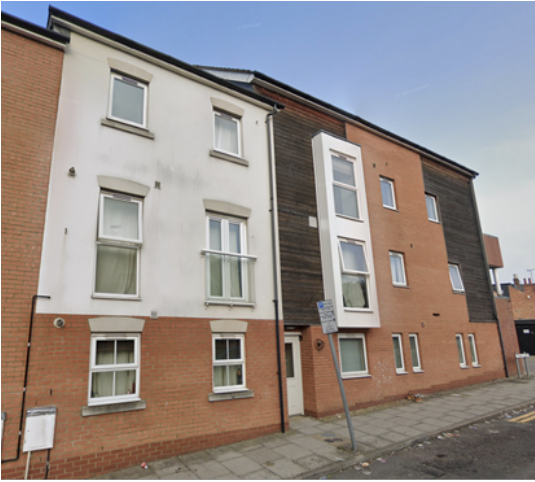
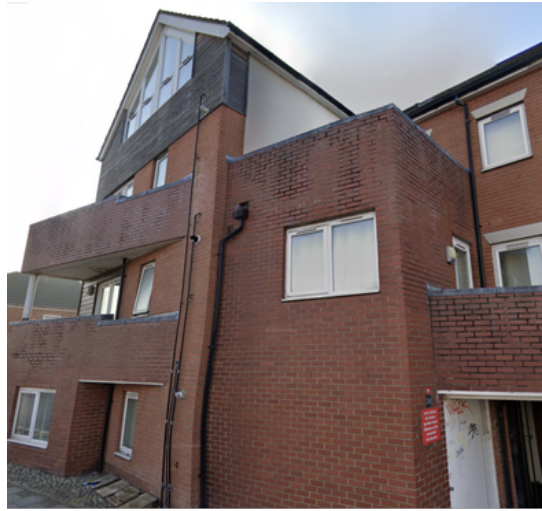
The external walls of the building are constructed from traditional brick and block. There are also noted to be sections of smooth render and timber cladding, both of which are installed over an unknown substrate.

At the time of the assessment the external wall system (including the construction materials used, the presence of balconies and other attachments), could not be confirmed as meeting the functional requirements of the building regulations and should therefore be assessed with a PAS 9980 assessment. The Building manager is to commission an assessment under PAS 9980.
