Futures Fire Risk Assessment

Futures Homeway, Henry Smith House:
NN11 9BP, - UPRN: 1979990 / 171955 /
QA Approved / Piotr Iwan

Futures Homeway, Henry Smith
House: NN11 9BP, - UPRN:
1979990, Fire Risk Assessments,
Futures Homeway

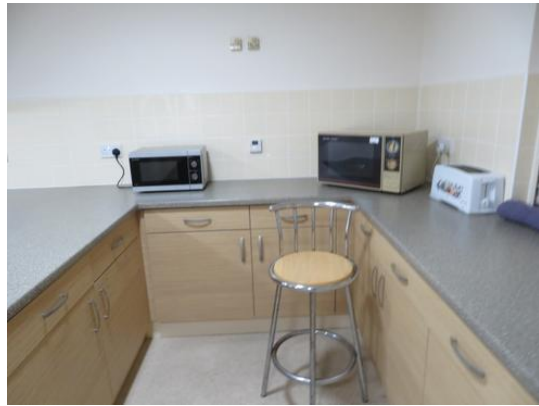
Photo 17

A communal kitchen is located on the ground floor via the communal lounge.

Heat detection noted to be installed to the communal kitchen.

The kitchen was installed with 2no electric ovens, 1no electric hob, 2no microwaves and a toaster. No open flame methods of cooking were noted at the time of the assessment.

A commercial extraction and filtration unit was installed above the ovens. A visual inspection found this to be clean in the drip trays and filters. There was no evidence at the time of the assessment to suggest that the extraction unit is adequately serviced.

The kitchen was noted to be installed with manual fire extinguishers and a fire blanket. See R1.

The kitchen was installed with automatic smoke/heat detection.

To prevent fire from spreading within the duct work it is recommended that the duct work is inspected regularly to identify the level of grease built up within the duct work and when there is an excessive build up the duct work is to be cleaned to reduce the risk of ignition and rapid fire spread. It is recommended that the client ensure regular inspections of filters and ductwork are conducted to check for build ups of combustible materials and annual deep clean are completed.

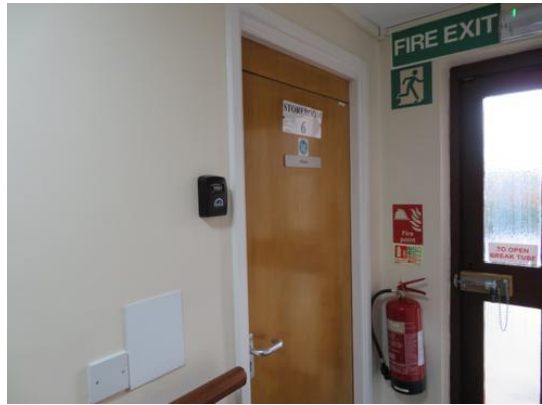
Photo 29

There were multiple non-accessible locations at the time of the assessment. These were noted to be all store cupboards on all floors.

The locked stores noted should be checked for the presence of combustible materials in the presence of sources of ignition.

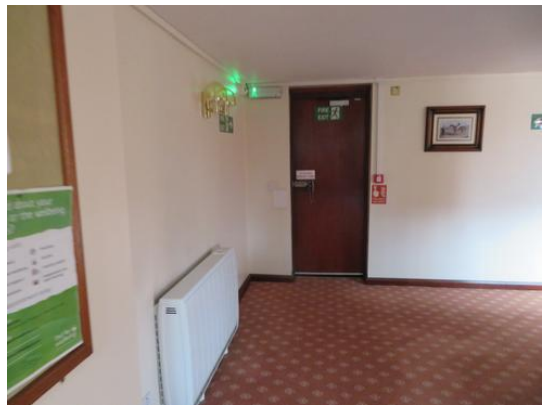
Photo 37

The front entrance doors are installed with lever handles to override the magnetic locking mechanisms.

Emergency exit doors located around the block on the ground floor were all noted to be installed with REDLAM bolts. These are not recommended for locations that are accessed by members of the public.

It is recommended that the REDLAM bolts installed to the final exit doors should be removed and replaced with quick release, non-lockable mechanisms such as push pads/bars or thumb turn mechanisms.

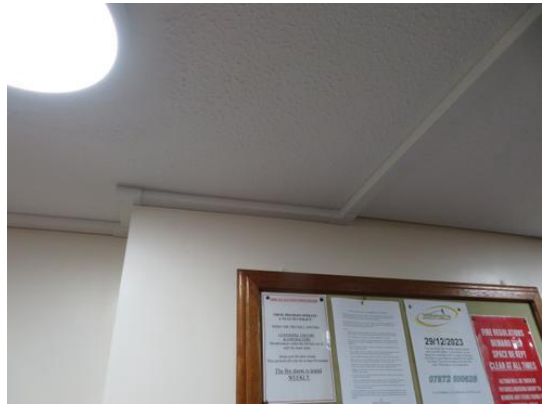
Photo 43

Plastic conduit was noted directly above the front entrance door to the block. It could not be confirmed if wiring within was adequately supported to prevent premature collapse in the event of a fire situation.
