## Futures Fire Risk Assessment

Futures Homescape, Andrews Drive 42-48: NG16 4GG, - UPRN: FB143 / 173558 / QA Approved / Andy Cloke

Futures Homescape, Andrews Drive 42-48: NG16 4GG, - UPRN: FB143, Fire Risk Assessments, Futures Homescape

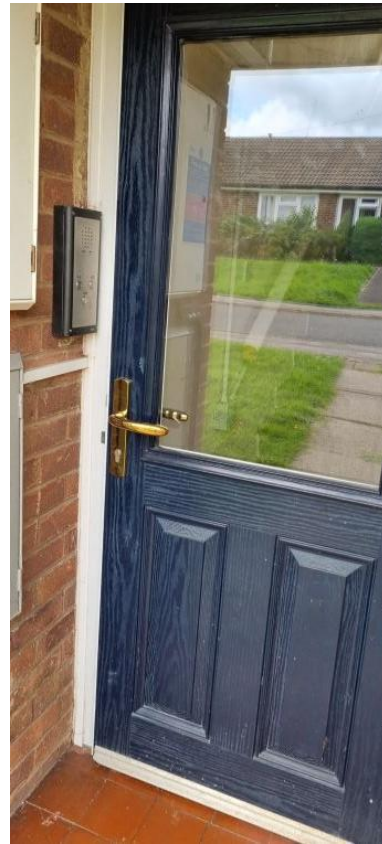
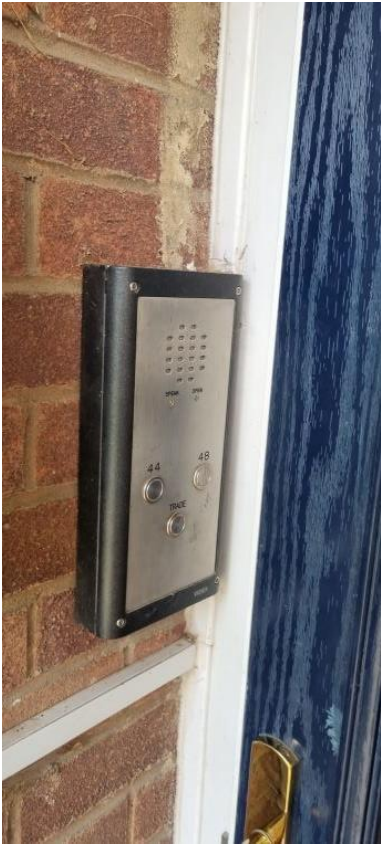
Access to the premise is via standard security lock and intercom with 'Trades' button. The door was accessible at the time of assessment.

Management should liaise with residents and ensure that the entrance is locked when not in use in order to maintain adequate measures of security.

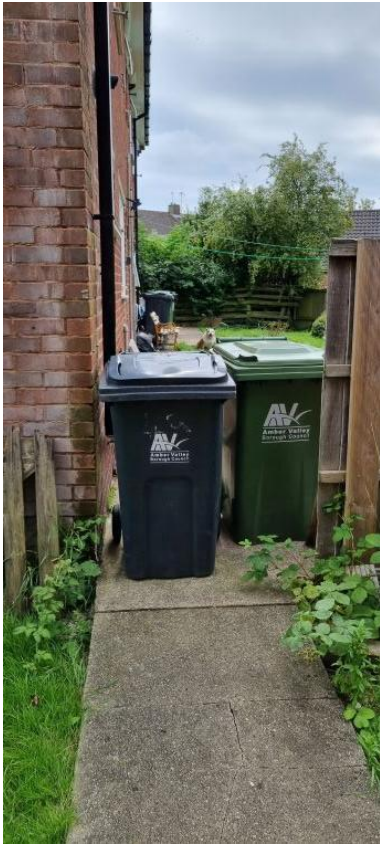
Photo 6

Wheelie bins are located against the building wall to the side / rear of the premise.

Management should ensure that waste bins are located away from the premise wall.

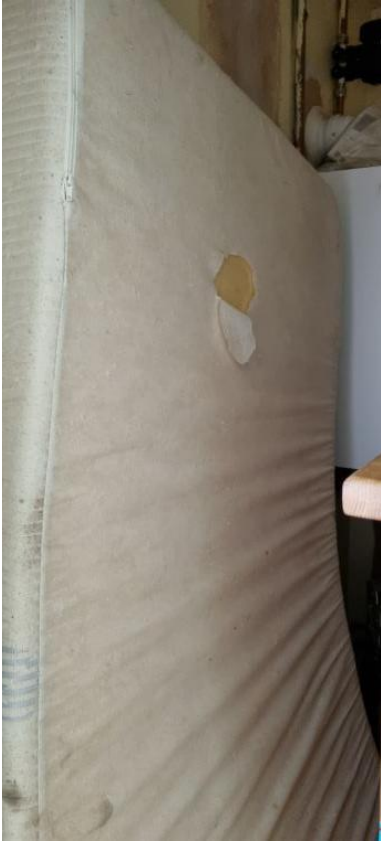
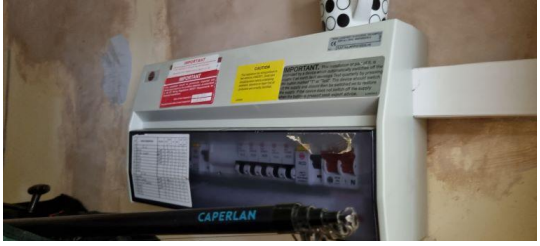
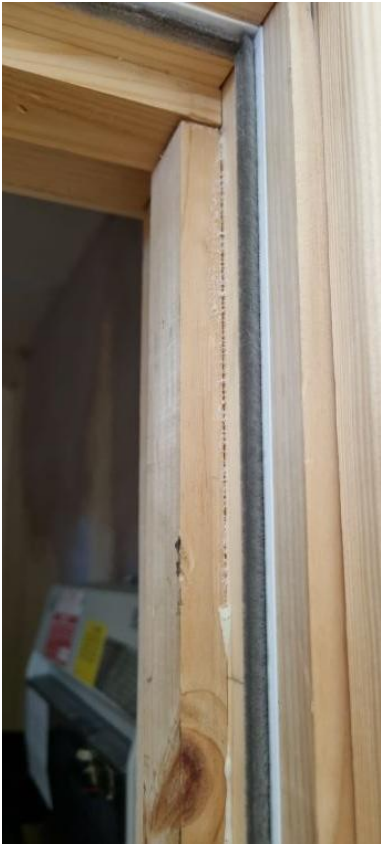
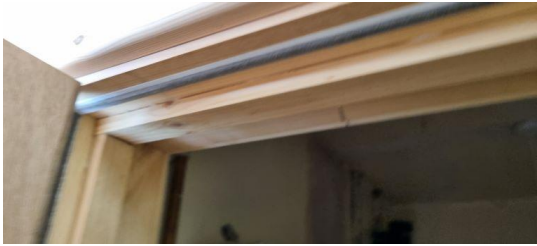
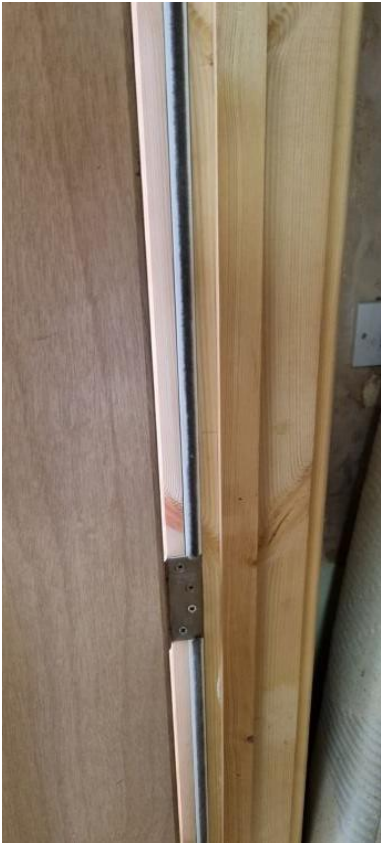
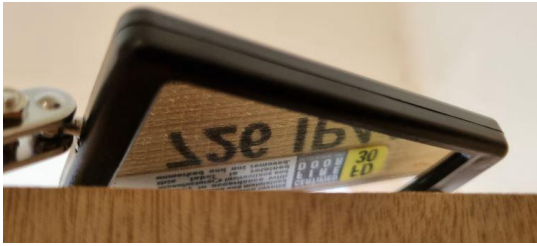
There are cupboards to the top of the stairs which house gas meter / gas boiler and electrical consumer units for dwellings. Combustible materials were stored within and gas infrastructure is stored in the same area as electrical ignition risks. Cupboard doors are labelled to confirm that they are PWL FD30 fire doors. Intumescent strips are fitted and doors were in sound condition.

Management should liaise with residents and ensure that combustible materials are removed. The electrical consumer unit should either be relocated or contained within a fire rated cabinet.

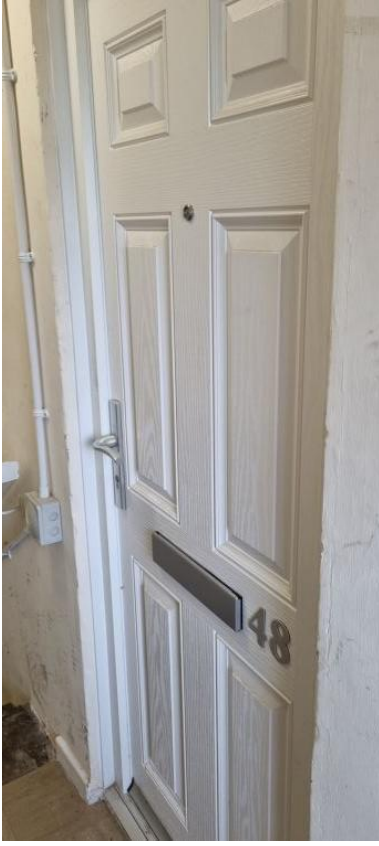
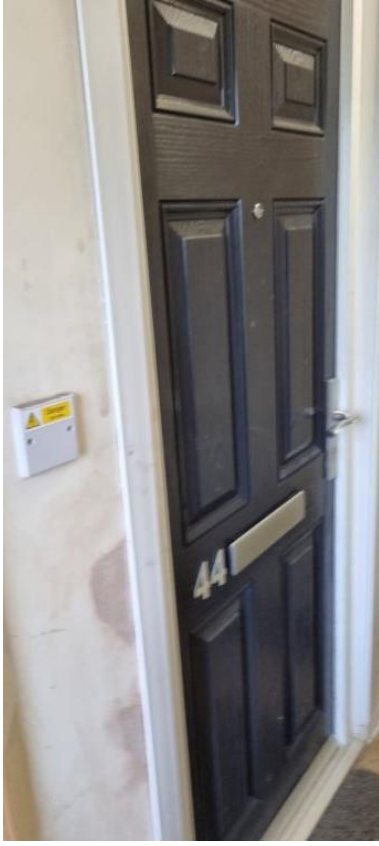
It was not possible to establish fire rating or condition of dwelling doors as no flats were accessible at the time of assessment.

Management should inspect dwelling doors to flats 19 and 23 to establish fire rating and condition. Where doors do not conform to FD30 specification, they should be replaced with a certified self closing fire door set to a minimum of FD30 specification. Any installation or repairs should only be conducted by a certified third-party contractor. Doors that egress directly to open air and have no passing fire risk are not required to be fire rated.

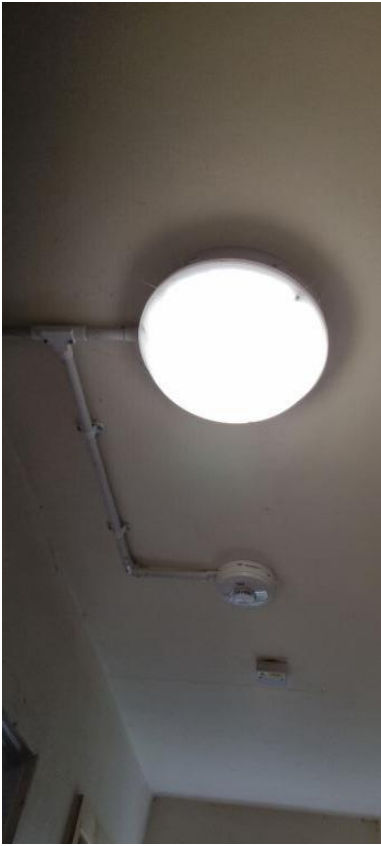
Photo 21

There is no manual fire alarm system however hard wired AFD is installed to common area. "Section 20.4 of the guidance used highlights how in 'general needs' blocks designed to support a 'stay put' policy, it is unnecessary and undesirable for a fire alarm system to be provided. A communal fire detection and alarm system will inevitably lead to a proliferation of false alarms. This will impose a burden on fire and rescue services and lead to residents ignoring warnings of genuine fires. This is dependent on compartmentation within the block. Sounders present within common area which are presumed to be interlinked with the flats."

Responsible person to confirm that the installed alarm system is warranted, appropriate and effective. Depending on the outcome modify system accordingly.

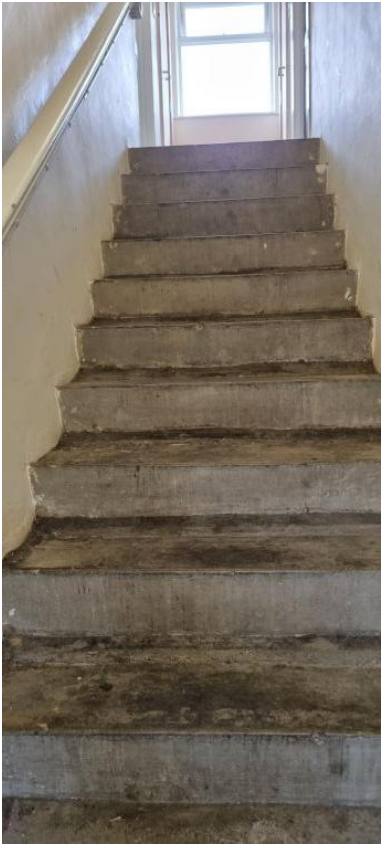
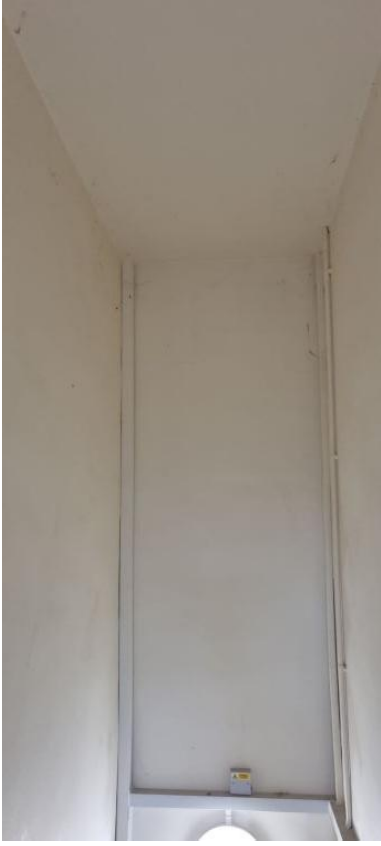
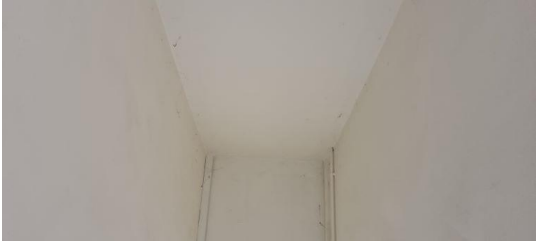
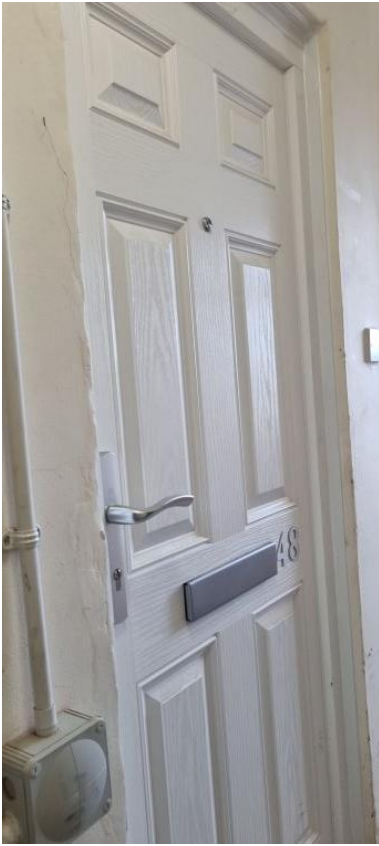
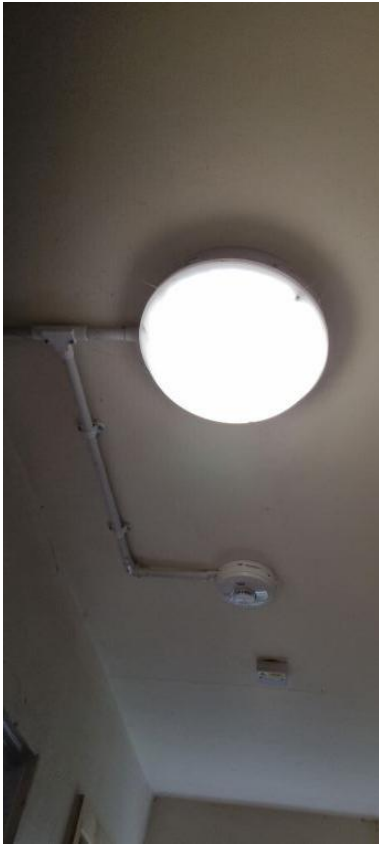
Walls are solid plastered with emulsion painted finish. The ceiling is emulsion painted plaster. Floors and stairs are of solid construction. Conduit is installed to the common area; it was not possible to establish if there are any penetrations behind.

Management should inspect behind conduit. Any penetrations identified should be fire stopped with fire rated building materials. Fire stopping should only be conducted by a certified third-party contractor.

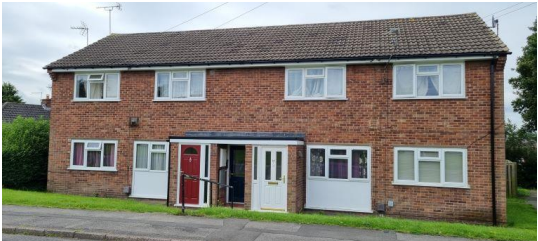
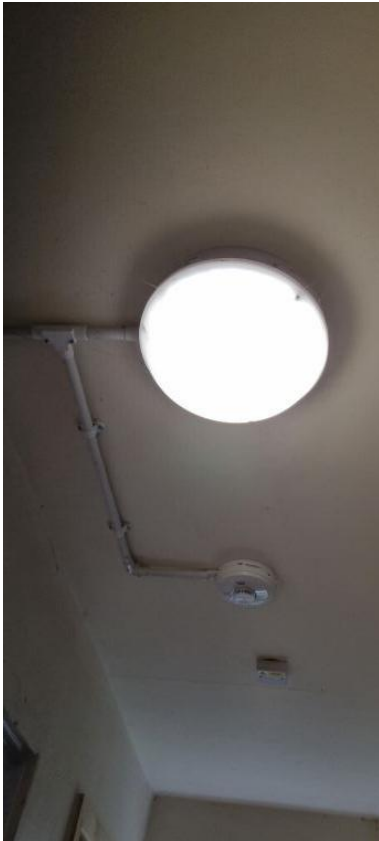
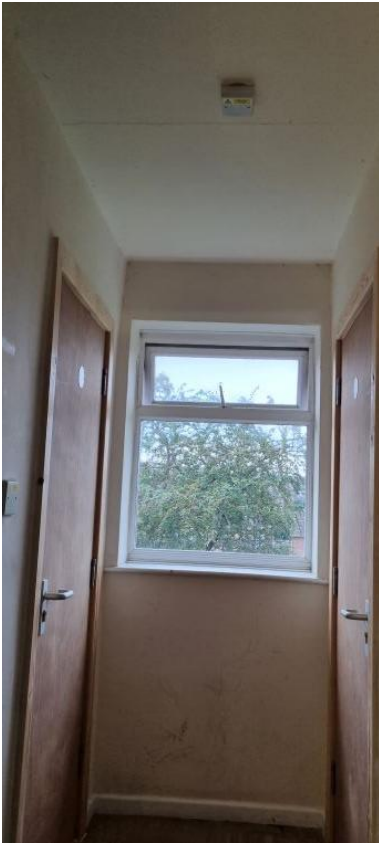
There is no access hatch within common areas. It was not possible to establish the level of compartmentation within the roof space.

Management should inspect the roof space to ensure that is an adequate fire break for the size of compartment in accordance with building regulations. Any penetrations identified should be fire stopped using fire rated building materials. Any work required should only be conducted by an approved third-party contractor.

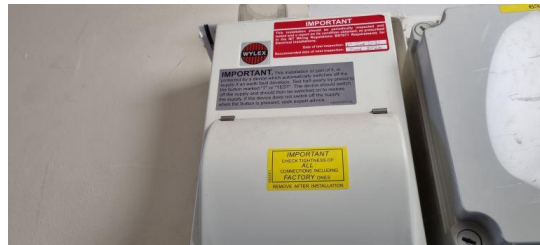
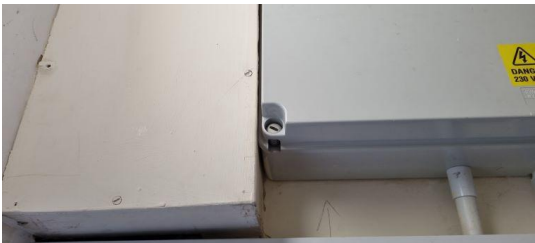
Electrical meter / gas meter cupboards have fire rated doors fitted however, electrics are stored within the same cupboard as gas infrastructure. Refer to G1. The consumer unit within the ground floor entrance hallway is not contained within a fire rated cabinet. In addition, there is a plywood box which appears to have cables / conduit running in.

Management should ensure that the consumer unit and any other electrical ignitions risks are contained within fire rated cabinets / enclosures. Any work required should only be completed by a certified third-party contractor.
