Futures Fire Risk Assessment

Futures Homeway, Flats 1-4 Drake Close: NN11 4LU, - UPRN: 1710000 / 171913 / QA Approved / Jack McLinden

Futures Homeway, Flats 1-4
Drake Close: NN11 4LU, -
UPRN: 1710000, Fire Risk
Assessments, Futures
Homeway

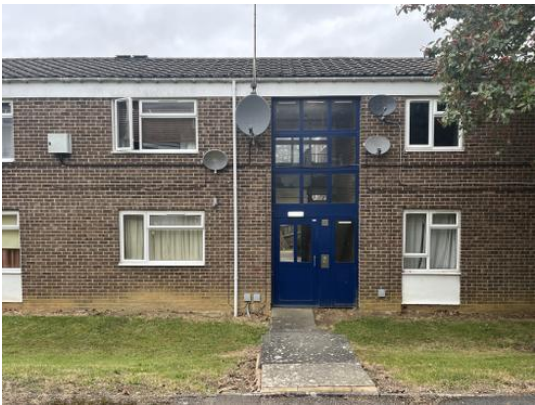
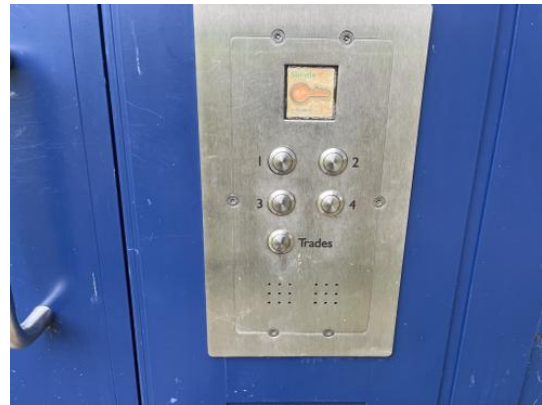
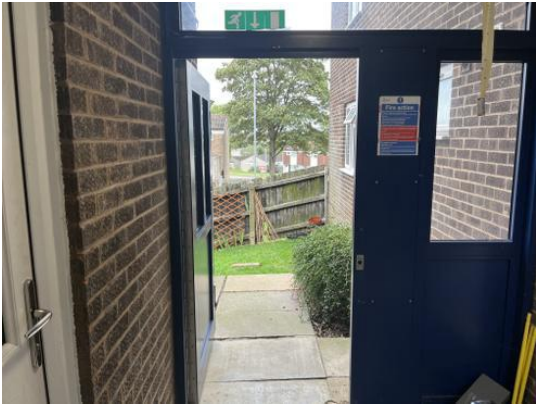
The block is installed with an access control system and self closing entrance doors.

The access control system was not working at the time of the assessment resulting in the block entrance door at the front of the block being open access.

The rear entrance door to the block was noted to be wedged open at the time of the assessment.

Block entrance doors must remain closed at all times when not in use. Residents should be informed that they are not to wedge doors open. Regular checks should be conducted to ensure compliance.

The access control system to the block should be repaired to ensure it is in full working order.

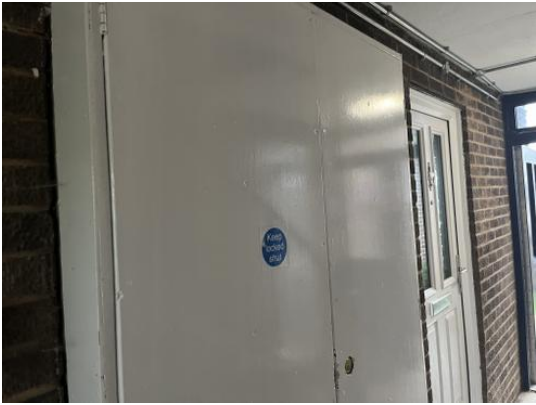
Photo 9

The electrical intake cupboard could not be accessed at the time of the assessment due to non-standard keys being required.

The client should access the electrical intake cupboard to check for the presence of combustible materials within close proximity of electrical sources of ignition.

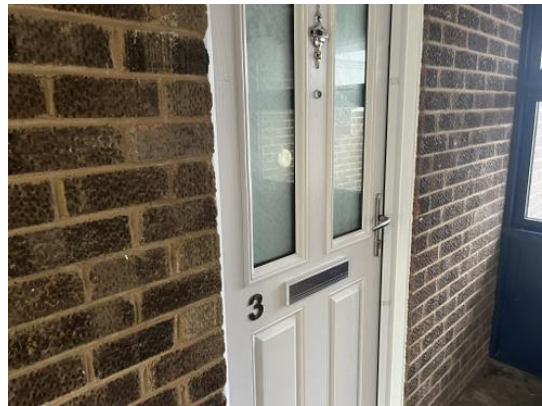
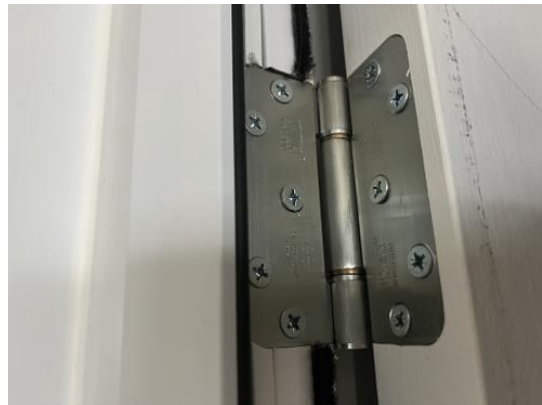
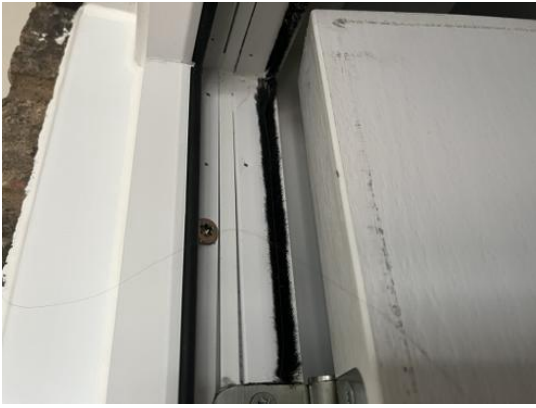
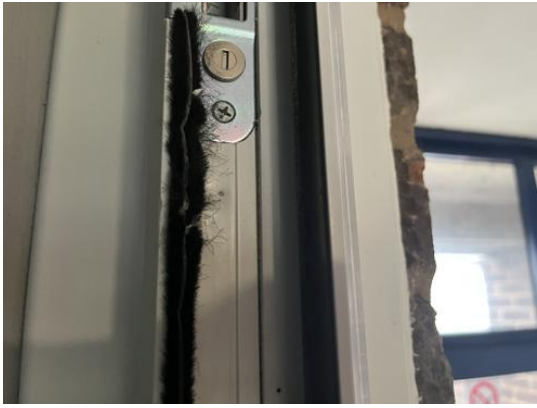
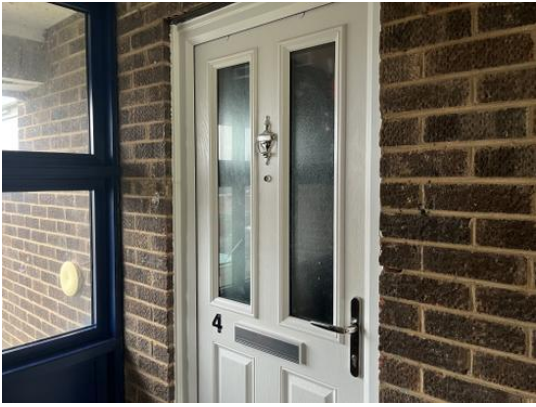
Flat entrance doors were seen to be composite doors. (NB. - from limited visual inspection, certification not seen; adequacy of installation not confirmed).

Flat 3 entrance door was sample inspected at the time of the assessment. The door appeared to be a composite door with a uPVC or composite frame. A concealed door closer was installed to the door capable of closing the door fully from all angles.

As flat entrances have been fitted with composite doorsets, these should have test evidence demonstrating they meet the performance requirement in Building Regulations guidance for fire resistance and smoke control from the flat side only. Management should confirm that suitable fire door test certificates are held and that these relate to the doors fitted. If adequacy cannot be confirmed it may be necessary for doorsets to be replaced under a risk-based programme.

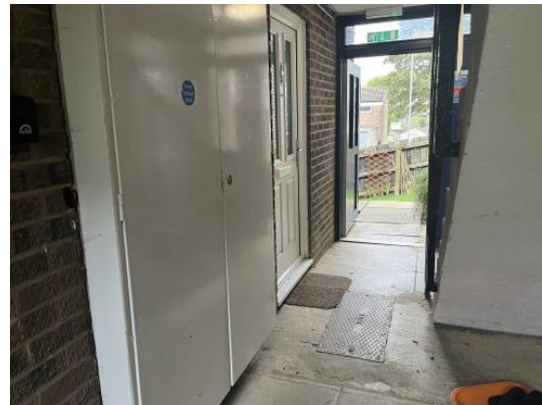
Photo 24

The electrical intake cupboard did not appear to be adequately fire resisting. The cupboard was not available for full inspection at the time of the assessment due to non-standard keys being required.

The client should fully inspect the electrical intake cupboard to determine its fire resistance. The cupboard should meet a minimum of 30 minutes fire resistance. If the cupboard does not meet 30 minutes fire resistance it should be upgraded to achieve this level by a competent contractor. This should include fire stopping of all penetrating services.
