Futures Fire Risk Assessment

Futures Homeway, Flats 41-45
Fallowfields: NN6 7GA, - UPRN: FB258 /
171940 / QA Approved / Andy Cloke

**Futures Homeway, Flats 41-45
Fallowfields: NN6 7GA, - UPRN:
FB258, Fire Risk Assessments,
Futures Homeway**

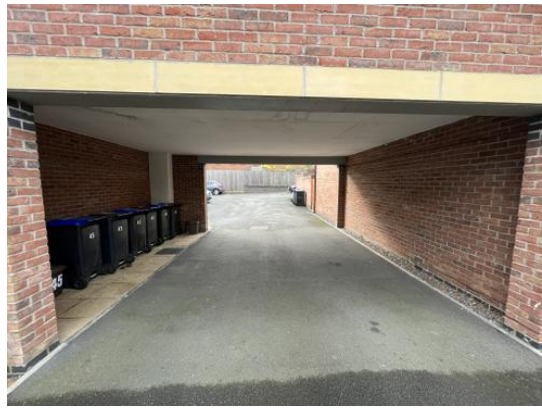
Photo 8

At the time of the inspection, domestic wheelie bins were seen to be stored in the undercroft area that leads to the rear car park.

The wheelie bins noted should be relocated away from the building a minimum of 2 meters. Ideally bins should be placed in a secure bin store. Regular checks should be conducted by the client to ensure that bins remain away from the building in their designated storage area.

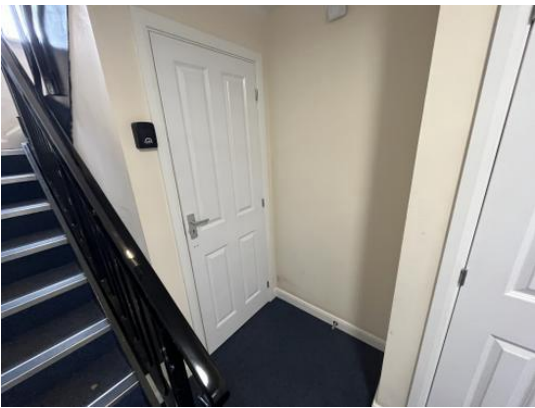
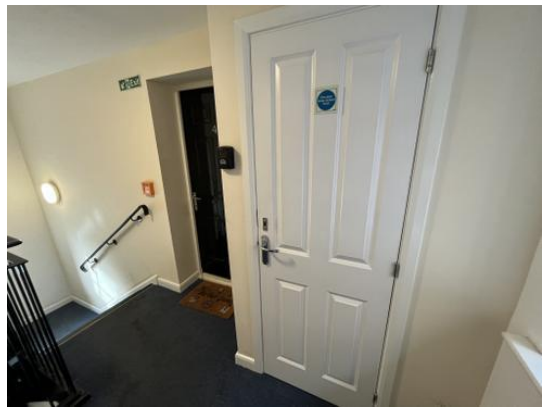
No combustible materials noted close to sources of ignition at the time of the assessment.

The under stairs cupboard and 1st floor riser could not be checked at the time of the assessment due to non-standard keys being required.

The areas noted should be checked to ensure combustible materials are not being stored in the vicinity of sources of ignition.

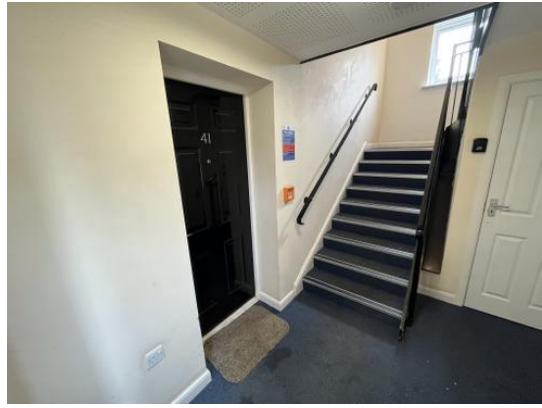
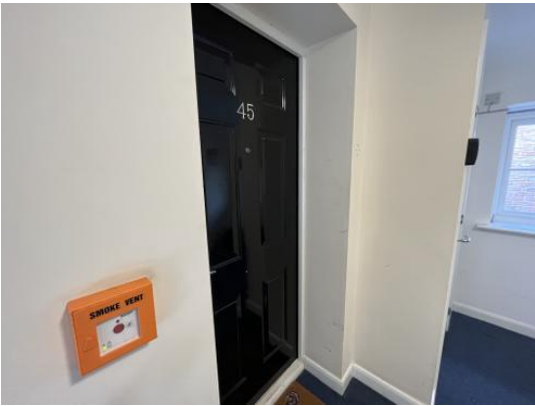
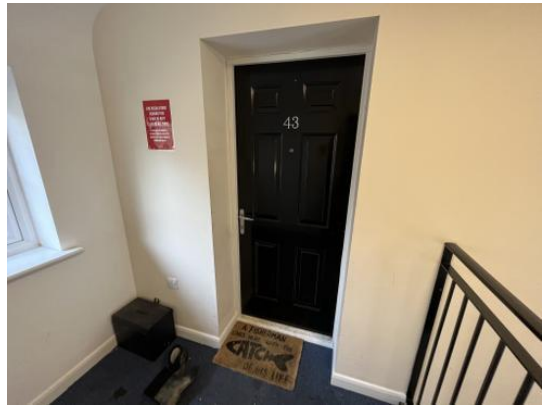
Flat entrance doors appeared to be timber fire doors. (NB. - from limited visual inspection, certification not seen; adequacy of installation not confirmed).

No flats available for sample inspection at the time of the assessment.

Management should establish an ongoing programme of rolling checks to flat entrance doors to ensure they are installed with combined intumescent strips/cold smoke seals and positive action self-closing devices.

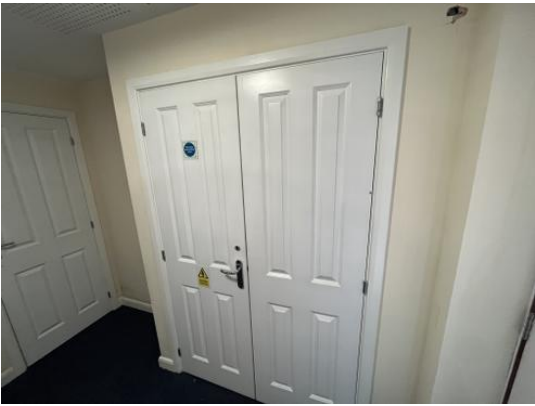
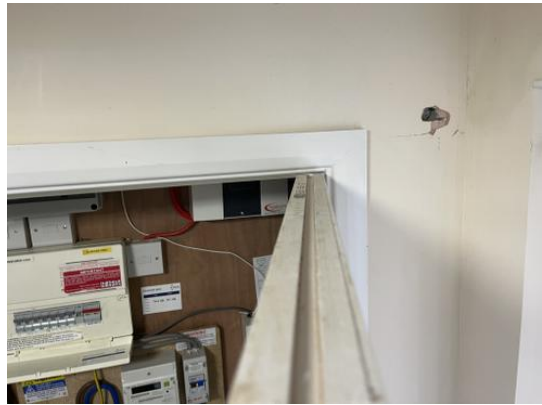
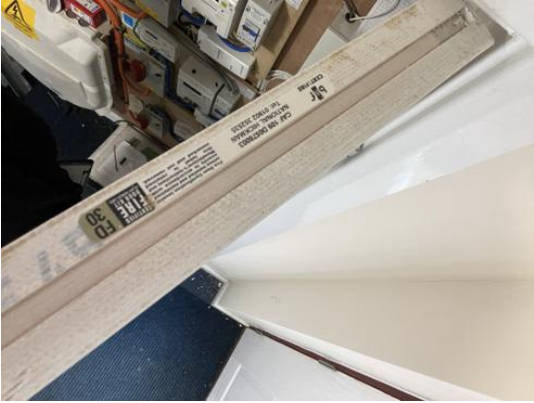
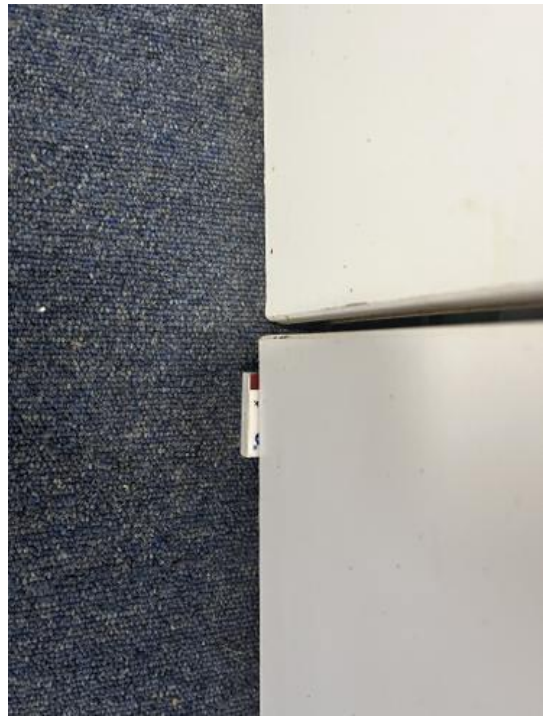
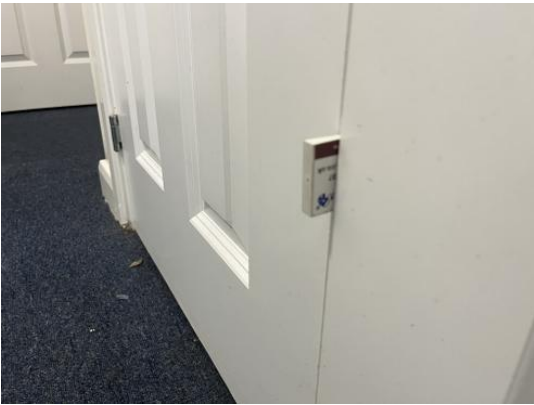
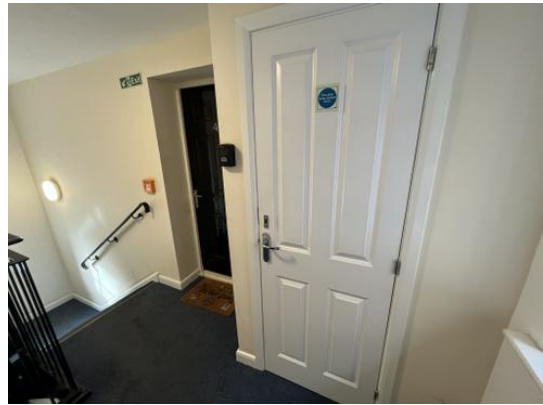
Communal fire doors were noted to be 44mm thick solid core timber fire doors.

The electrical intake cupboard door was missing multiple sections of combined intumescent strip & cold smoke seal. There were also noted to be excessive threshold, meeting and perimeter gaps to the doors. The door was also found to be unlocked at the time of the assessment.

The cupboard under the stairs and first floor riser cupboard were not accessible at the time of the assessment due to non-standard keys being required.

The doors to the electrical intake cupboard should be repaired/adjusted to reduce the perimeter, threshold and meeting gaps to within acceptable tolerances. Remedial works should be completed by a competent third party accredited contractor.

The entire combined intumescent strip and cold smoke seal installed to the electric intake cupboard doors should be replaced. This is to ensure compatibility is maintained when replacing the missing sections.

The electricity intake cupboard should remain locked shut at all times when not in use. Regular checks should be conducted to ensure compliance.

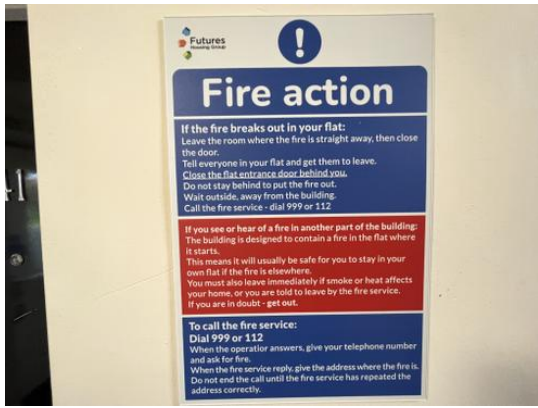
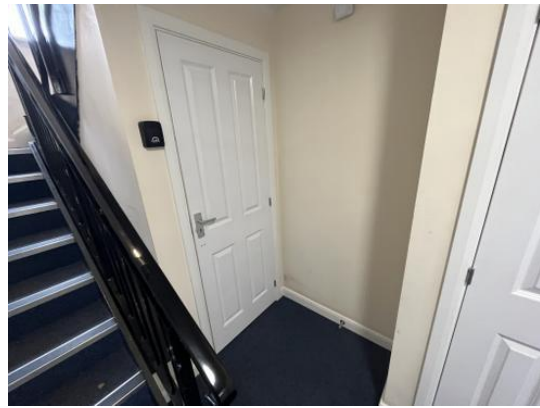
A fire action notice was installed to the common areas of the block denoting a 'Stay Put' evacuation strategy.

The fire door under the stairs was no installed with 'Fire Door - Keep Locked Shut' signage.

Fire door signage should be installed as noted in O1 to the door under the stairs.

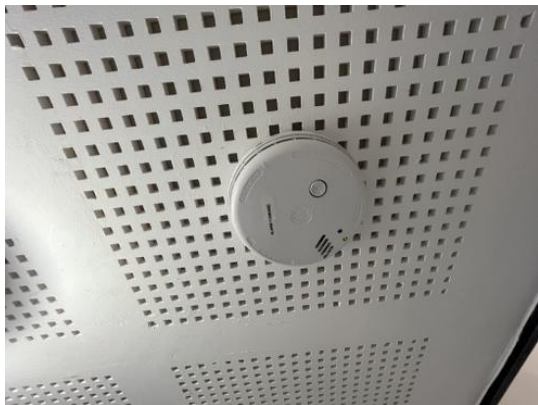
Photo 31

A grade D smoke detector was installed to the ground floor lobby.

This building operates a 'Stay Put' evacuation strategy. There is no requirement for any form of smoke or fire alarm to be installed in the communal areas and this may lead to confusion of residents causing them to evacuate a place of safety and enter a hazardous area. It is recommended that the Grade D smoke detector noted is removed as soon as is reasonably practicable.

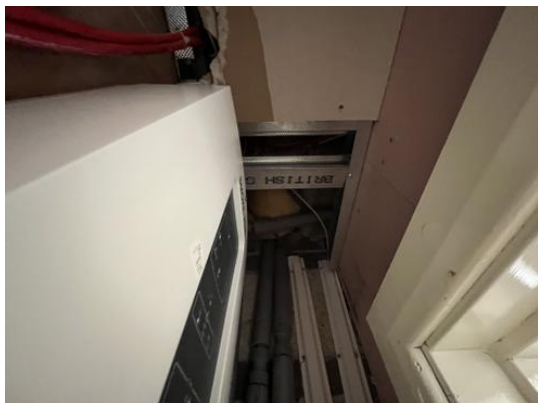
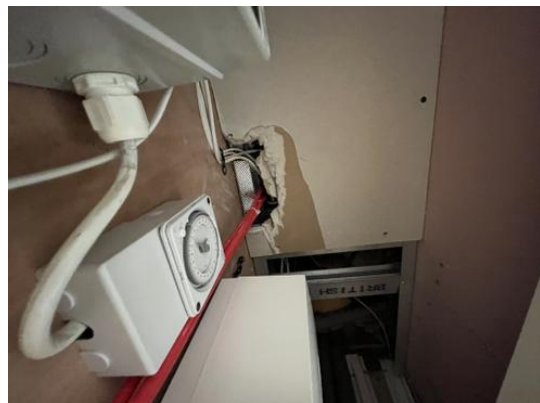
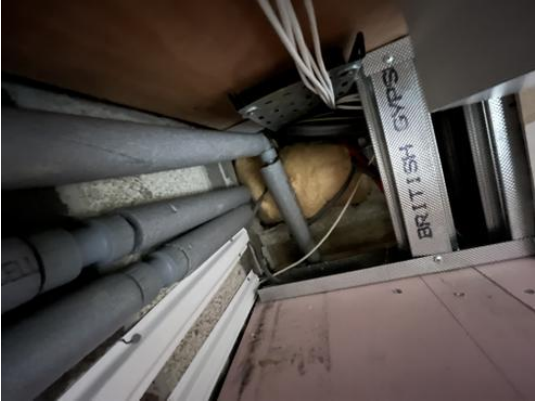
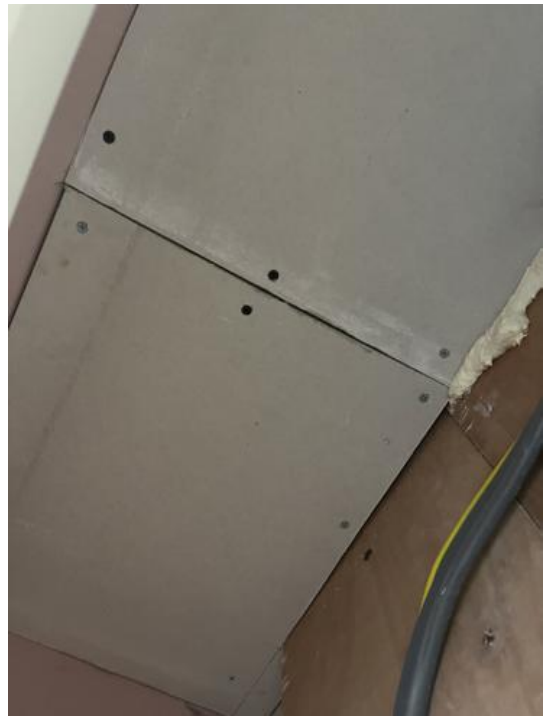
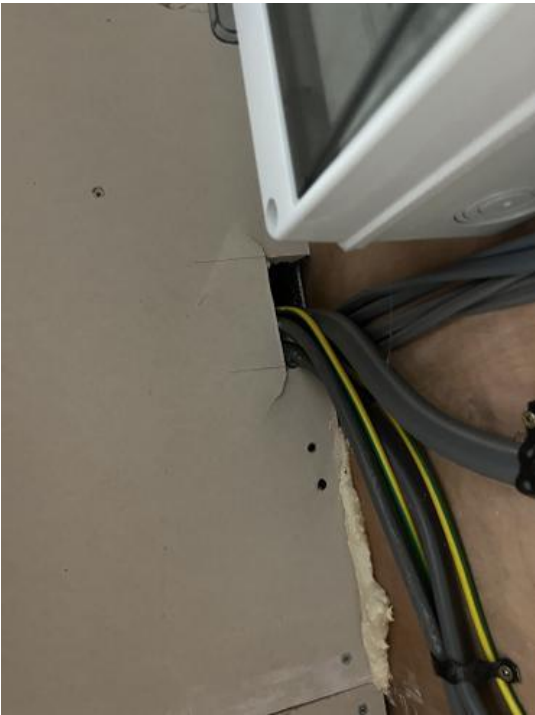
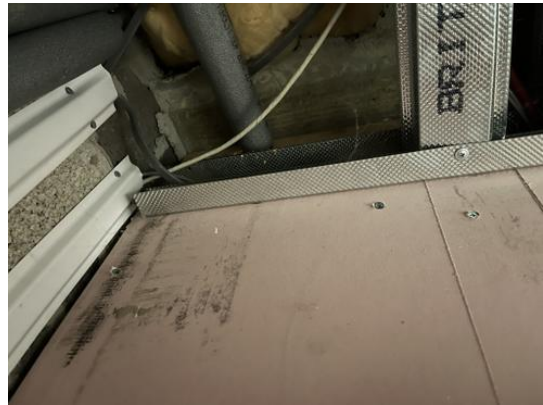
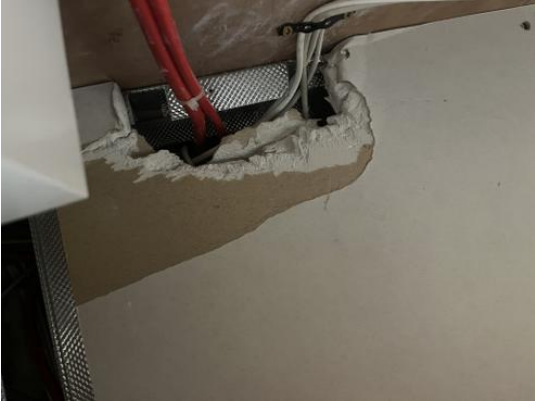
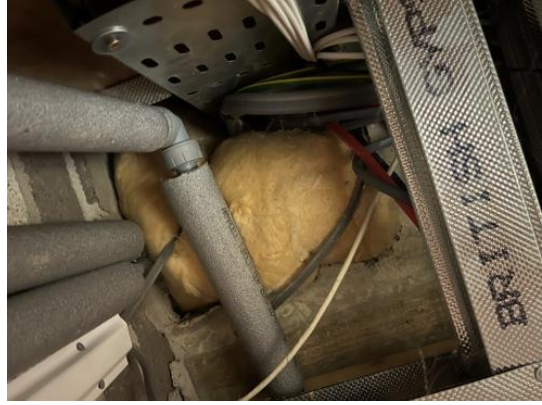
The electrical intake cupboard was not found to be adequately fire resisting or fire stopped. Compartment walls were not found to be enclosed or fire resisting with large holes in construction seen.

The cupboard under the stairs and 1st floor riser cupboard could not be checked at the time of the assessment due to non-standard keys being required.

The areas not accessed should be checked to ensure they are adequately fire resisting for a minimum of 30 minutes with all penetrating services fire stopped. Any remedial works required should be completed by a competent third party accredited contractor.
