Futures Fire Risk Assessment

Futures Homescape, Community Centre
 Connaught Court community centre: DE55 7EJ, -
 UPRN: 27 / 173536 / QA Approved / Andy Cloke

Futures Homescape,
 Community Centre Connaught
 Court community centre: DE55
 7EJ, - UPRN: 27, Fire Risk
 Assessments, Futures
 Homescape

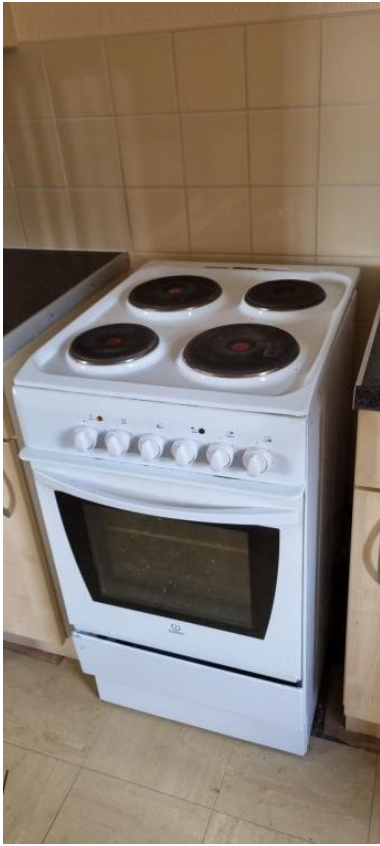
Photo 8

There is an electrical cooker within the community centre kitchen. It was not possible to establish how often the kitchen is used or what rules are in place for cooking etc.

Management should consider removing the electrical cooker in favour of a microwave only if cooking is not frequent. Where the cooker is to remain it is advisable that it is only used for low risk activities and that high risk (deep fat frying etc) is prohibited. Rules for the use of the kitchen should be disseminated to users.

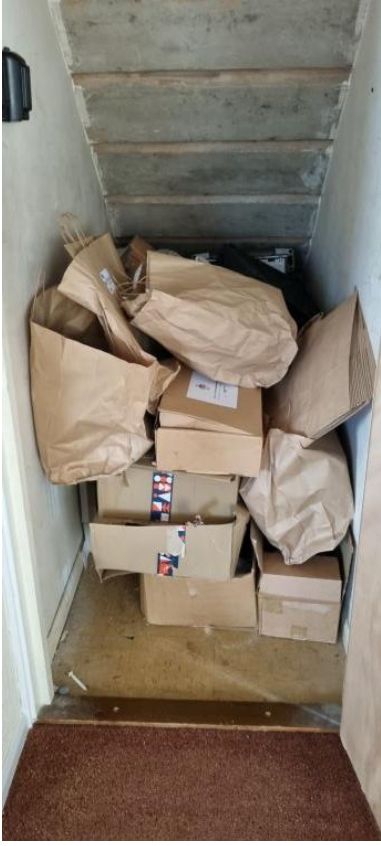
Photo 9

No combustible materials in proximity of ignition risks however, combustible materials are stored in an understairs cupboard.

Management should remove items. Combustibles should not be stored under stairs as this is a major fire hazard.

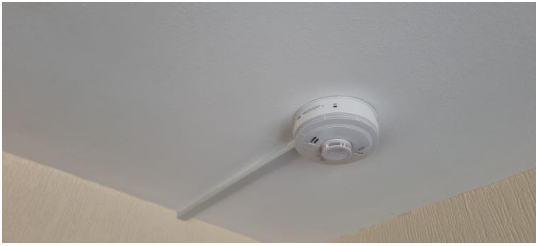
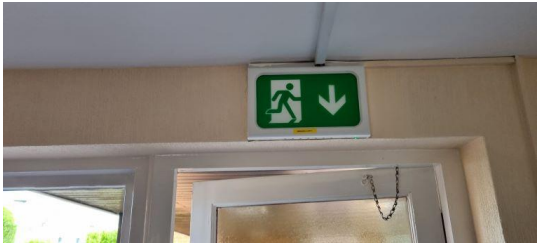
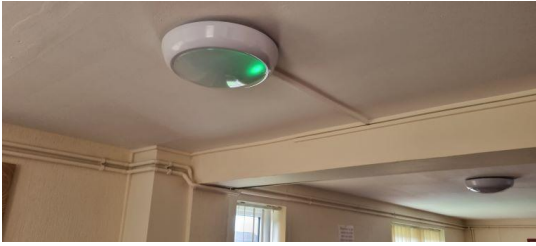
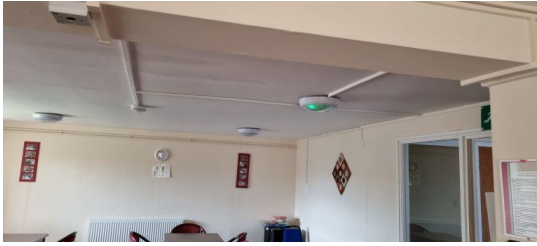
Conduit was noted to the sitting room and foyer. It was not possible to confirm that the requirements of Regulation 521.10.202 of the BS 7671 - 18th Edition of The IET Wiring Regulations, which requires all cables to be adequately supported using non-combustible fixings to prevent premature collapse in the event of a fire. The new regulation is not applied retrospectively so any wiring systems fitted before 2019 do not need to be immediately updated. Any new installation or additions and alterations to existing systems, including temporary wiring, have to comply with the regulations.

Management is to consider the requirements of the Regulation 521.10.202 of the BS 7671 - 18th Edition The IET Wiring Regulations which requires all cables to be adequately supported using non-combustible fixings to prevent premature collapse in the event of a fire albeit not retrospective and seek the advice of a suitably qualified competent person or organisation and undertake any remediation identified by the aforementioned competent person or organisation.

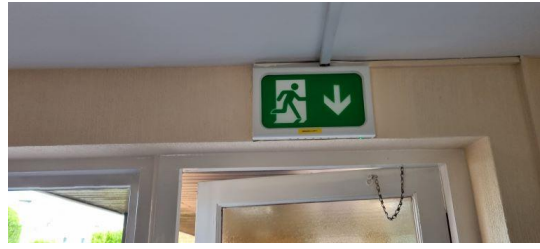
Photo 30

An illuminated sign is installed above the exit. A fire door sign is attached to the electrical intake cupboard. No Fire Action Notice is displayed.

Management should display a completed fire action notice with the centre to outline what action are required in the event of an emergency and where to assemble etc.

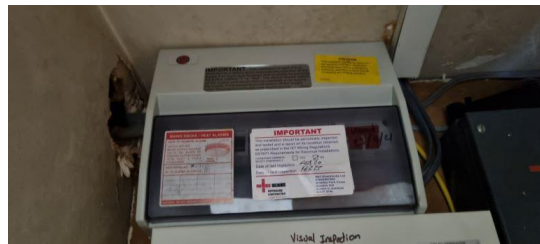
Photo 38

Penetrations were identified within the electrical intake cupboard.

Management should ensure that penetrations are fire stopped with fire rated building materials. Fire stopping should only be completed by a certified third-party contractor.

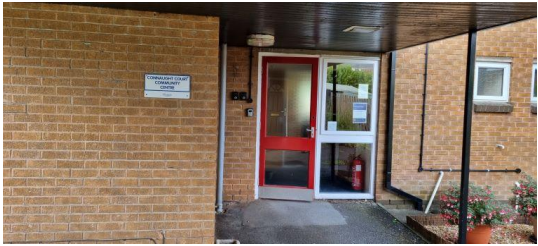
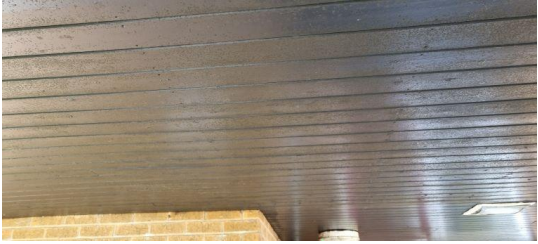
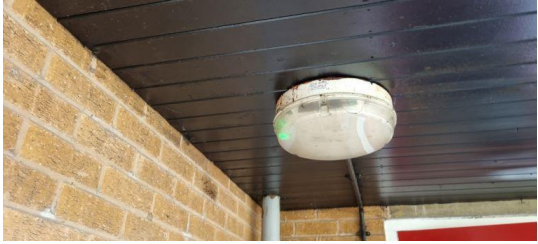
There is a canopy that connects the community centre with the premises opposite which is under boarded with wooden cladding. It was not possible to establish if the cladding is fire rated.

Management should confirm fire rating of wooden cladding. Where the cladding is not fire rated it should be replaced with fire rated materials.

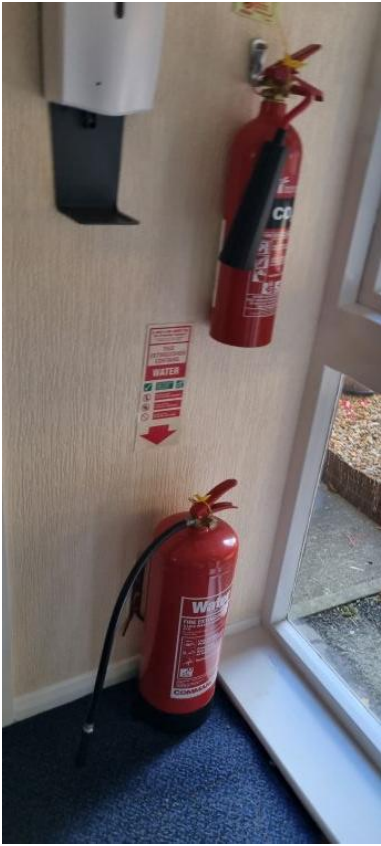
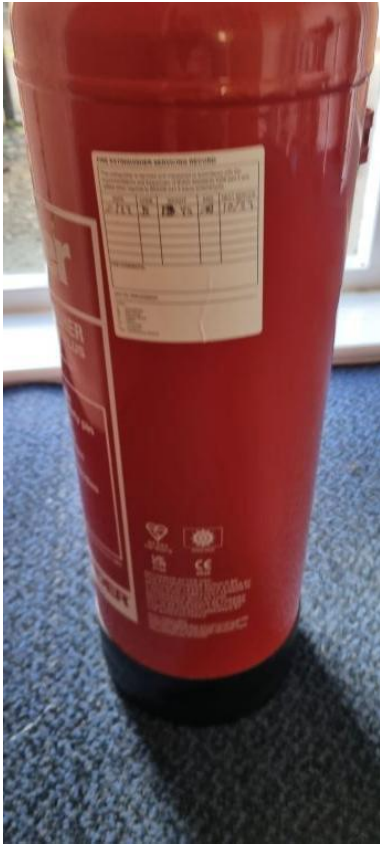
A 9Ltr 27A Water and 2KG CO2 extinguishers are installed. Extinguishers are maintained under service contract with Harmony. The last service was completed in November 2022. In addition, community centre users are unlikely to be trained on the use of FFE and no signage is displayed to state 'only to be used by trained persons'

Management should display signage at fire points to state 'extinguishers should only be used by trained persons'.
