Futures Fire Risk Assessment

Futures Homescape, Community Centre
Gladstone Avenue: DE75 7PU, - UPRN: 5 / 173542
/ QA Approved / Andy Cloke

Futures Homescape,
Community Centre Gladstone
Avenue: DE75 7PU, - UPRN: 5,
Fire Risk Assessments, Futures
Homescape

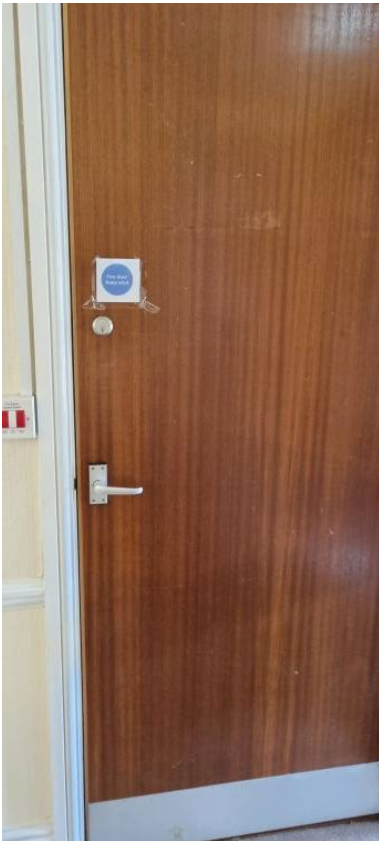
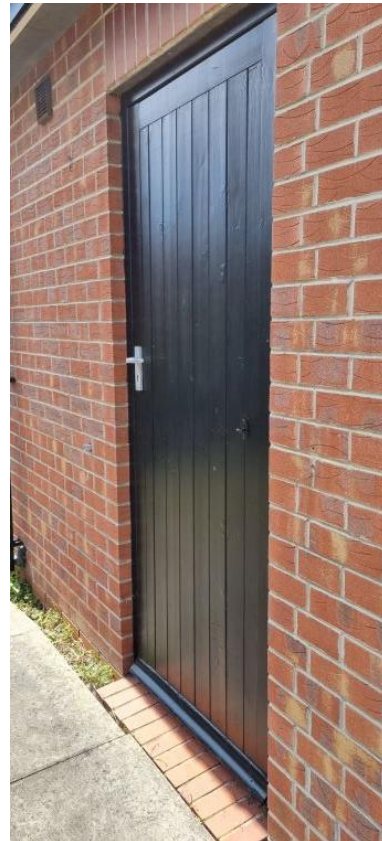
No electrical consumer unit was identified at the time of assessment. There is a locked cupboard and plant room that were not accessible and it was not possible to establish the date of the last fixed wiring test. Refer to Policy Principle.

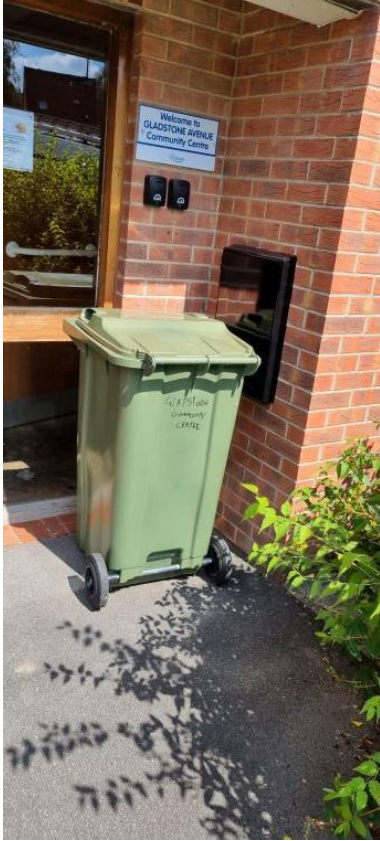
Photo 8

There is a wheelie bin stored against the entrance

Management should relocate the waste bin away from the premise wall in a suitable location.

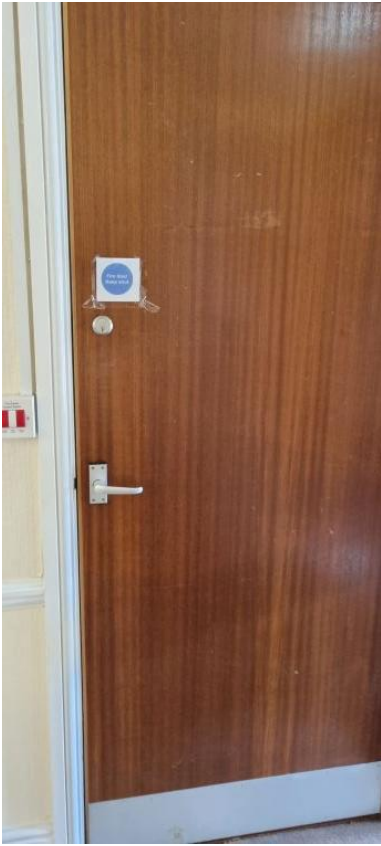
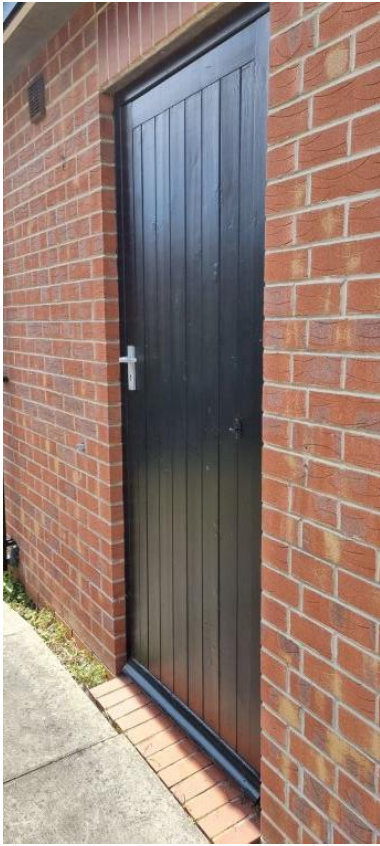
There is a locked cupboard within the community centre and a presumed plant room to the rear. It was not possible to establish if there are ignition risks present or combustibile materials stored within. In addition, it was not possible to establish if the internal cupboard door is fire rated or if there are any compartmentation issues within either cupboard.

Where ignition sources are present, the internal cupboard doors should conform to a minimum of FD30 specification. Where doors do not conform, they should be replaced with certified FD30 fire door sets. Any penetrations identified within the cupboard and plant room should be fire stopped with fire rated building materials. Any work required should only be conducted by a certified third-party contractor.

Management should ensure that no combustible materials are stored in proximity of ignition sources.

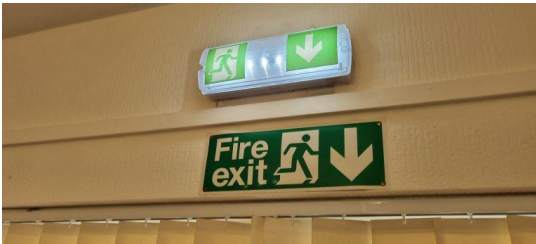
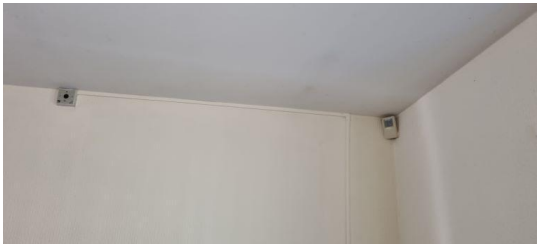
Conduit was noted above the rear exit. There is some other conduit present that is not likely to compromise safe egress. It was not possible to confirm that the requirements of Regulation 521.10.202 of the BS 7671 - 18th Edition of The IET Wiring Regulations, which requires all cables to be adequately supported using non-combustible fixings to prevent premature collapse in the event of a fire. The new regulation is not applied retrospectively so any wiring systems fitted before 2019 do not need to be immediately updated. Any new installation or additions and alterations to existing systems, including temporary wiring, have to comply with the regulations.

Management is to consider the requirements of the Regulation 521.10.202 of the BS 7671 - 18th Edition The IET Wiring Regulations which requires all cables to be adequately supported using non-combustible fixings to prevent premature collapse in the event of a fire albeit not retrospective and seek the advice of a suitably qualified competent person or organisation and undertake any remediation identified by the aforementioned competent person or organisation.

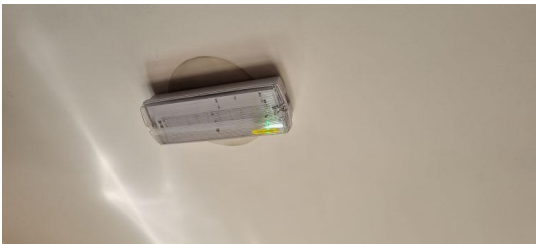
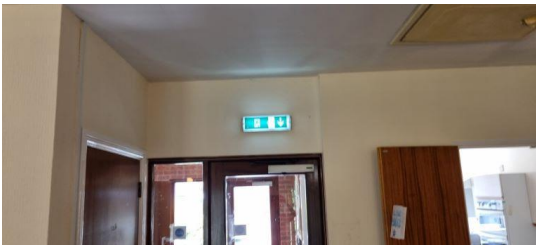
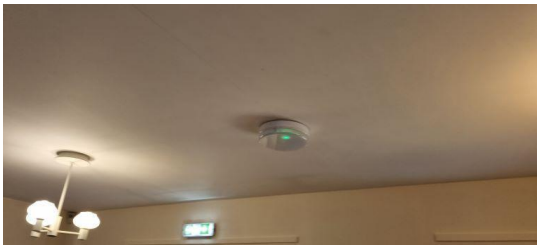
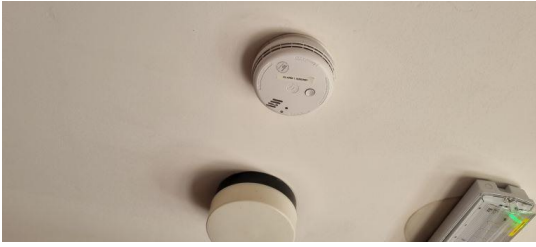
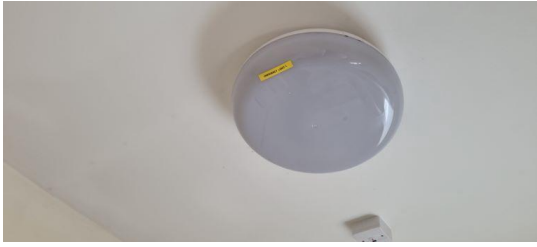
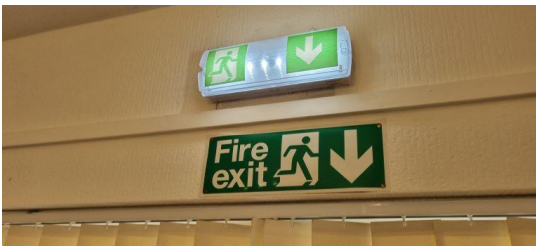
Emergency lighting is fitted and appeared sufficient. The unit to the toilets was defective.

The detective EL unit to the toilet requires repair.

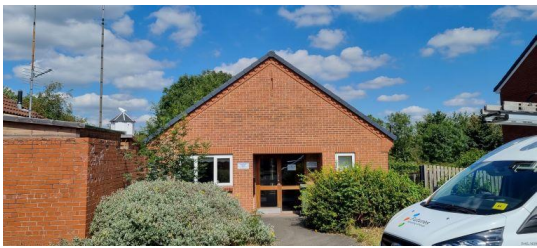
Photo 30

There was no emergency lighting detected to the front entrance.

An emergency light unit should be installed above the front entrance.

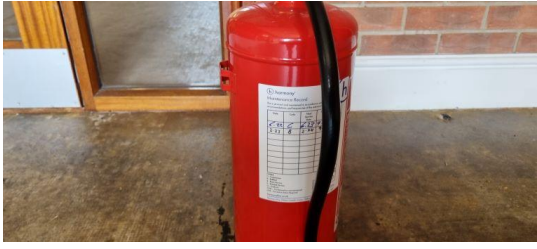
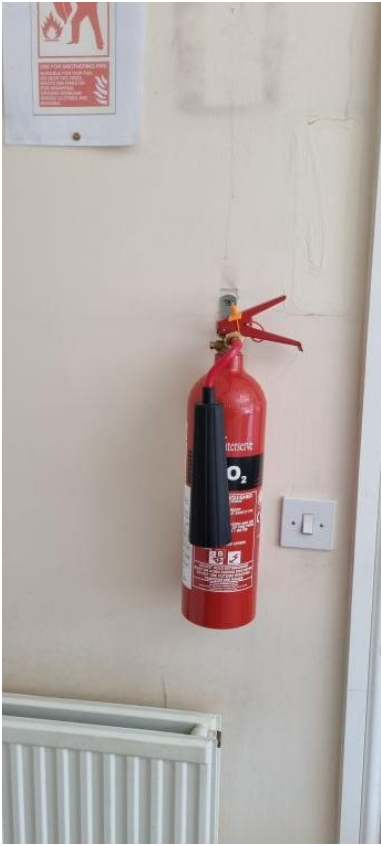
Extinguishers do not meet the requirements of BS5306: Part 8. There is only 1 x 6L 21A Water unit and 1 x 2KG CO2 unit present. BS5306: Part 8 requires that a minimum of 2 x 13A rated units are provided for compartments of up to 400 square metres. In addition, community centre users are unlikely to be trained on the use of FFE and no signage is displayed to state 'only to be used by trained persons'. Extinguishers are maintained under service contract with Harmony with the last inspection completed 02/23.

Management should display signage at fire points to state 'extinguishers should only be used by trained persons'. An addition 6L 13A Water / Foam unit should be installed in order to comply with BS5306: Part 8.
