Futures Fire Risk Assessment

Futures Homescape, Tower Court Flats
16-17: CB7 4SX, - UPRN: 15541 / 316076 /
QA Approved / Andy Cloke

Futures Homescape, Tower Court
Flats 16-17: CB7 4SX, - UPRN:
15541, Fire Risk Assessments,
Futures Homescape

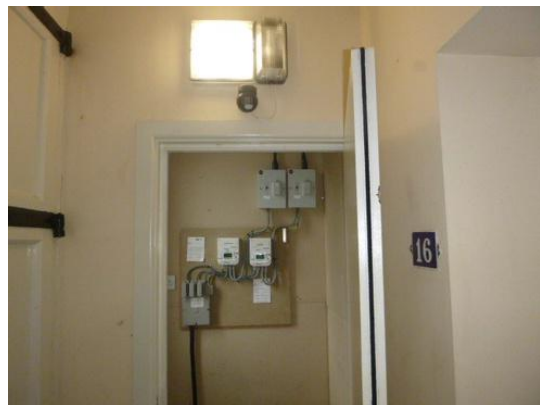
Photo 4

No labelling noted on the electrical intake cupboard, however refer to the policy statement.

Policy Principle: FHG complete Fixed wire testing in line with current regulations every 5 years and complete an annual visual inspection on all properties.

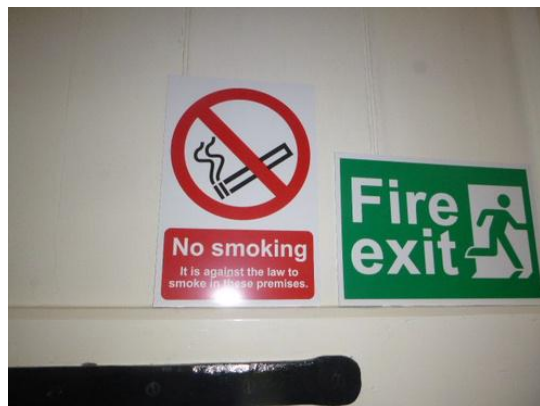
Photo 6

There was no evidence of any illicit smoking and adequate signage instructing persons not to smoke in the communal areas is displayed.

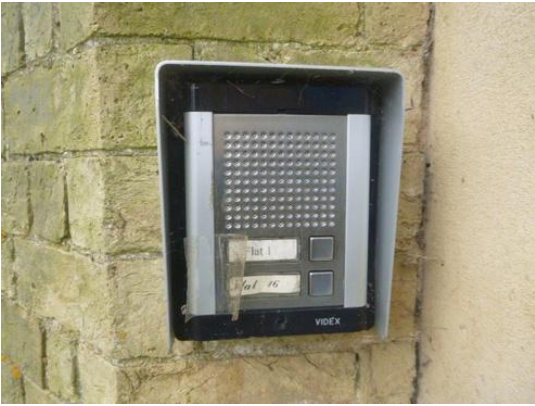
Photo 7

The single entrance into the building is secured locked shut. It can only be opened from outside by the resident's fobs/keys.

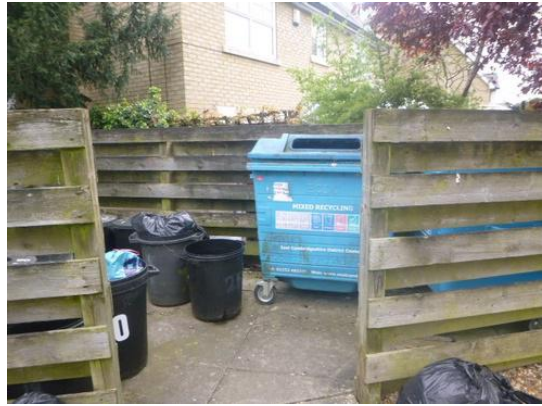
Photo 8

External bin store present, this was a sufficient and safe distance away from the premises.

Externally accessed bin compound for the use of the estate provided and is located sufficiently away from the building.

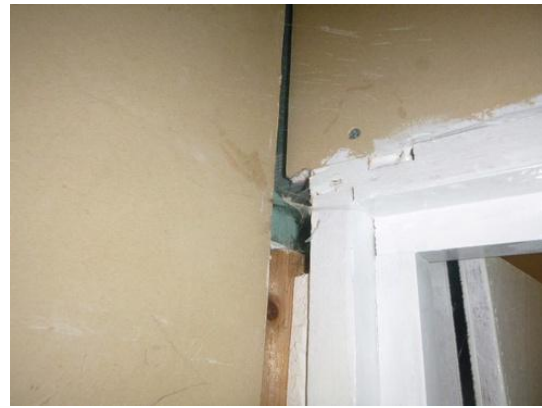
Photo 16

There appears to be small breaches in compartmentation around the internal frame of the door. Electrical intake cupboard is fitted with a FD30s door considered satisfactory.

Electrics located within the common area are to be enclosed with 30 minute fire resisting construction. Any works are to be completed by an approved third party accredited contractor.
