Futures Fire Risk Assessment

Futures Homeway, Flats 1-6 Frobisher Close:
NN11 4JH, - UPRN: 1850000 / 171916 / QA
Approved / Andy Cloke

14 Sep 2023

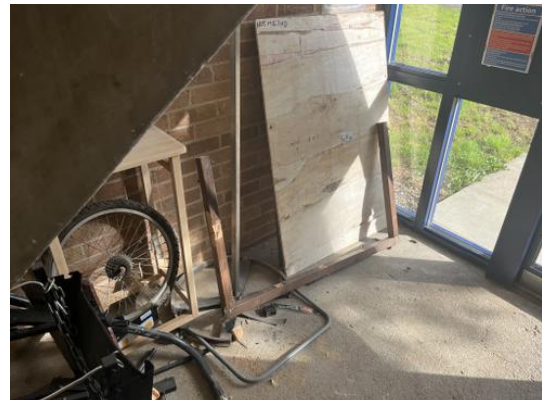
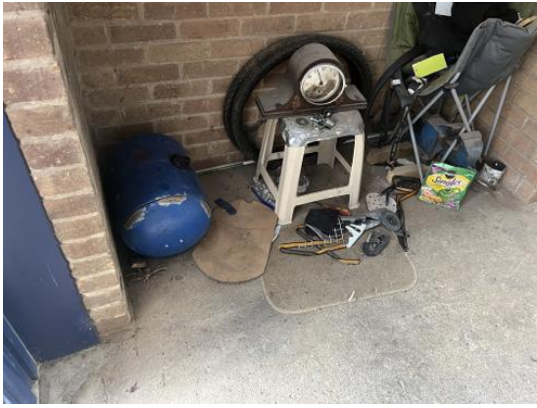
A large amount of miscellaneous materials had been discarded in the ground floor common areas.

The materials noted should be removed from the common areas as soon as is reasonably practicable. Residents should be informed that personal items are not to be stored in the common areas. Regular checks should be conducted to ensure compliance.

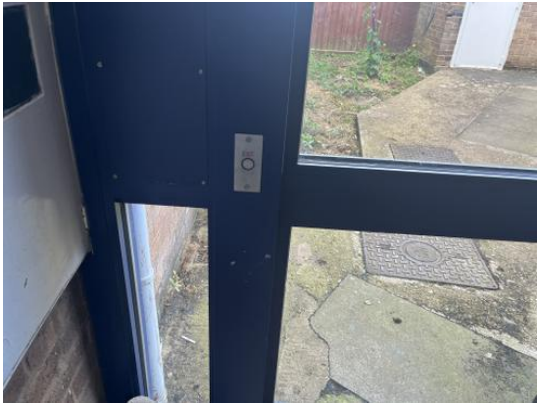
Photo 10

Push to exit release buttons are installed to the front and rear entrance doors for the block. IT could not be confirmed if doors default to open in the event of a power failure.

The client should conform that the exit system defaults to an open position in the event of a power failure, or that it is installed with a battery backup power supply. The omission of a manual override in accordance with BS7273-4 is noted and acceptable if the above is confirmed and if malicious activation risk is high. If the risk of malicious activation is deemed to be low, the client should consider the installation of manual override systems to the entrance doors of the block.

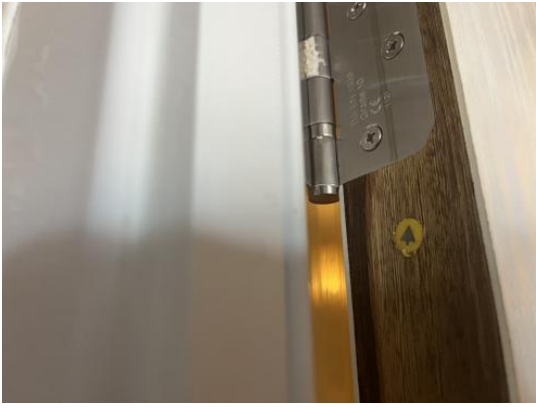
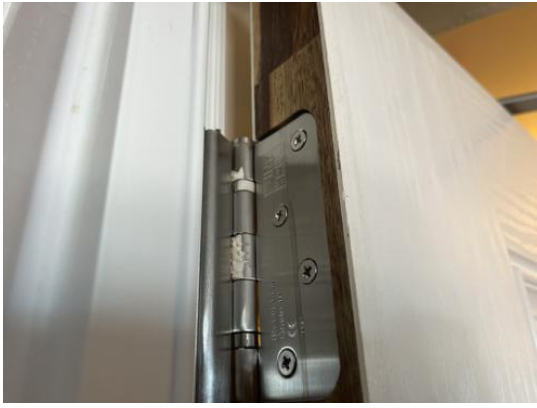
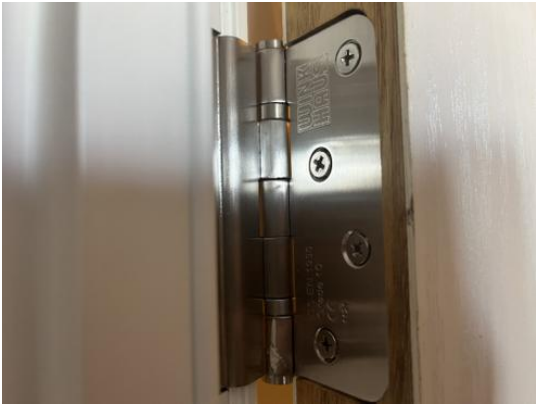
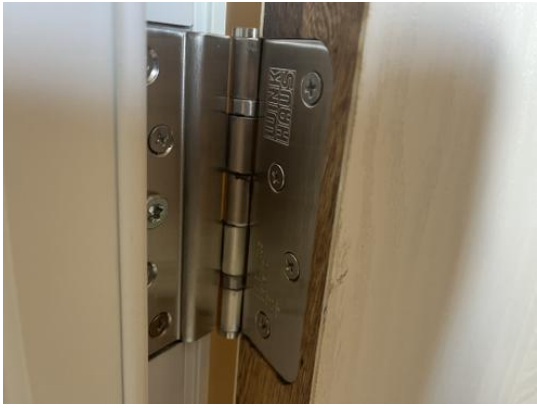
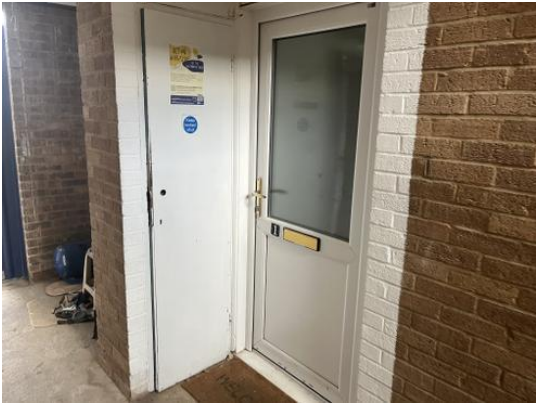
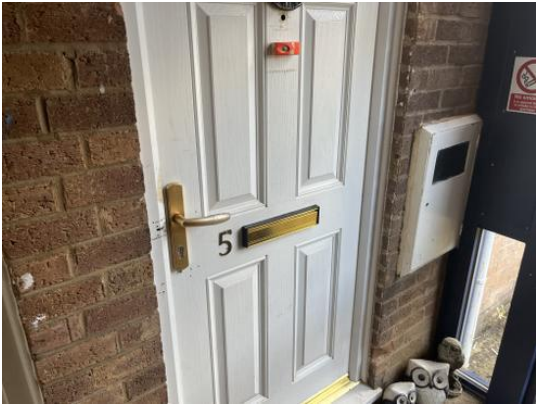
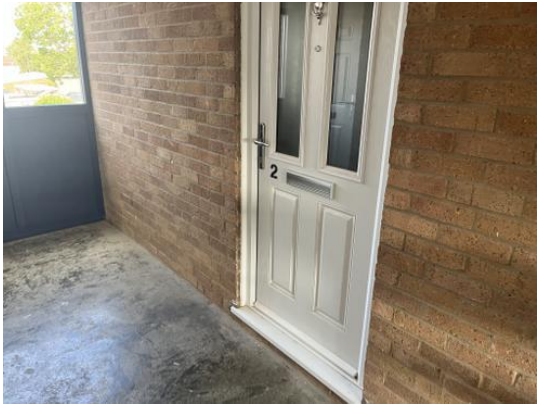
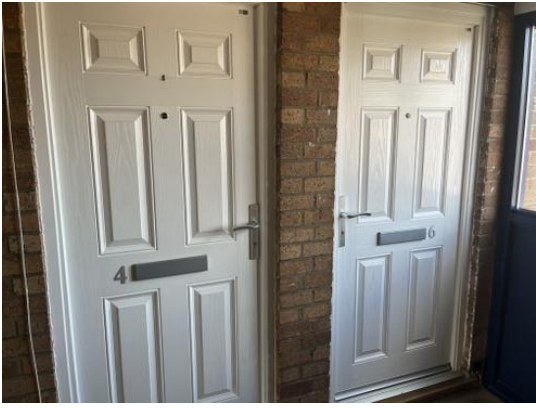
Flat entrance doors were seen to be a combination of replacement FD30 fire rated doors (flats 3, 4 & 6), replacement composite doors (flats 2 & 5) and a replacement uPVC door (flat 1). (NB. - from limited visual inspection, certification not seen; adequacy of installation not confirmed).

Sample inspection of flat 3 found the door to be a replacement certified FD30 solid core timber fire rated door. The door was installed with intumescent strips, cold smoke seals and a positive action self closer. The door was noted to be installed to a composite frame.

The client should ensure that the composite frame for flat 3 entrance door is approved/certified for use with the certified fire door installed. If approval for the frame cannot be obtained, it may be a requirement for the frame to be replaced with an approved alternative.

As flat entrances have been fitted with composite/uPVC doorsets, these should have test evidence demonstrating they meet the performance requirement in Building Regulations guidance for fire resistance and smoke control from the flat side only. Management should confirm that suitable fire door test certificates are held and that these relate to the doors fitted. If adequacy cannot be confirmed it may be necessary for doorsets to be replaced under a risk-based programme.

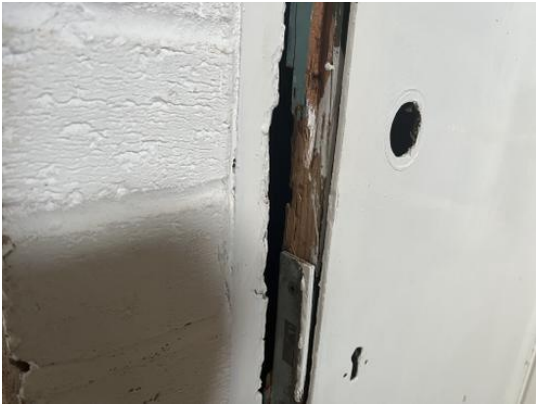
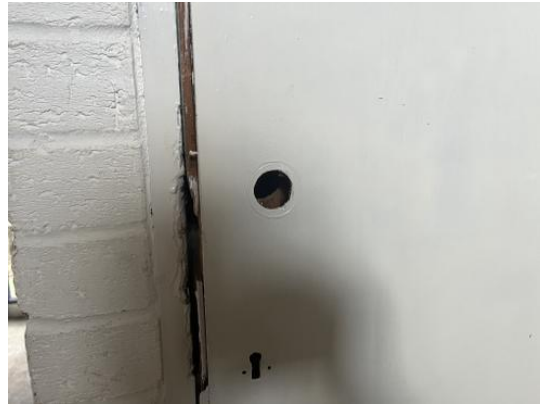
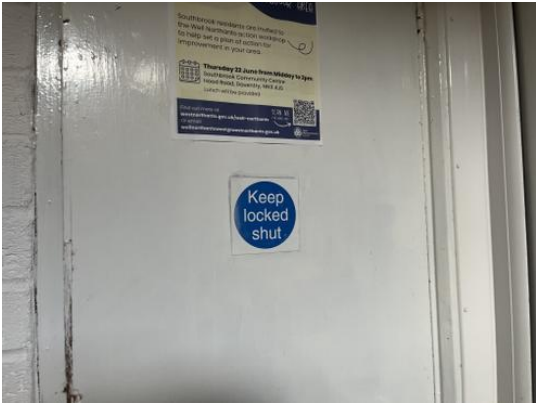
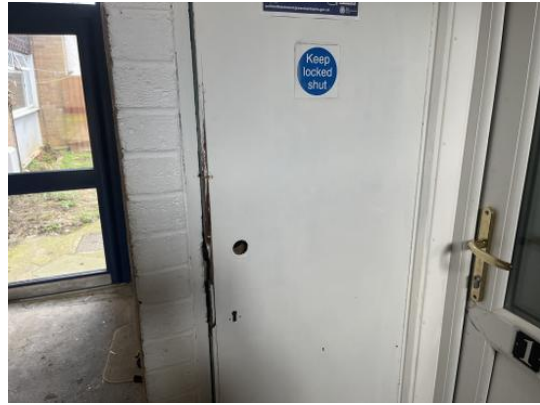
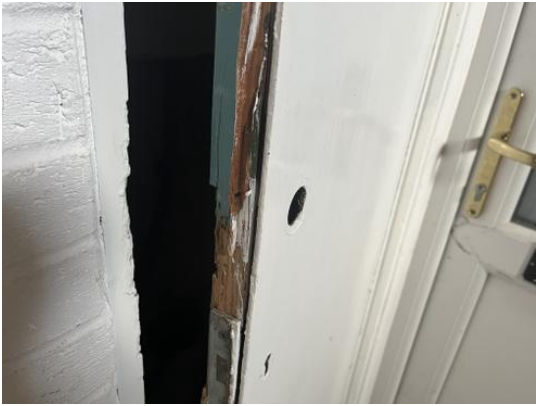
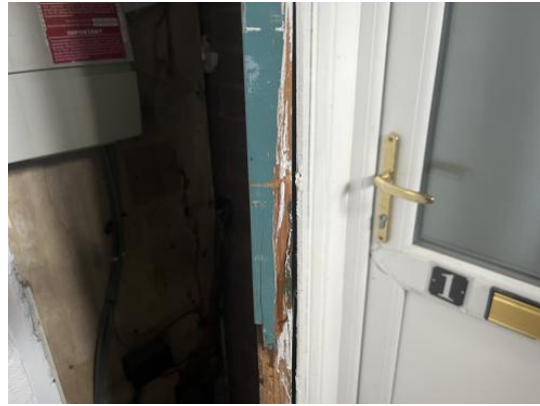
The electrical intake cupboard door could not be confirmed as adequately fire resisting. The door was also seen to be severely damaged requiring replacement.

The electrical intake cupboard door should be replaced with an FD30/S replacement fire door.

Remedial works should be completed by a competent third party accredited contractor.

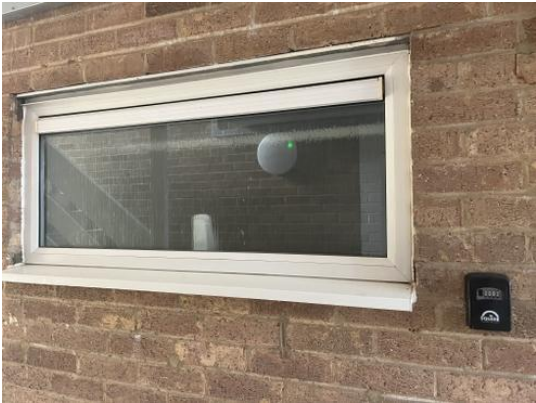
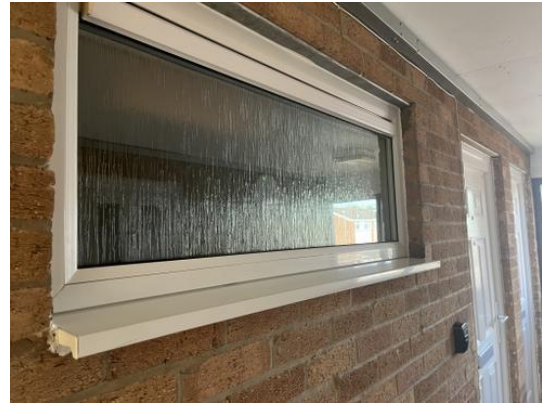
Windows from flats open directly onto escape routes. It is likely that the block was once open access and has since been enclosed with a new front and rear entrance wall and door.

The windows noted that open into the enclosed communal area should be replaced with non-openable 30 minute fire rated windows and frame assemblies. Remedial works should be completed by a competent third party accredited contractor.

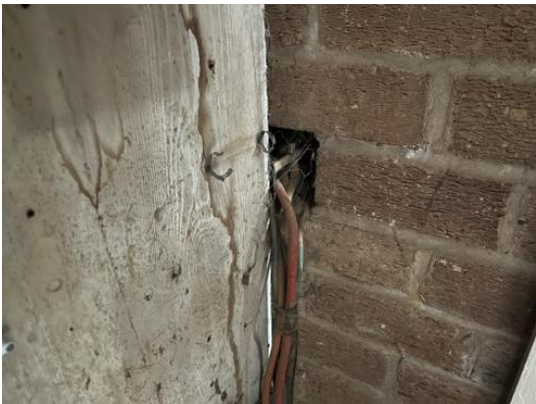
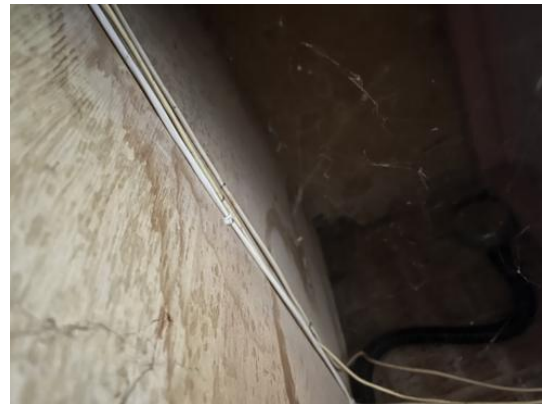
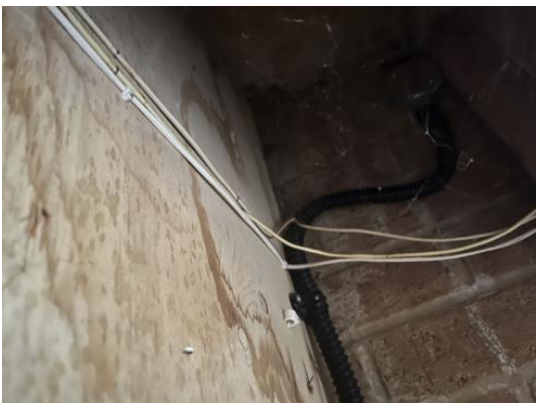
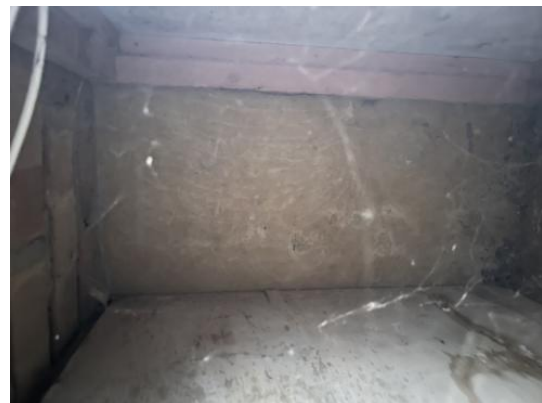
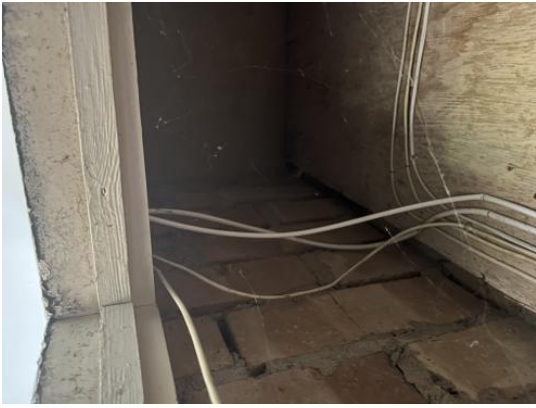
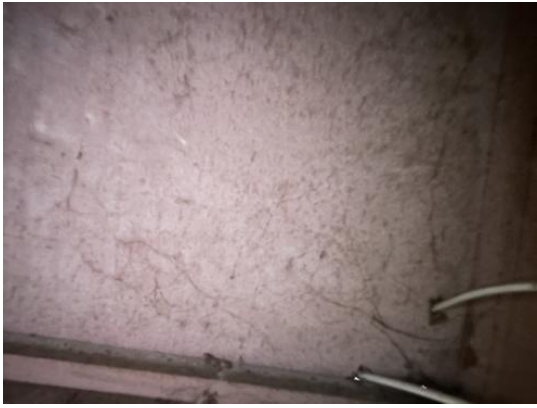
Internal compartment walls of the electrical intake cupboard did not appear to be fire resisting.

The electrical intake cupboard should be upgraded internally to ensure that it provided a minimum of 30 minutes fire resistance. All penetrating services should also be fire stopped. Remedial works should be completed by a competent third party accredited contractor.
