Futures Fire Risk Assessment

Futures Homeway, Flats 27- 33 Trafalgar
Way: NN11 4LY, - UPRN: 2650000 /
171958 / QA Approved / Piotr Iwan

Futures Homeway, Flats 27- 33
Trafalgar Way: NN11 4LY, - UPRN:
2650000, Fire Risk Assessments,
Futures Homeway

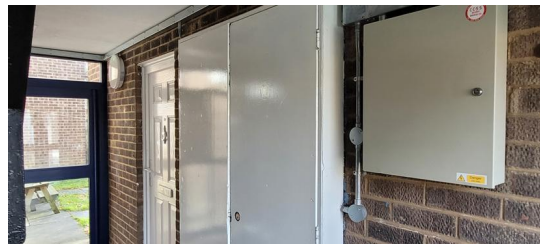
Photo 8

It was not possible to check for the presence of combustible materials in the electrical intake cupboard at the time of the assessment due to non-standard locks being installed.

It is recommended that the management inspect the electrical intake cupboard for the presence of combustible materials.

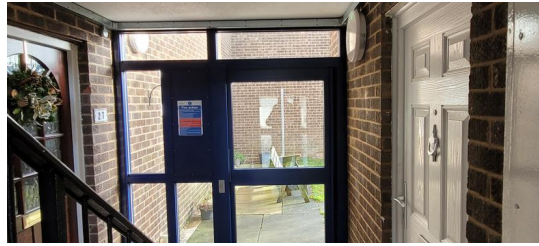
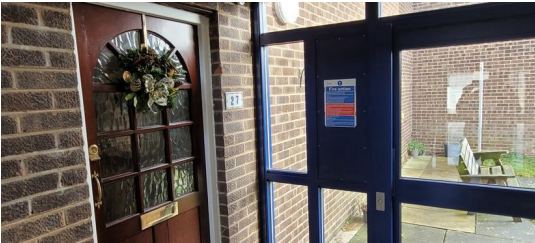
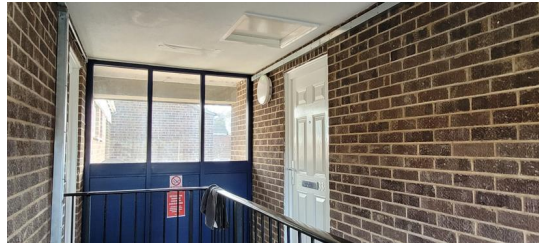
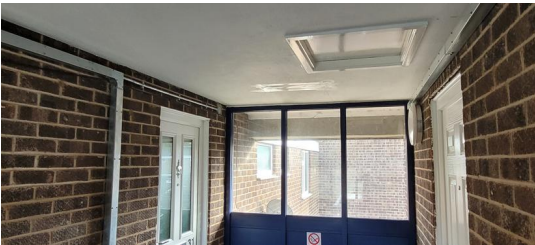
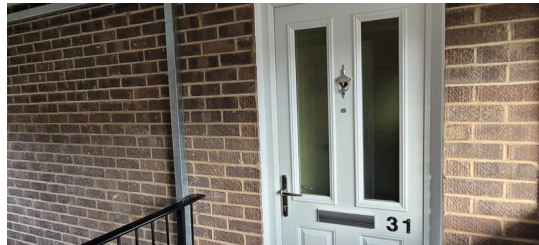
Flat entrance doors appeared to be replacement FD30 timber fire doors with the exception of flat 27 which appears to be a non-fire rated timber panel door and flat 31 which appears to be a replacement composite fire door. (NB. - from limited visual inspection, certification not seen; adequacy of installation not confirmed).

As flat entrances have been fitted with composite doorsets, these should have test evidence demonstrating they meet the performance requirement in Building Regulations guidance for fire resistance and smoke control from the flat side only. Management should confirm that suitable fire door test certificates are held and that these relate to the doors fitted. If adequacy cannot be confirmed it may be necessary for doorsets to be replaced under a risk-based programme.

Flat 27 does not appear to be a fire rated entrance door. This door should be replaced with an FD30 certified timber fire door unless certification of the current door can be provided. Remedial works should be completed by a competent third party accredited contractor.

Management should establish an ongoing programme of rolling checks to flat entrance doors to ensure they are installed with combined intumescent strips/cold smoke seals and positive action

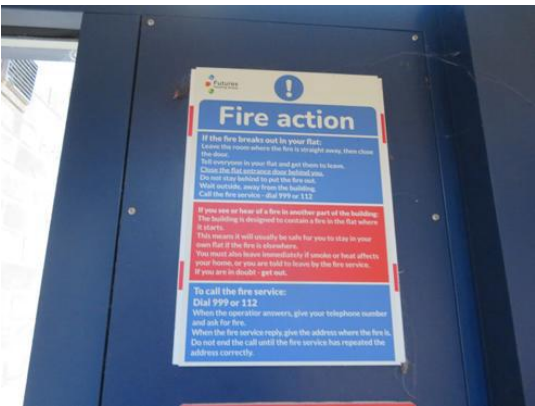
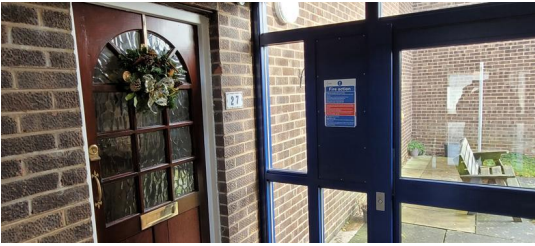
A fire action notice was installed to the common areas of the block denoting a 'Stay Put' evacuation strategy.

Fire door signage was not installed to the electrical intake door.

'Fire Door - Keep Locked Shut' signage should be installed to the electrical intake cupboard doors on the outer face of both leaves.

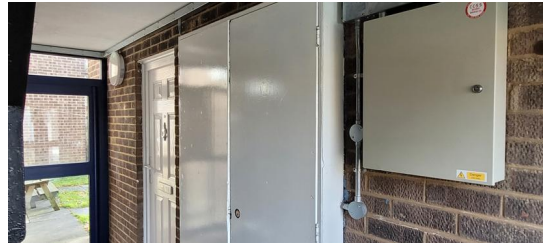
Photo 22

It was not possible to check the electrical intake cupboard at the time of the assessment due to non-standard locks being installed.

Management should check the electrical intake cupboard to ensure it is fully fire resisting and that all penetrating services are adequately fire stopped from both sides. Any remedial works must be completed by a third party accredited contractor.
