Futures Fire Risk Assessment

Futures Homescape, Tower Court Flats
1-6: CB7 4SX, - UPRN: 15541 / 316075 /
QA Approved / Emma Lipscomb

Futures Homescape, Tower Court
Flats 1-6: CB7 4SX, - UPRN: 15541,
Fire Risk Assessments, Futures
Homescape

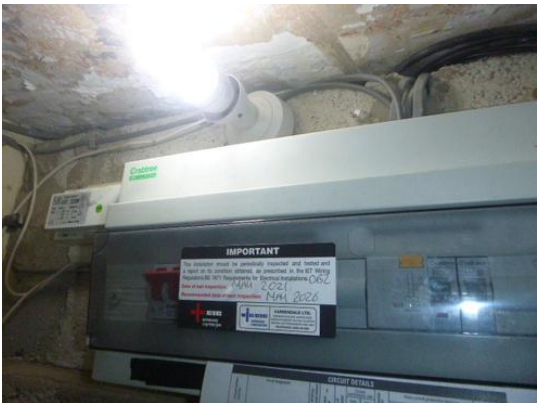
Photo 4

Labelling on the electrical intake equipment indicates the date of the current periodic electrical test being completed in May 2021.

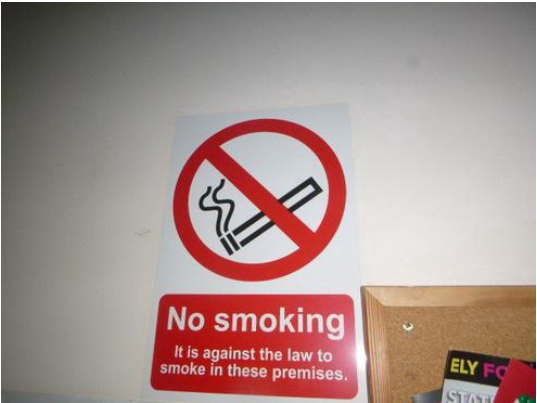
Photo 5

There was no evidence of any illicit smoking and adequate signage instructing persons not to smoke in the communal areas is displayed.

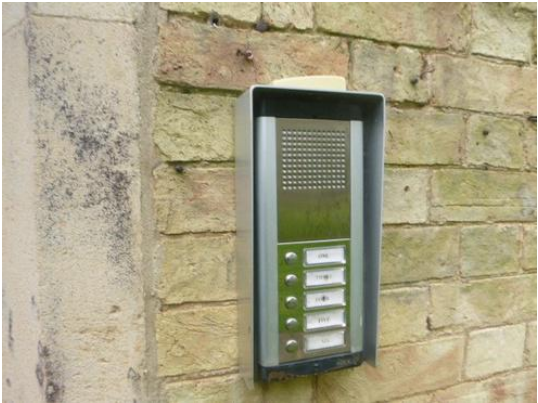
Photo 6

The single entrance into the building is secured locked shut. It can only be opened from outside by the resident's fobs/keys.

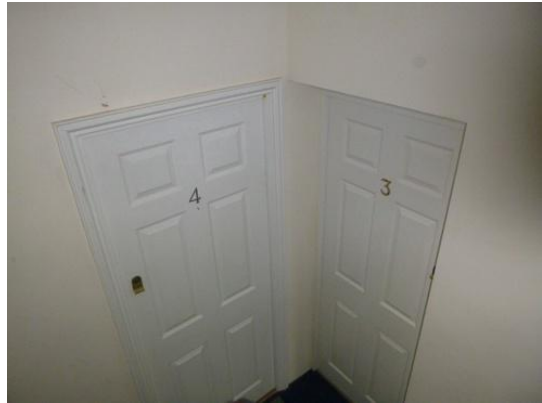
Photo 12

It was unable to be confirmed if flat entrance doors offer 30 minutes fire resistance. Ineffective flat entrance doors in a fire condition may allow smoke heat and fire to spread; this may impede escape and may cause physical harm to the occupants of the building.

Management to confirm that adequate FD30S certification is present for the flat entrance doors. If certification is unavailable, then a comprehensive fire door survey should be undertaken to the flat entrance doors by a competent 3rd party accredited company. Any recommendations from such a survey should be implemented as soon as practicable.

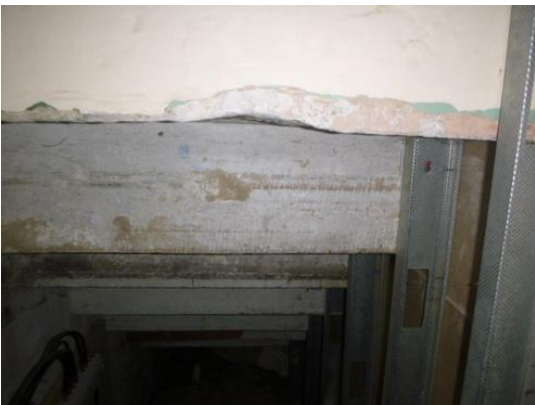
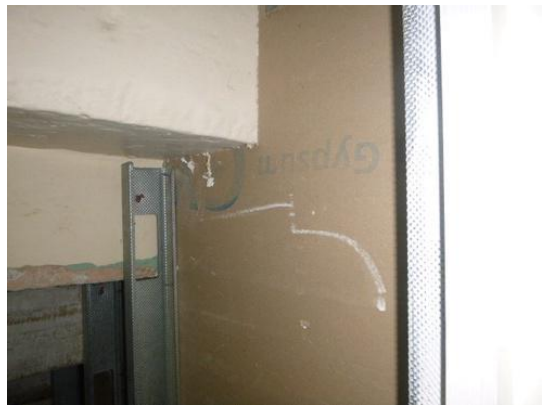
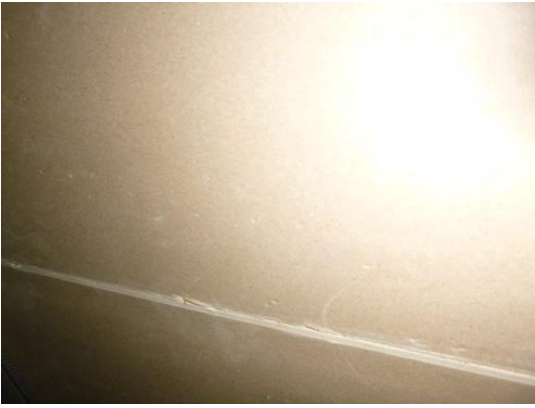
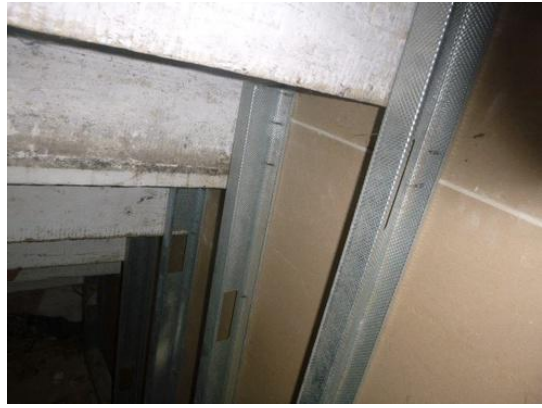
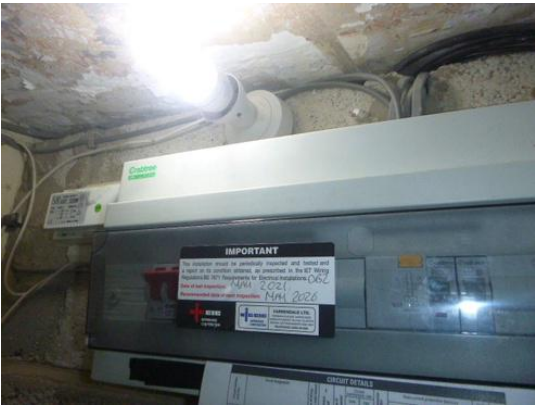
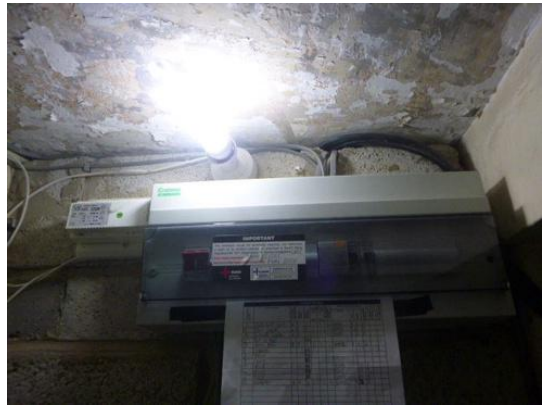
There appears to be a breach in compartmentation around cables exiting the electrical intake cupboard, in addition the cupboard is fitted with a FD30s door which was found locked at time of assessment.

Permanently seal the breaches in compartmentation as noted with appropriately rated fire resisting material. Any works are to be completed by an approved third party accredited contractor.
