Futures Fire Risk Assessment

Futures Homeway, Flats 37-47 Arnull Crescent: NN11 5AZ, - UPRN: 1250000 / 171954 / QA Approved / Piotr Iwan

Futures Homeway, Flats 37-47
Arnull Crescent: NN11 5AZ, -
UPRN: 1250000, Fire Risk
Assessments, Futures Homeway

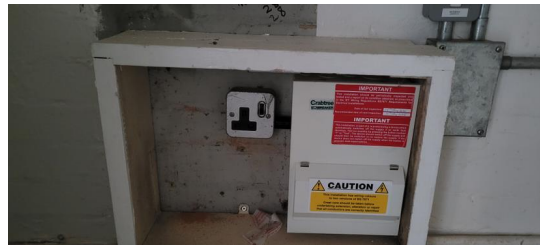
Photo 4

A single outlet was located adjacent to the electrical intake for the common area. This was open access and available for abuse by unauthorised users.

The electrical intake cupboard should be kept locked to prevent unauthorised access.

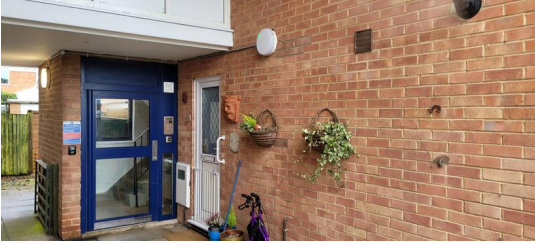
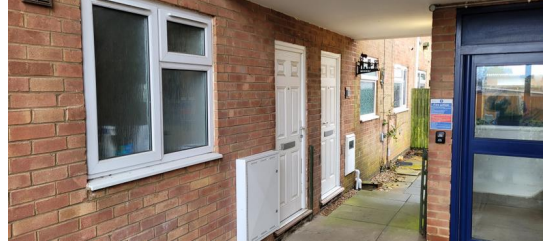
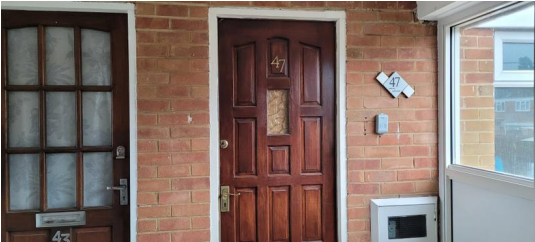
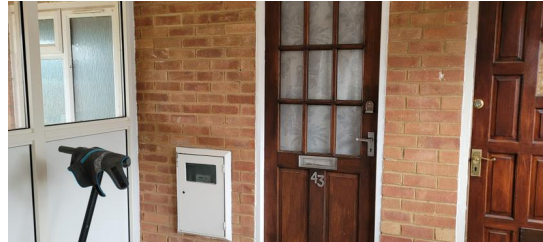
Flat entrance doors appeared to be a combination of replacement timber panel doors, replacement uPVC doors and replacement FD30 timber doors. (NB. - from limited visual inspection, certification not seen; adequacy of installation not confirmed).

Flat 37 is a uPVC door. Due to posing a passing a risk to residents evacuating, this door is required to be fire resisting.

Flats 43 & 47 are replacement timber panel doors that aren't believed to be adequately fire rated.

A baby gate is installed to flat 37 entrance door which could hinder escape of residents in the event of a fire situation.

Flats 37, 43 & 47 entrance doors should be replaced with FD30S fire rated flat entrance doors installed with overhead positive action self closing devices. Remedial works should be completed by a competent third party accredited contractor.

It is recommended that the baby gate noted as installed to flat 37 is removed. Words of advice should be given to the resident to ensure they are aware of the importance of keeping escape routes clear from obstruction. Regular checks should be conducted to ensure compliance.

Management should establish an ongoing programme of rolling checks to flat entrance doors to ensure they are installed with combined intumescent strips/cold smoke seals and positive action self-closing devices.

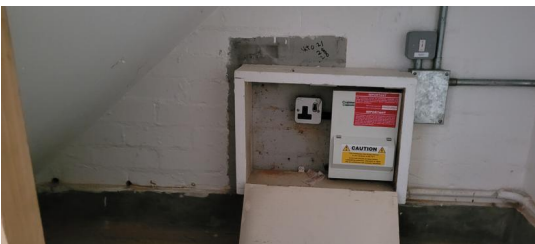
Photo 21

The communal electricity distribution board was not enclosed within fire resisting construction. This was located under the stairs directly on the means of escape.

It is recommended that the communal electrics are enclosed within 30 minute fire resisting construction including a 30 minute fire rated door. Remedial works must be completed by a third party accredited contractor.
